# PARROTT HALL

New York State Agricultural Experiment Station

## ARCHITECTURAL CONSERVATION ASSESSMENT

Prepared for the New York State Agricultural Experiment Station  
by Curtis Eaton  
Graduate Program in Historic Preservation  
University of Vermont  
Spring, 2000

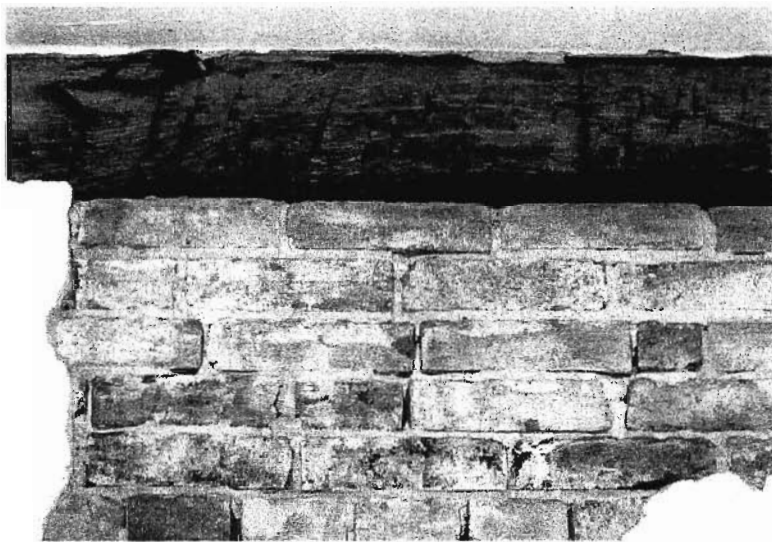
The building seems to be structurally stable. In 1984, Ms Hollings wrote the following: "The structural condition of Parrott Hall is also impressive, given the age of the building and its many years of heavy use. Structural appraisals by the Bureau of Historic Sites, while not exhaustive, have been favorable. Parrott Hall apparently has not suffered too badly from being unheated since 1971 (when the Experiment Station disconnected the steam and electricity lines to the building). There have been some moisture-related problems: periodic ponding in the basement worsened by the telltale lines of the water tower across the street; damage to the porch roof due to the lack of gutters; and the loosening of the cast iron window lintels caused by the rotting of their wooden-block anchors. The Bureau is addressing these problems, however, and believes that Parrott Hall will be able to withstand the adaptive uses under consideration."<sup>5</sup>

**Figure 4:** Plaster removed as part of 1970s building rehabilitation program reveals interior of brick bearing wall and hand hewn beam.

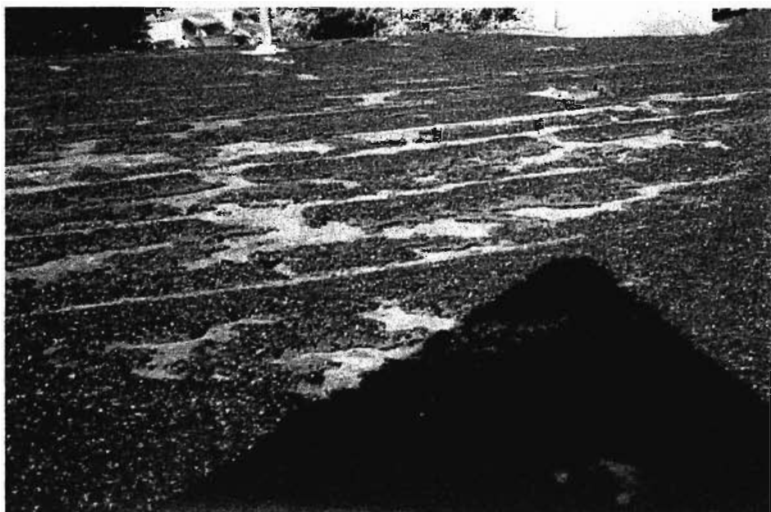
**Figure 5:** Roof of main block. View towards the west/northwest.

The original roofing material on both the main block and rear wing was a standing seam metal roofing. At some point after the property was purchased from the Dentons in 1882, the cupola at the pinnacle of the hipped roof above the main block was removed. In the mid-1970s, the metal roofing was replaced with asphalt rolled roofing as a temporary measure. There has been extensive loss of the asphalt surface as shown in Figures 1 and 2. The failure of the roofing system is the main source of unwanted moisture in the first, second and third floors of the building, as evidenced by buckled floors, peeling paint, mold growing on the plaster walls, and mildew on the wood.

The replacement of the roofing on the main block is critical to the survival of Parrott Hall. Rolled roofing should be installed until such time as the building reverts to Geneva Station and money is available for a more permanent roofing material similar to the original standing seam metal roofing. Gutters and downspouts need to be cleaned, repaired, or replaced, with downspouts directed away from the building. Leaders should be attached to all downspouts to ensure that water drains at least 10' away from building.

An architect, roofing contractor, or other qualified person should inspect the roof structure to determine the extent of moisture damage, if any, to supporting members of the roof prior to re-roofing the building. Flashing, gutters, and downspouts should also be inspected.

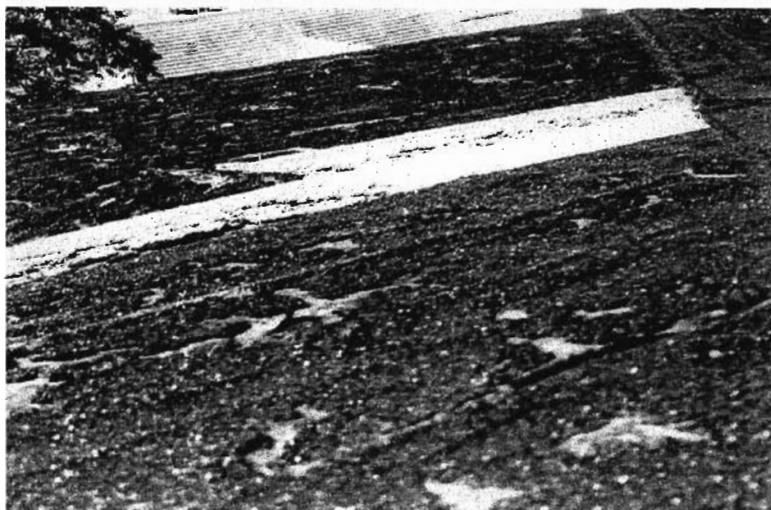
**Figure 6:** Roof of main block. View towards the south.

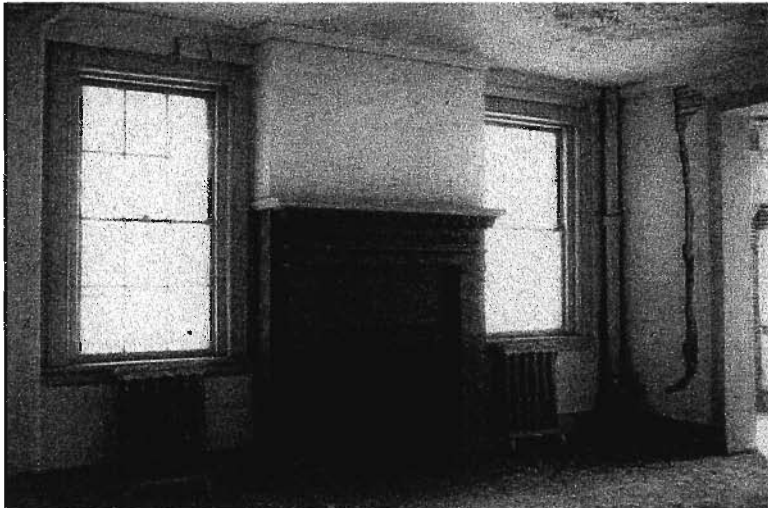
**Figure 7:** View of Room 103, east side of main block, showing 6/6 windows on either side of brick fireplace.

The window, the majority of which are six over six double hung sash, are in fairly good condition. The building is of brick construction and was painted in 1983, and little damage from moisture or vandalism has occurred since. However, windows are vulnerable to further damage from moisture and vandalism if the building continues to be unoccupied.

The interior of the building is in danger of severe deterioration from excess moisture. Oak woodwork (doors, windows, staircase) is being attacked by decay fungi of various sorts. The floor in Room 103 has buckled. Plaster, which was in the process of being repaired in the mid-1970s, is deteriorating.

If the building is to be mothballed, it is recommended that money be budgeted for vented plywood covers for at least the basement and first floor windows. This will preserve them until such time as they

can be repaired and repainted.

If the building will be put back into use in the near future (rehabilitation to begin within a year), nothing need be done to the windows. They provide ventilation for the building, which is an advantage when unwanted moisture is a problem. When the building is being prepared for occupancy, the windows should be repaired and repainted. This involves removing the sash from the window frame, scraping off the old paint, sanding the wood surface priming with a good quality oil-based primer, and painting with two topcoats of oil base paint. Several of the sills, especially those with southern and western exposure, will need to be filled with wood consolidant and filler before painting. (Abatron is a brand that has been used with success by John Leeke, a Preservation Consultant who specializes in wood window repair.)

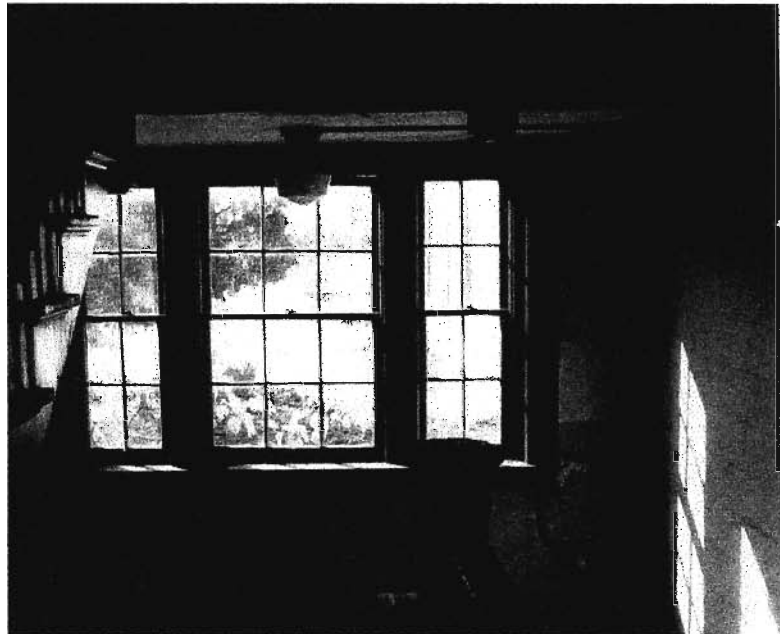
**Figure 8:** View of landing between first and second floors showing three-part window.

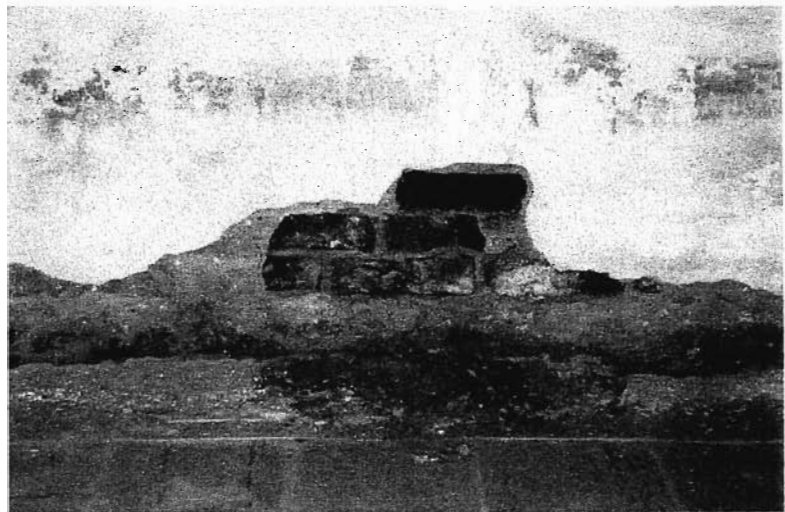
Due to the lot sloping downhill from front to rear, the basement of the main block is partially below grade, while the wing basement is substantially above grade. It is the basement of the main block that is of primary concern as more unwanted moisture enters this portion of the building. However, there are problems with rising damp in the wing portion as well and attention should be paid to the entire basement. Water is entering the basement of the main block through condensation in the summer, rising damp throughout the year, and apparently from a broken pipe in the vicinity of the northwest corner of the foundation.

**Figure 9:** Evidence of rising damp in Room B-10 showing destroyed plaster and efflorescence on underlying brick.

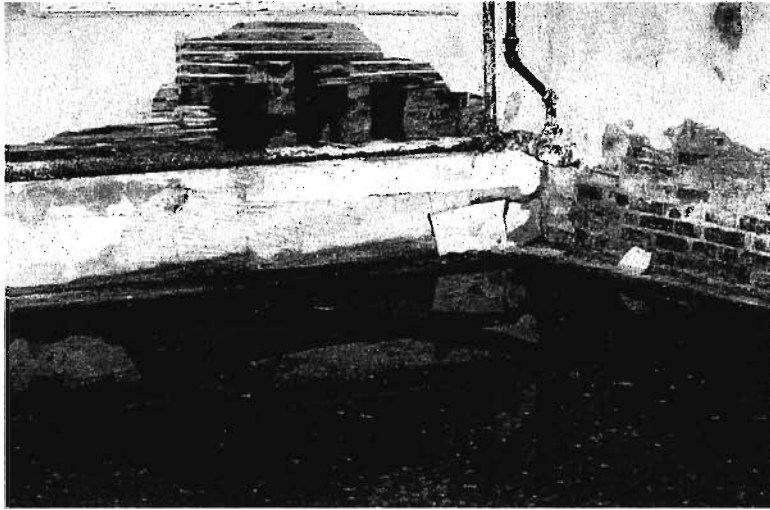
Moisture damage is severe in several areas, and includes mold, peeling paint, and dry rot. There is bulk water infiltration in the northwest corner of the building, creating a pool of water two feet deep in Room B-5 (see Floor Plans, Appendix D). It can be assumed that water is seeping through the foundation at this location. A sump pump, probably the original, is located in this room but is non-operational since electrical service has been disconnected.

**Figure 10:** Standing water in Room B-5, basement.

Standing water should be pumped out as soon as possible. The original sump pump should be brought back into service or a new sump pump should be installed in the basement, at least temporarily, in Room B-5. Drainage around the building should be improved to ensure that water from the roof does not enter the basement, either through seepage or as a contributing cause of rising damp. A dehumidifier should be installed as soon as is practicable, and cross ventilation should be improved by installing vents in doors and windows in several locations.

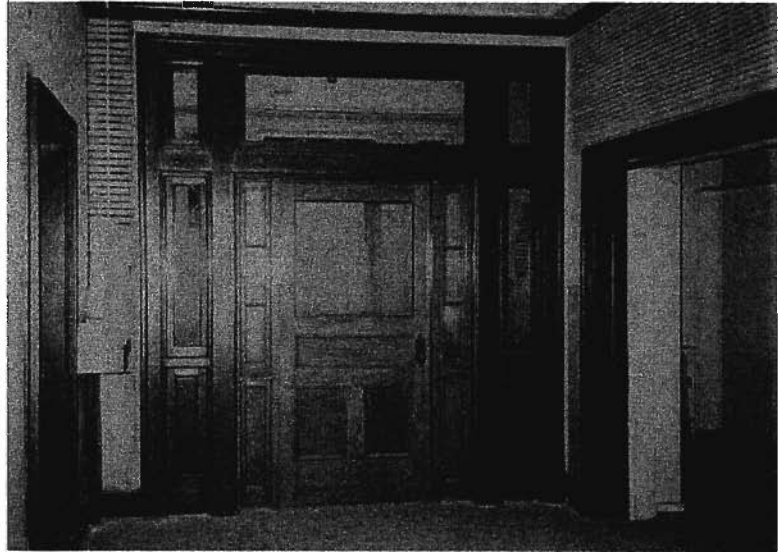
**Figure 11:** View of front entrance leading to vestibule from central hall. Opening to parlor on right has built-in sliding doors.

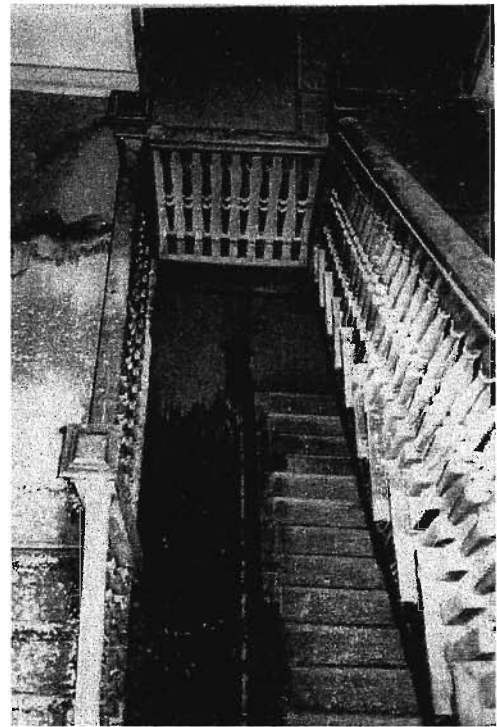
**Figure 12:** Central staircase, showing litter from flaking paint.

First, unwanted moisture must be controlled to reduce the moisture content of plaster and wood in the building. Plaster repair can be done after moisture levels have been reduced to below 15%. Once cured, plaster should be primed and painted with oil base paint.

Wood floors and interior woodwork can be refinished only after moisture levels are reduced to below 15%, also. Wood subjected to long-term moisture should be treated with a fungicide prior to refinishing. Where decay has progressed, wood should be repaired with wood consolidant and filler, or if necessary replaced using the same kind of wood with a similar grain. Floor and ceiling molding, and window and door frames should be sanded, primed and painted with an oil base paint.
