Under the Big Apple: a Retrospective of Preservation Practice and the New York City Subway System

UNDER THE BIG APPLE:
A RETROSPECTIVE OF PRESERVATION PRACTICE AND THE NEW YORK
CITY SUBWAY SYSTEM

A Thesis
Presented to the Faculty of the Graduate School
of Cornell University
In Partial Fulfillment of the Requirements for the Degree of
Master of Arts

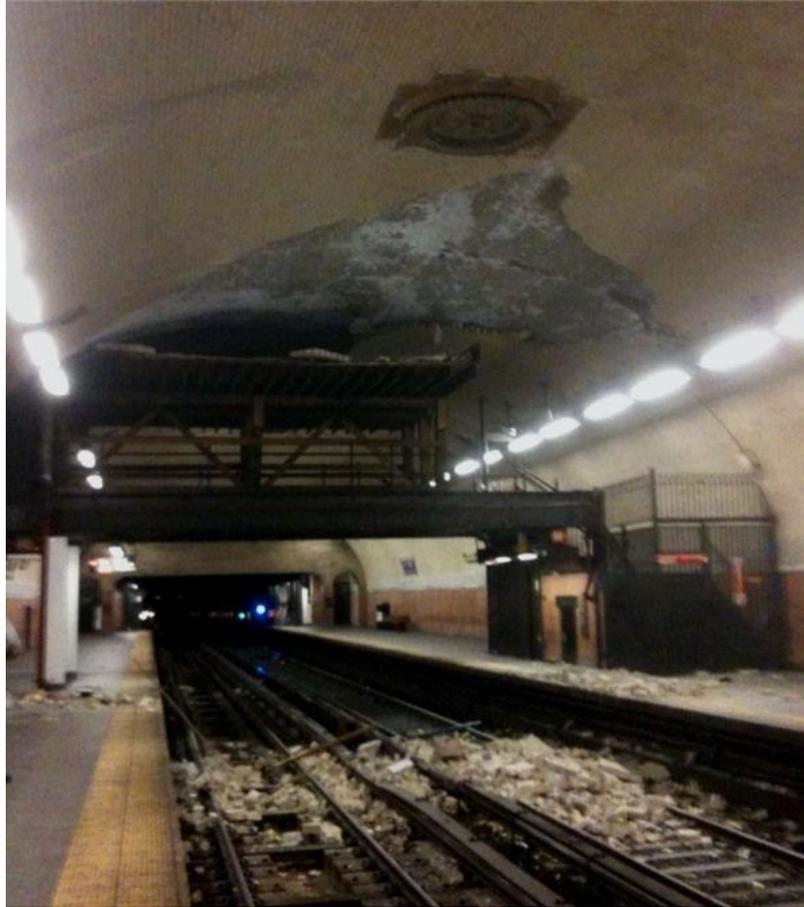
Figure 1: Collapse of the 181st Street Station on August 17, 2009. From MTA NYCTA.

The August collapse of the 181st Street station did not come without warning. Community groups had raised flags over the condition of the station, and in 2007 the bricks from the ceiling were known to not be structurally sound. Scaffolding was put up to protect pedestrians but repairs seem to have been postponed due to lack of funding.⁴ In recent years, the New York City Transit Authority (NYCTA), a subsidiary of the Metropolitan Transit Authority (MTA), has had to juggle

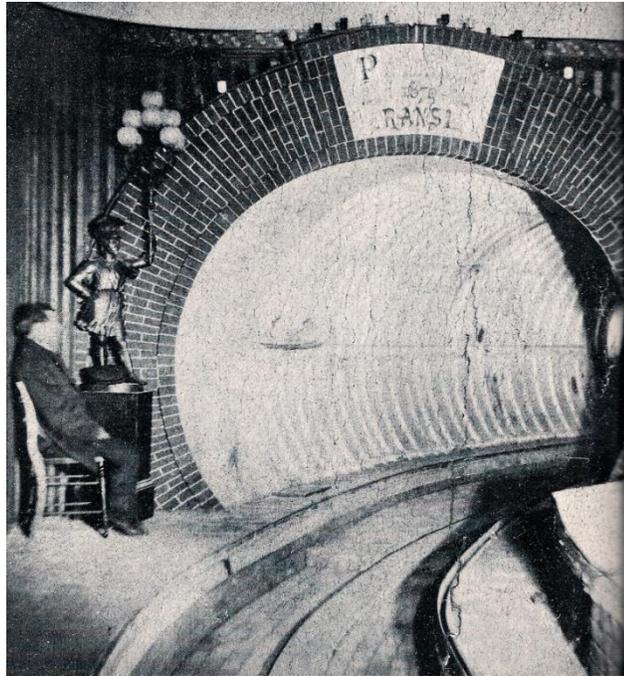
Figure 3: Station and tunnel of Beach's experimental pneumatic subway line. From the New York Historical Society.

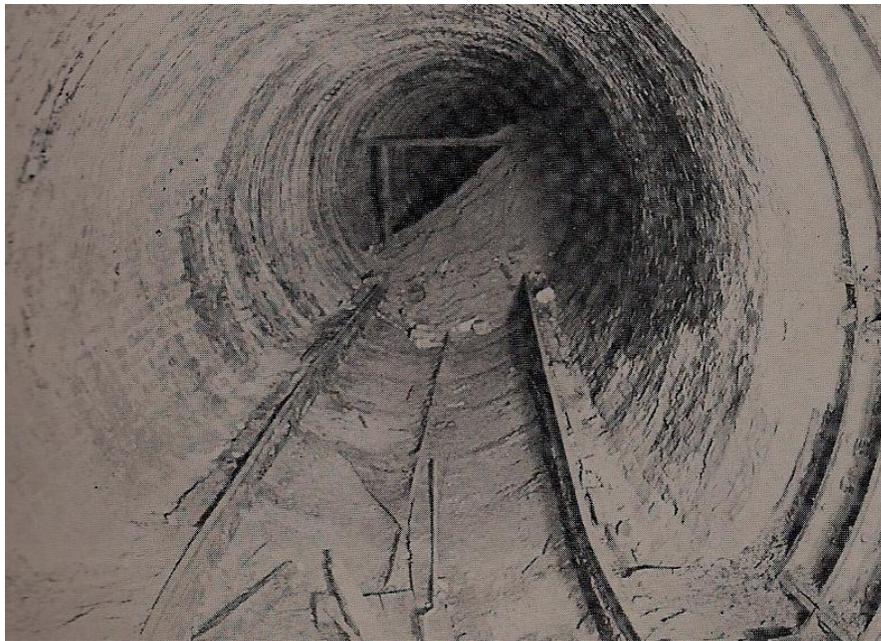
Figure 4: The discovery of Beach's tunnel in 1912. Taken from *Under the Sidewalks of New York* by Brian Cudhay, page 9.

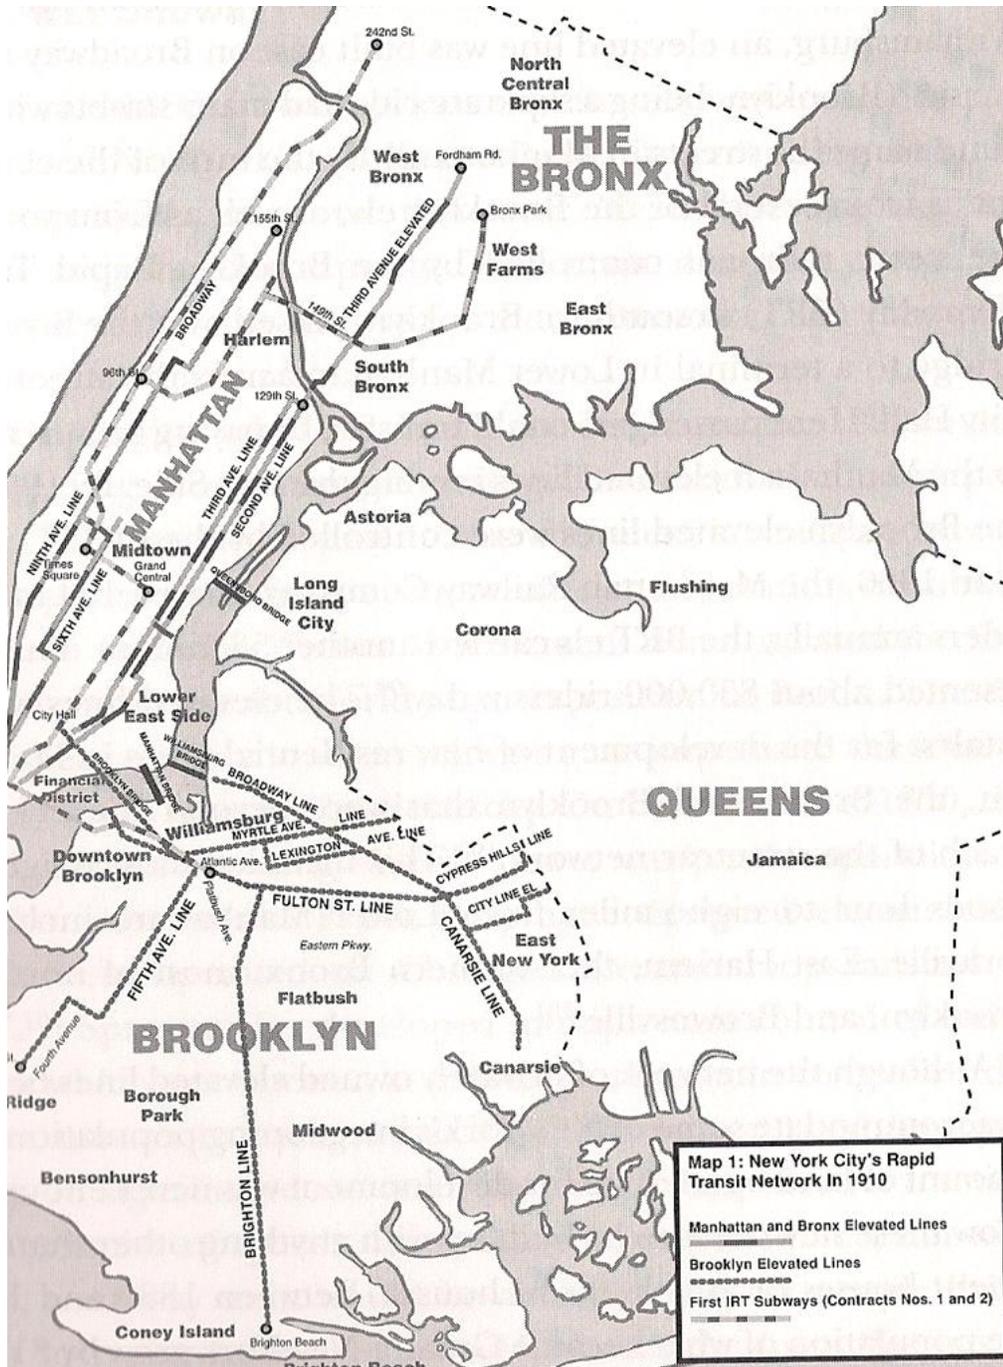
Figure 5: Map of rail lines in New York in 1910. Note the route of the first subway system. From *Tunneling to the Future*, page 31.

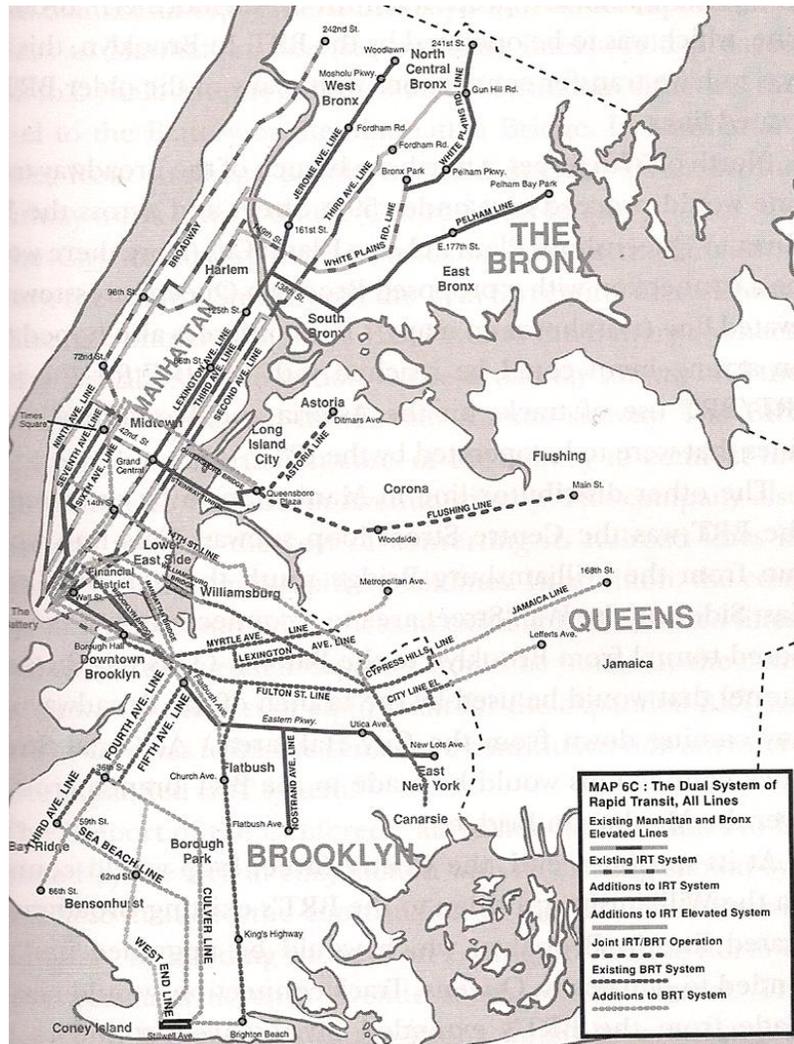
Figure 6: Map of the Dual System. From *Tunneling to the Future*, page 177.

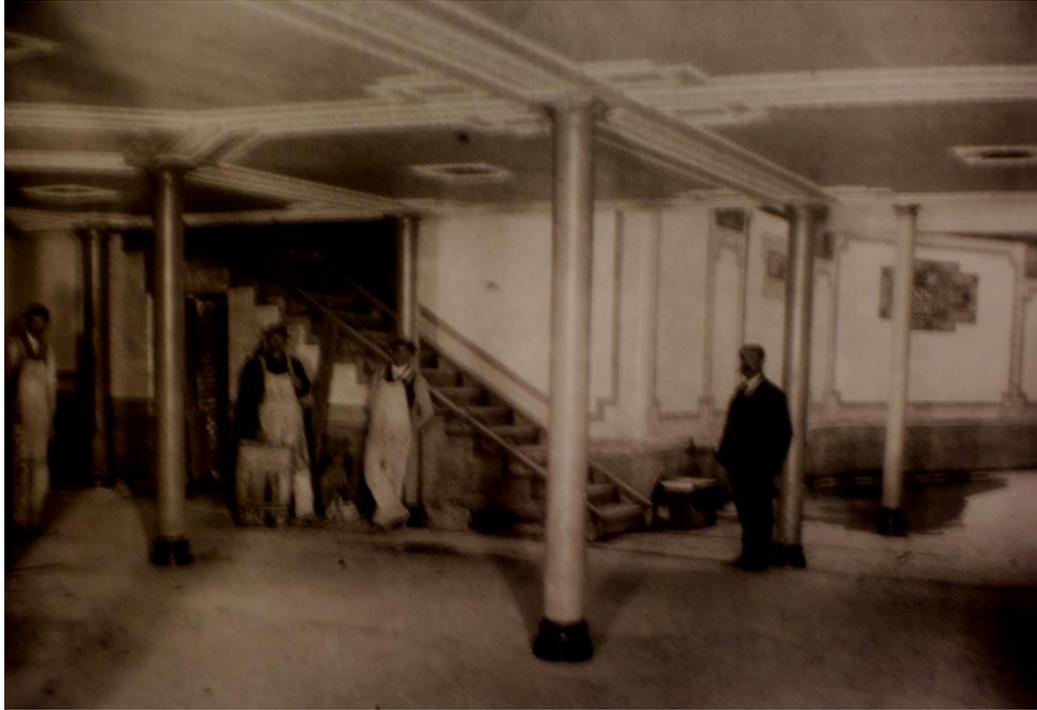
Figure 7: "Typical" Heins and LaFarge Station Design. 28th Street Station, circa 1917. From the Transit Museum.

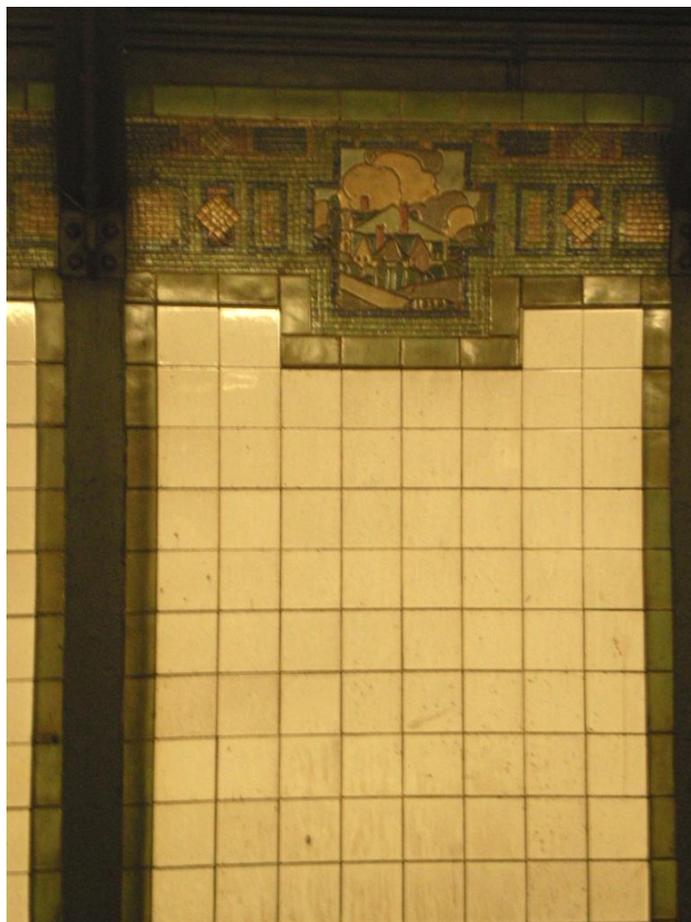
Figure 8: Typical Vickers Arts and Crafts station design. 14th Street/ Union Square. Photo by author.

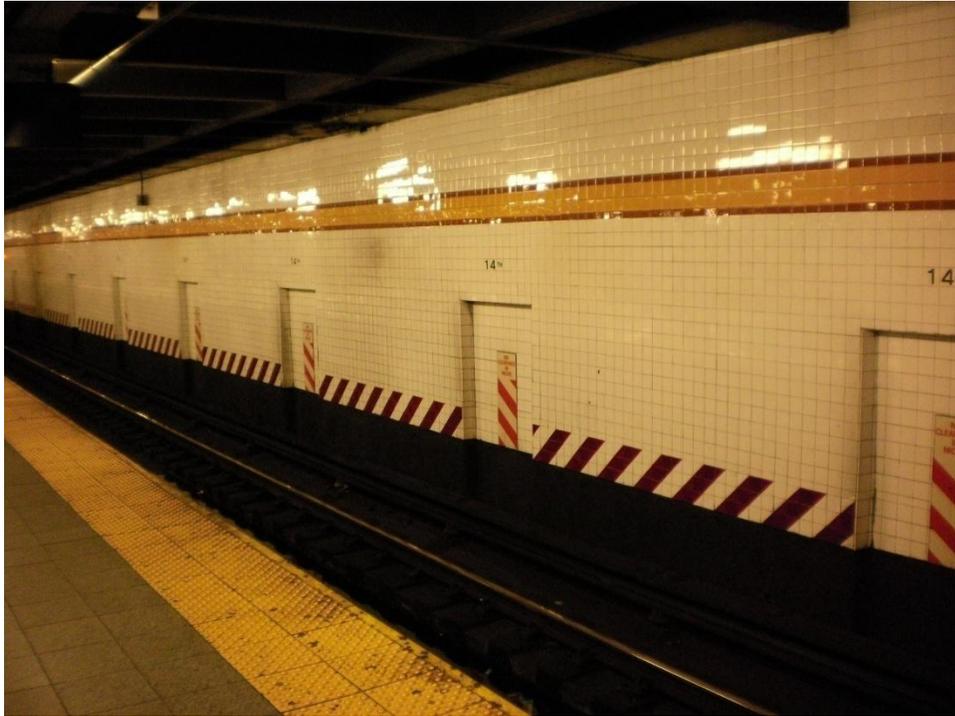
Figure 9: "Typical" station design by Vickers for the Machine Age. Lower level, 14th Street/ Union Square. Photo by author.

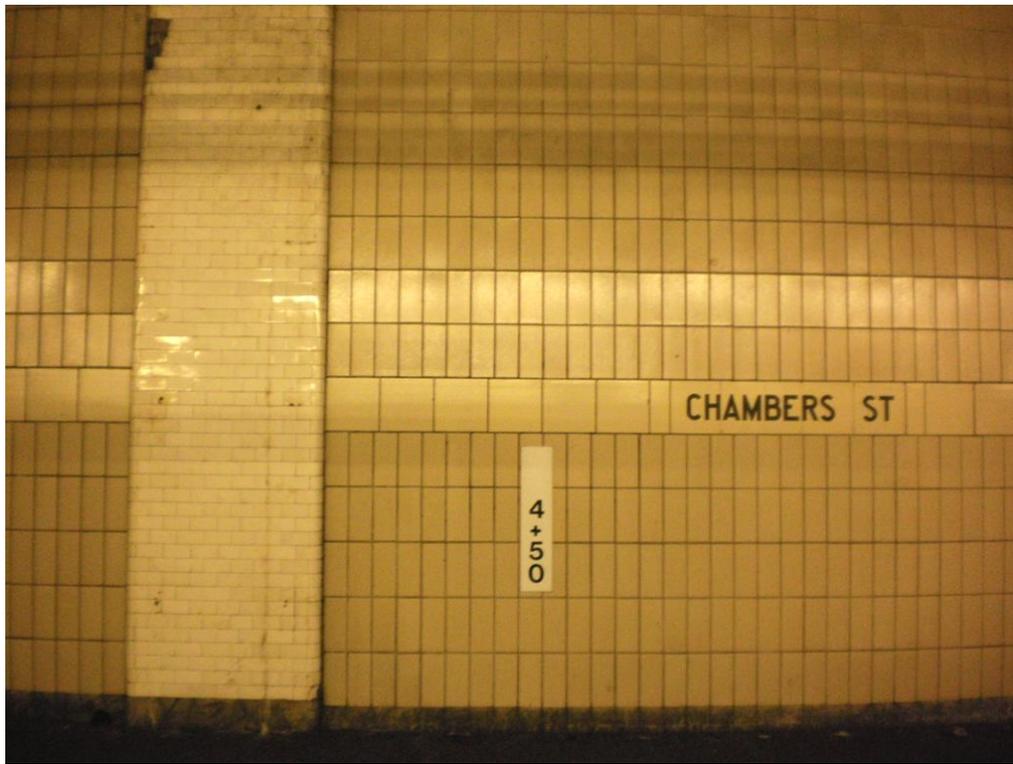
Figure 12: Example of a patchwork station repair at the Chambers Street Station. Notice the original white glazed tile cladding on the pilaster at left and the newer yellow-beige replacement tiles covering the wall. Photo by author.

Finally in 1981, the New York State legislature passed a Capital Improvement Program for the restoration of the New York City subway system to the tune of \$7.2 billion. Under this Capital Improvement Program, NYCTA selected 50 stations for modernization, seven of which were extensively documented by the Perkins & Will Partnership. The recommendations by Perkins & Will Partnership called for the preservation of certain elements of each of the stations, such as tile work, mosaics, and station exteriors.¹¹⁵ This is an early example of preservation recommended for the subway system and is at odds with the absolute renovation NYCTA had recently completed at the Bowling Green station. These recommendations for preservation were the exception, and not the rule. NYCTA continued to repair deteriorated stations with modern materials, often juxtaposing new dark-colored tiling next to the original white glass tiles on walls, giving stations rehabilitated at this time a hodge-podge appearance (Figure 12).

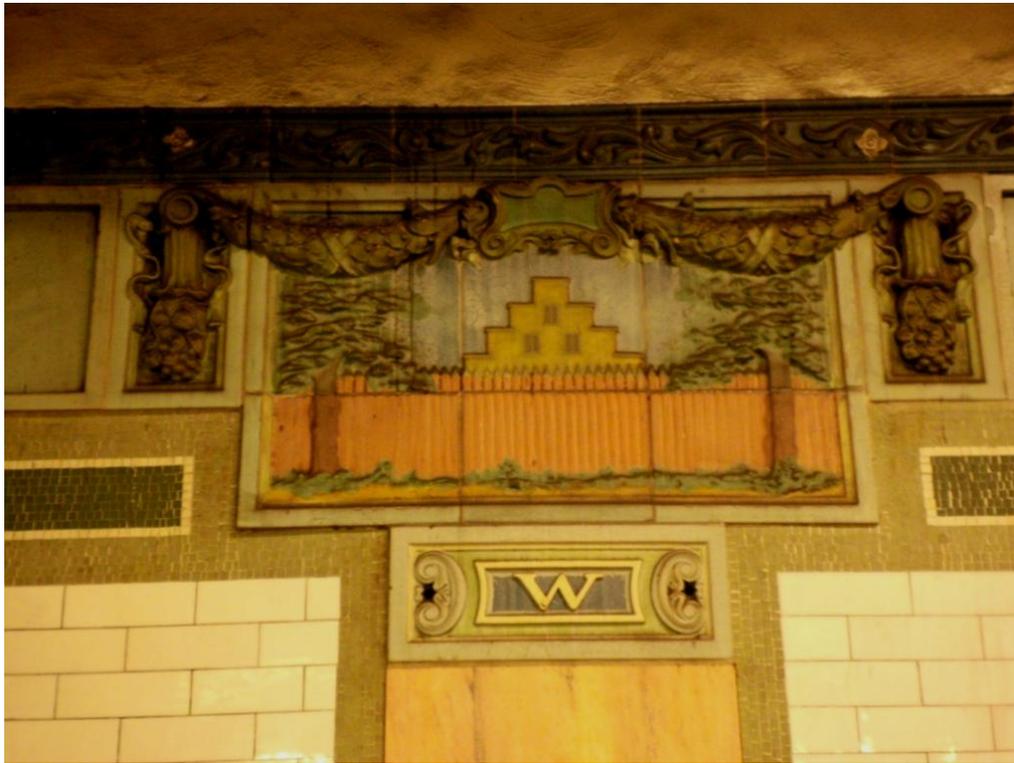
Figure 14: Pilaster with "W" capital and faience plaque with identifying station imagery. Photo by author.

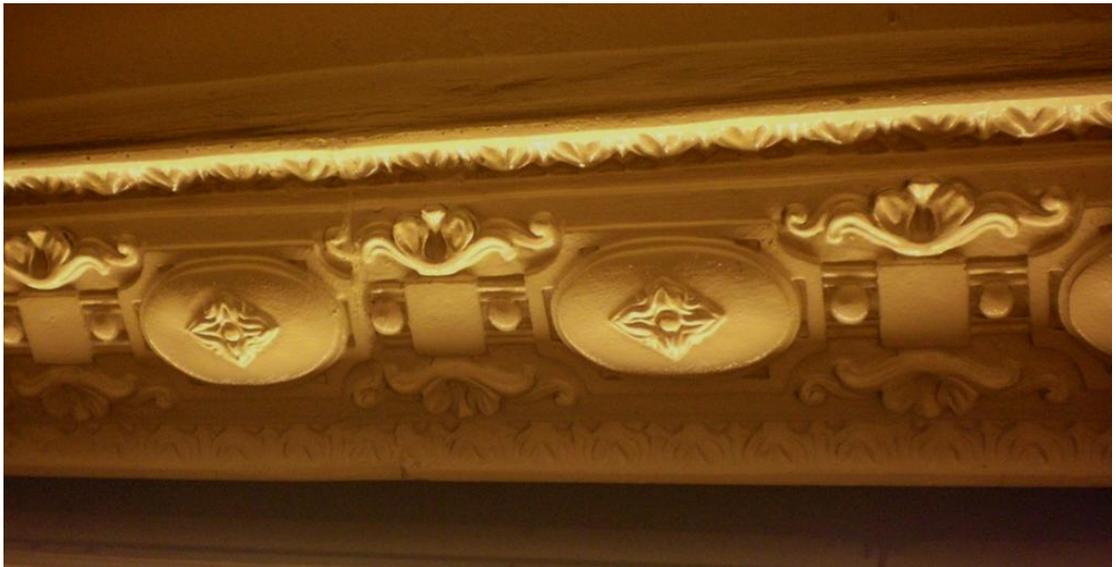
Figure 17: Detail of the Wall Street station's plaster ceiling decorations along platform edge. Photo by author.

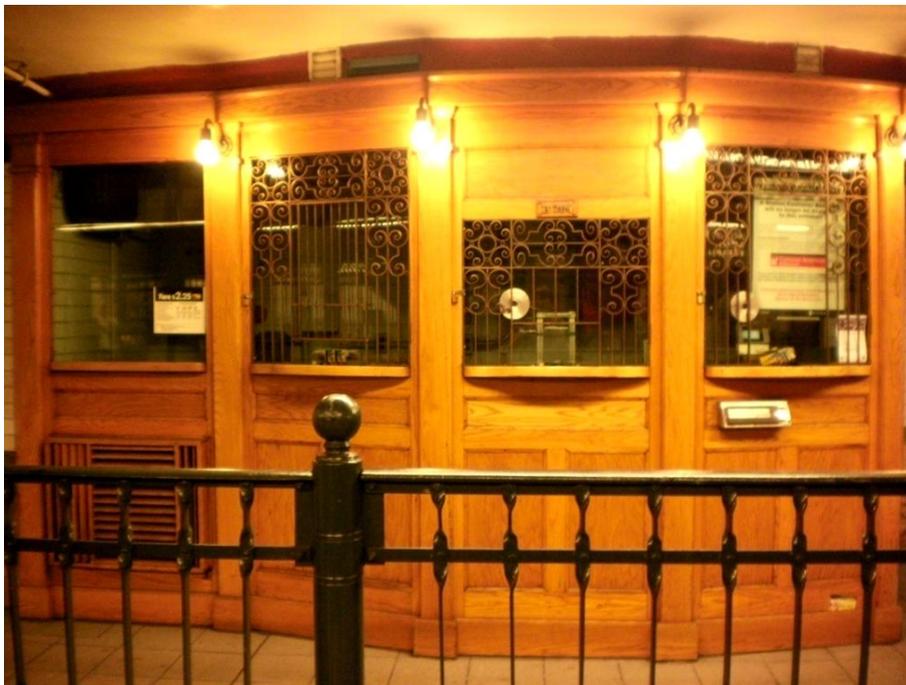
Figure18: Reproduction of the original ticket booth, added during the first rehabilitation campaign. Photo by author.

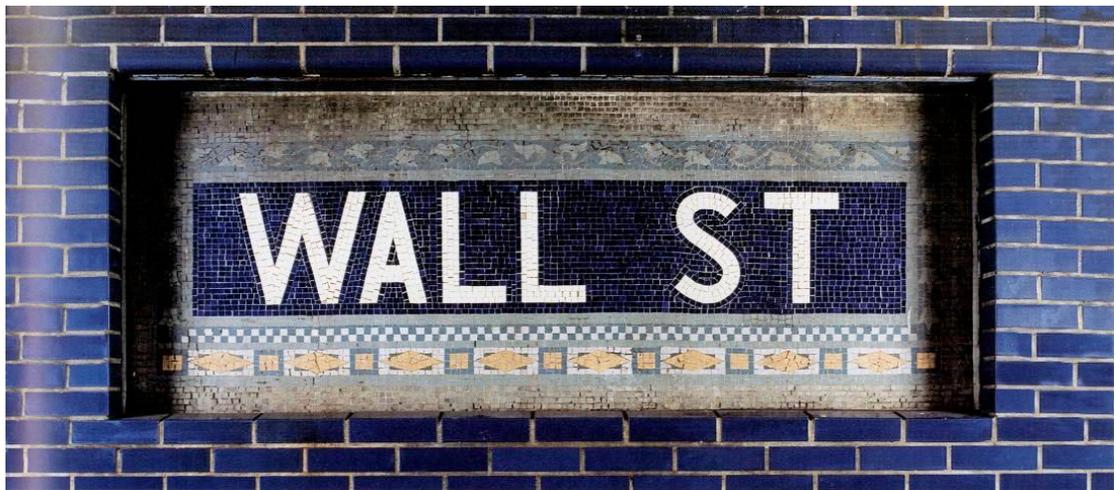
Figure 21: Sample of the blue glazed bricks from the Wall Street station. Photo from *Subway Style*, page 67.

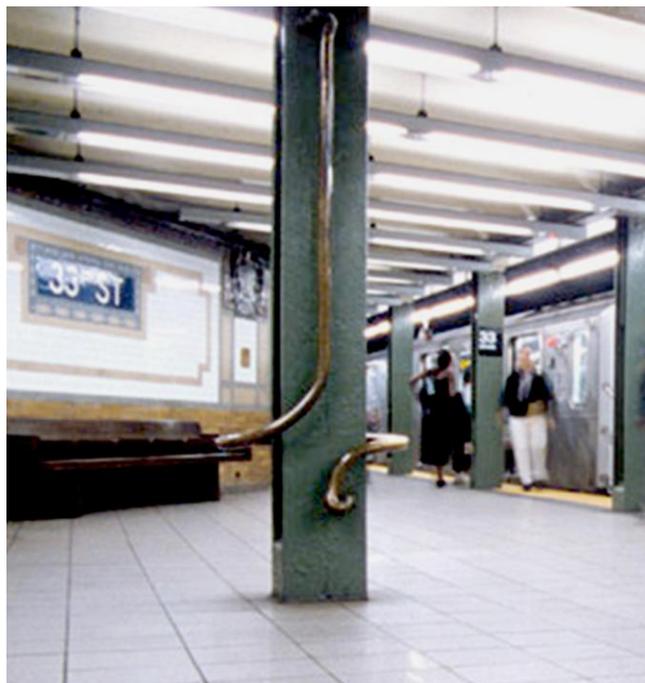
Figure 22: Bronze laurier loops installed in the 33rd Street station. From NYCsubways.org.

Figure 22. Since this would misrepresent the historic character of the station, the SHPO advised that the installation of these loops would be an adverse impact on the otherwise exemplary station rehabilitation.¹⁴⁸

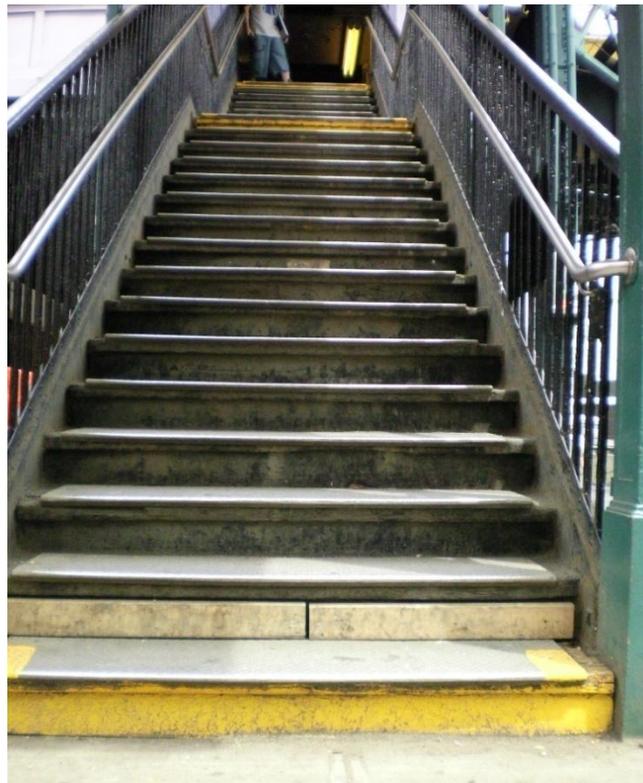
Figure 25: Wood and steel stairs leading from the street level to the control house, Courthouse Square station. Photo by author.

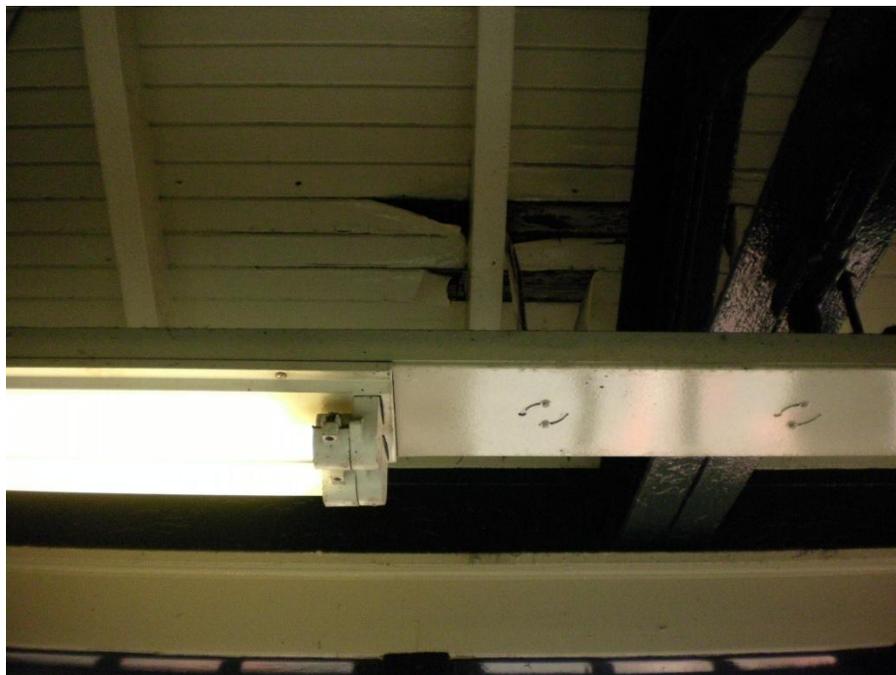
Figure 27: Tongue and groove ceiling in control house interior. The condition of the ceiling is one of the elements that the SHPO is encouraging NYCTA to restore. Photo by author.

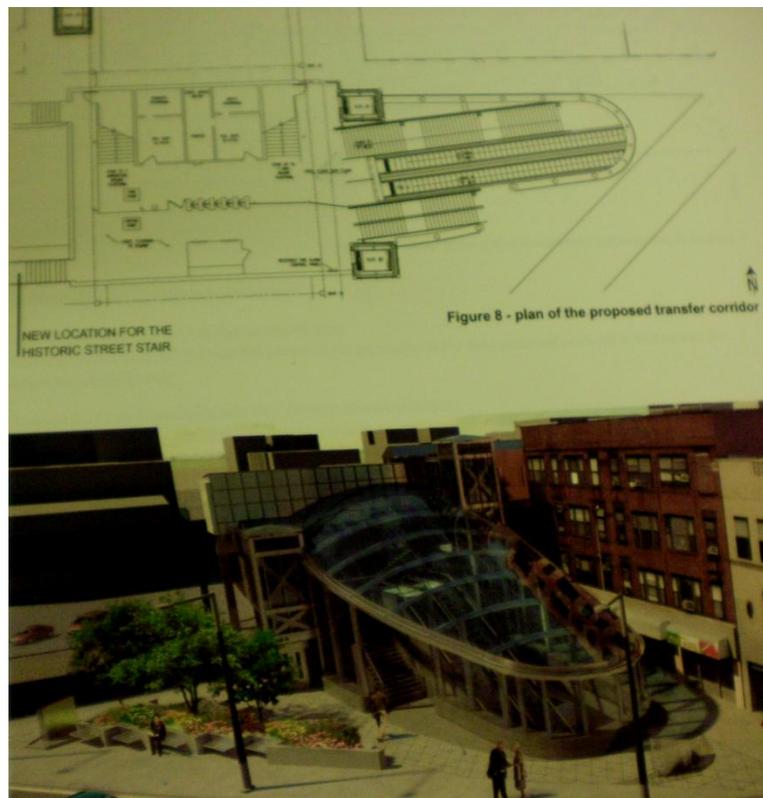
Figure 28: Original transfer corridor proposal for the Courthouse Square station. From the New York SHPO file on the Courthouse Square station.

between the elevated station and underground stations in the immediate vicinity. In total there are three underground stations that could potentially be linked to the Courthouse Squares station, creating a transfer to the G, E, and V trains which are all part of the IND system. The original proposal requires the removal of the entire east façade of the station and the closure of 45th Road to traffic to put in a glass structure that accommodates two stairs, two escalators, and two elevators to provide sufficient access between the above and below ground stations and satisfy ADA requirements. The design tentatively calls for moving one of the historic stairs from the east façade to the west, creating a symmetrical non-historic façade on the west, to salvage the historic fabric (Figure 28).¹⁵⁵

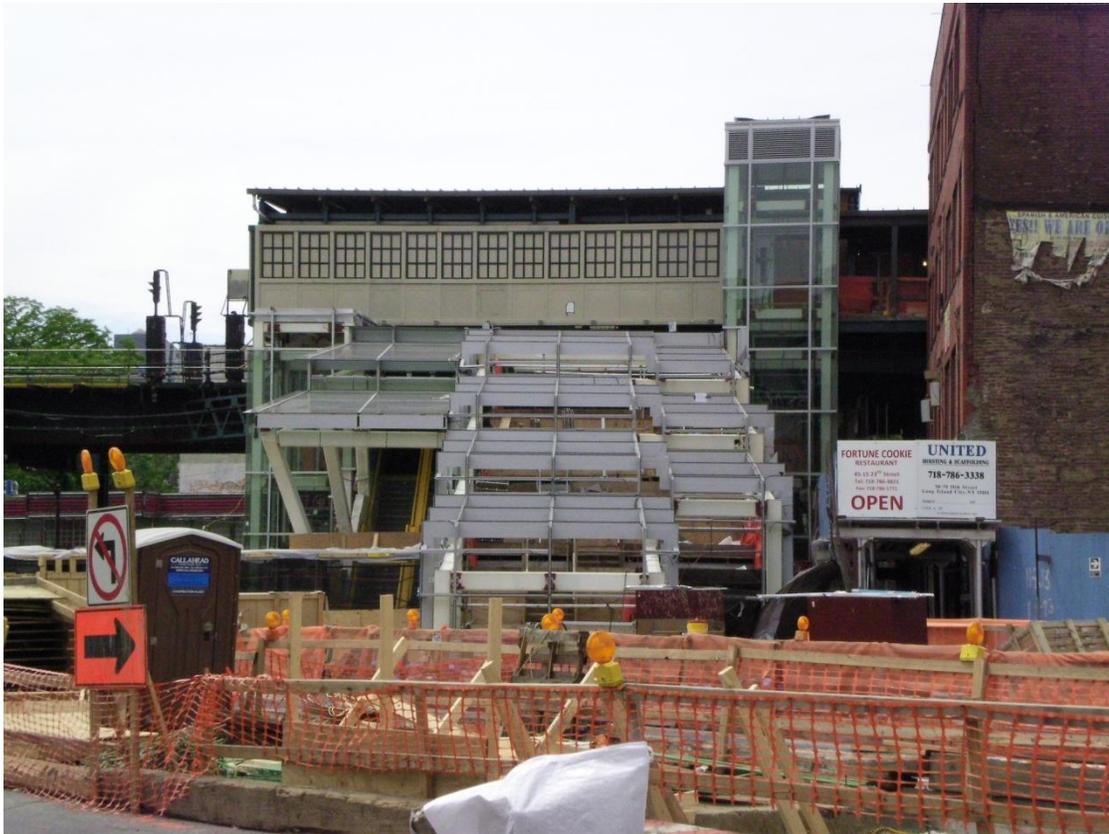
Figure 29: Construction of the transfer corridor at the Courthouse Square station as of May 22, 2010. Photo by author.

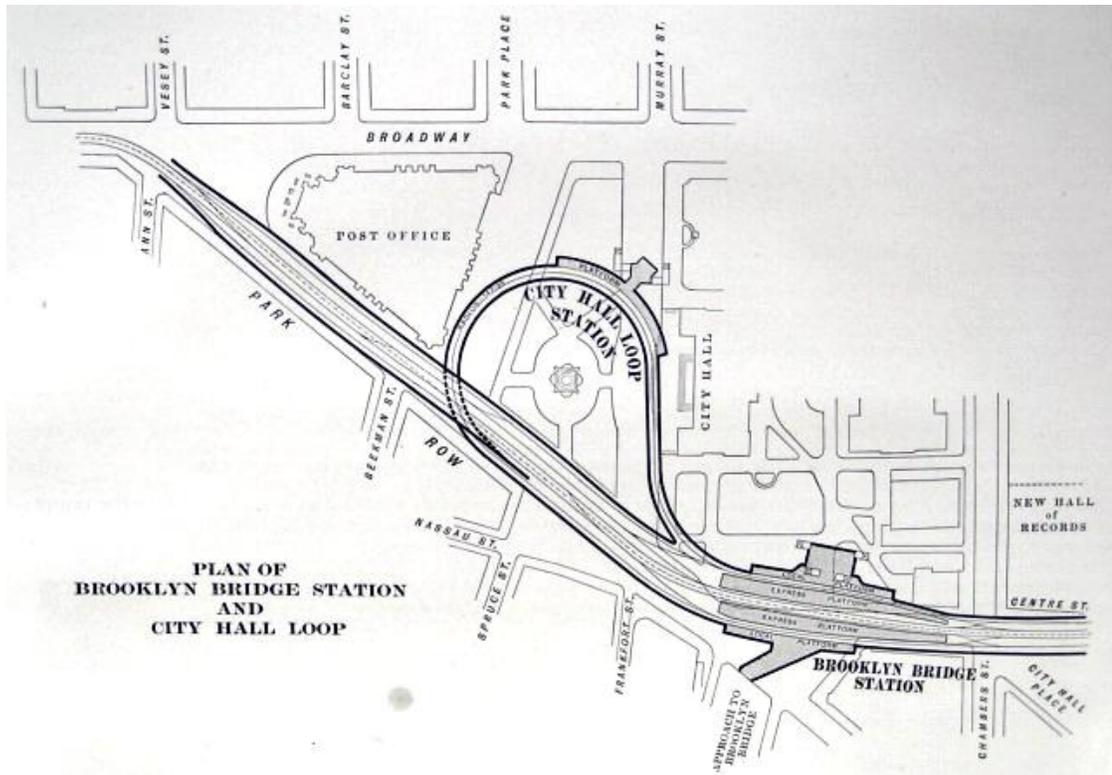
Figure 30: Map of the City Hall loop. From NYCsubways.org.

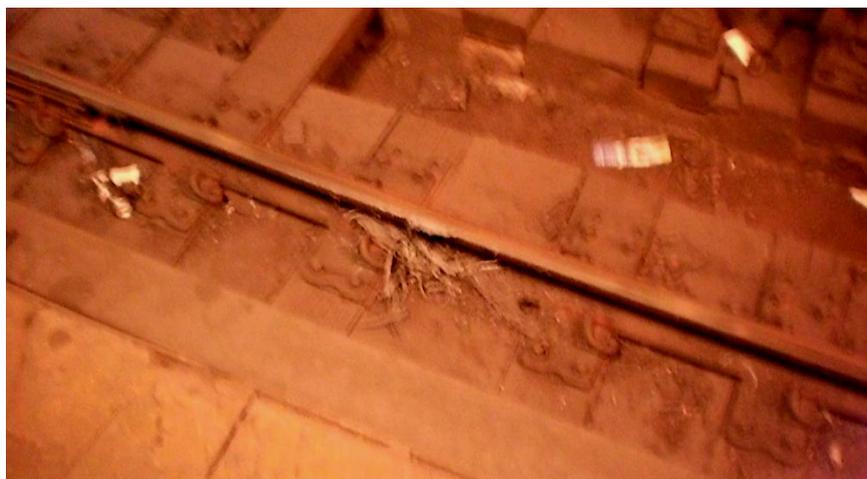
Figure 31: Track damage from rolling stock, City Hall Station.
Photo by author.

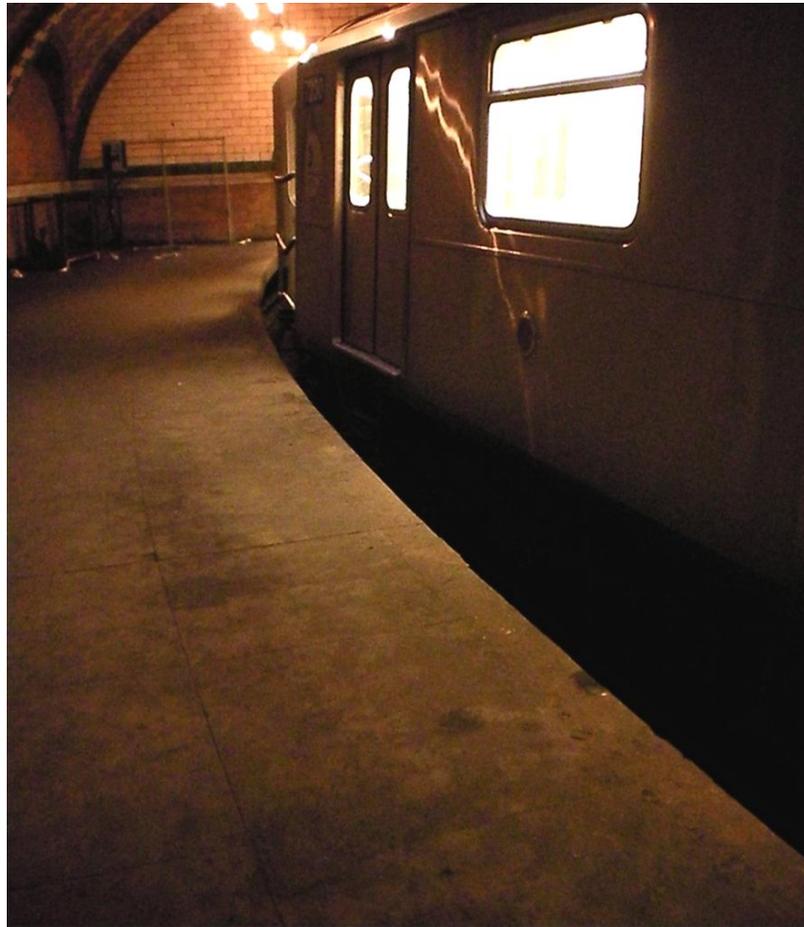
Figure 32: Gap between the City Hall platform and modern rolling stock. For the exit doors at the center of the car, this gap is upwards of three feet. For tours, the Transit Museum has constructed a portable bridge to help members of the tour safely cross the gap from a door at the end of a car.
Photo by author.

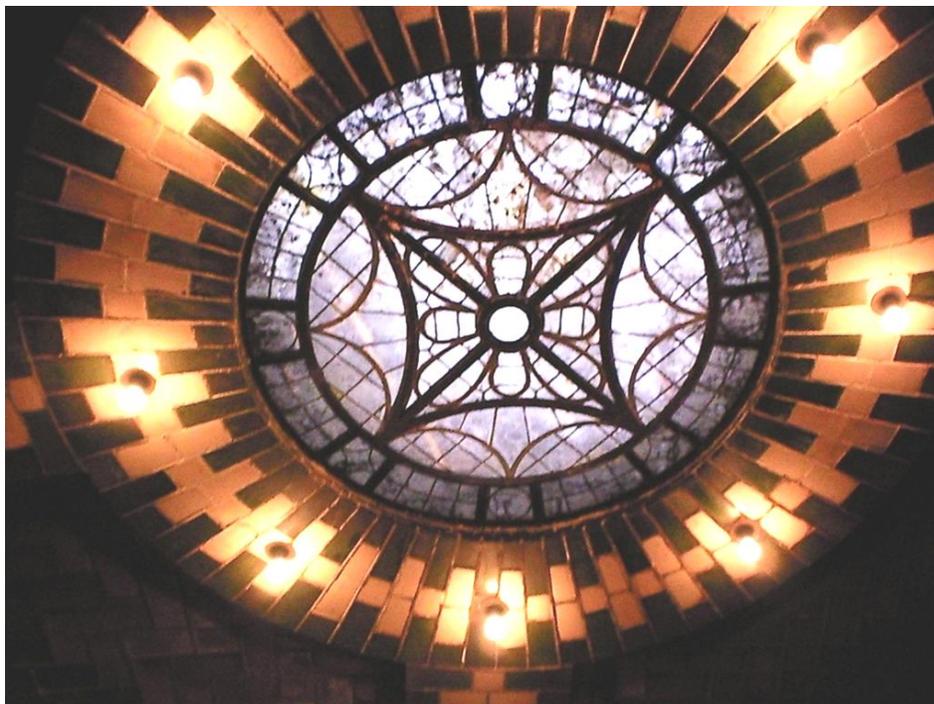
Figure 34: Mezzanine oculus at the City Hall station. The black smudges on the leaded glass or not just dirt, but remnants of black out paint from World War II. Photo by author.

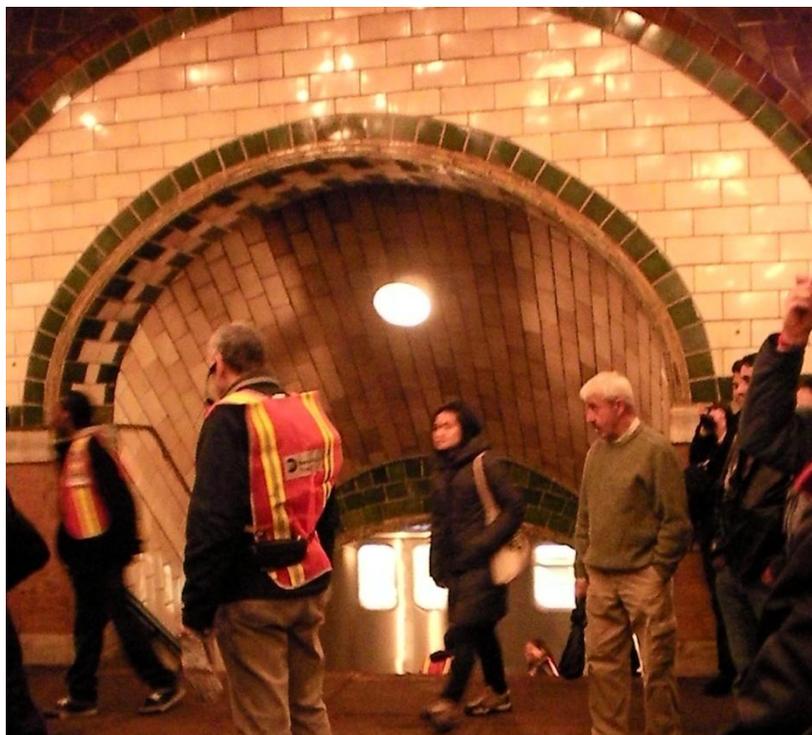
Figure 35: Barrel vault over stairs to the platform from the mezzanine level, City Hall station. Photo by author.

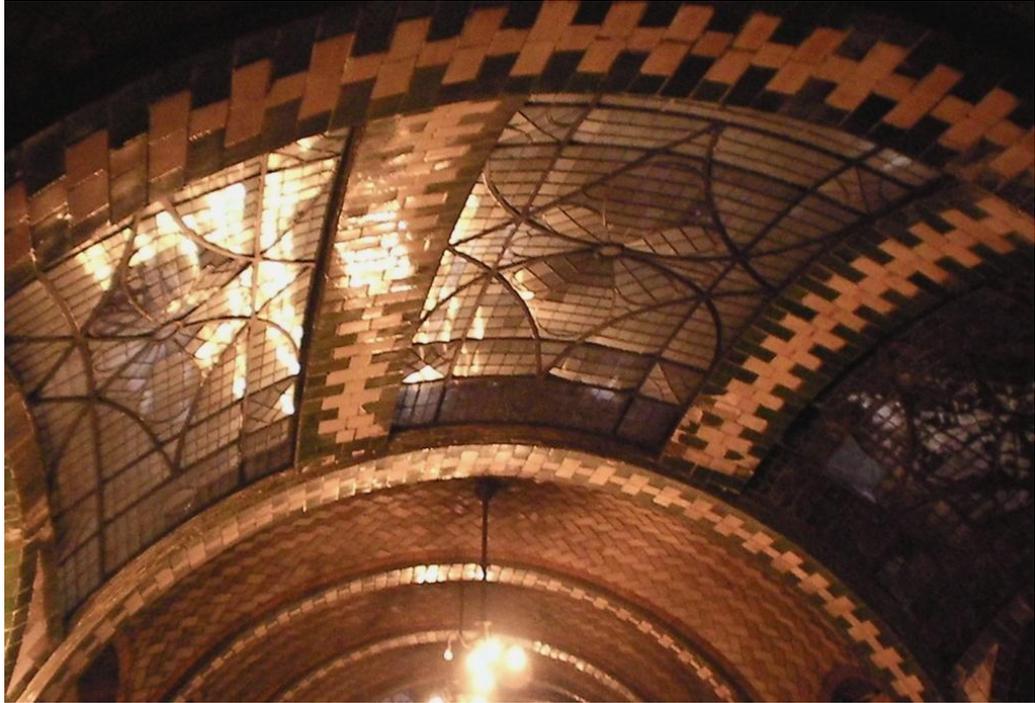
Figure 38: Skylights set into vaults at platform level. Photo by author.

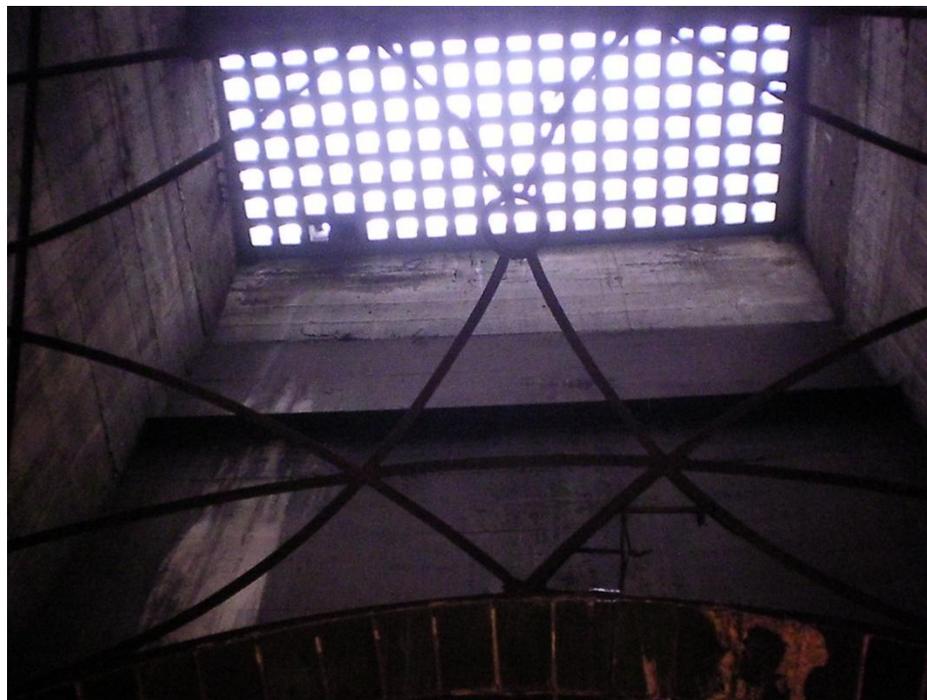
Figure 39: Broken skylight, City Hall station. Photo by author.

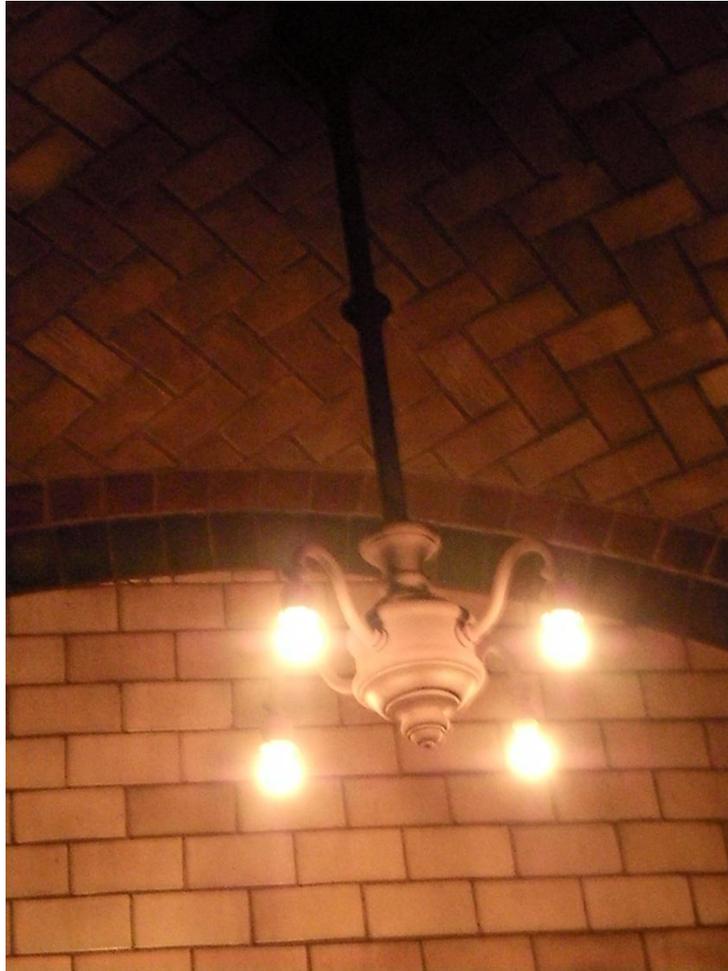
Figure 40: Sample brass chandelier from the City Hall station. Originally, these had glass sconces which were lost early on to vibration from the trains. Photo by author.

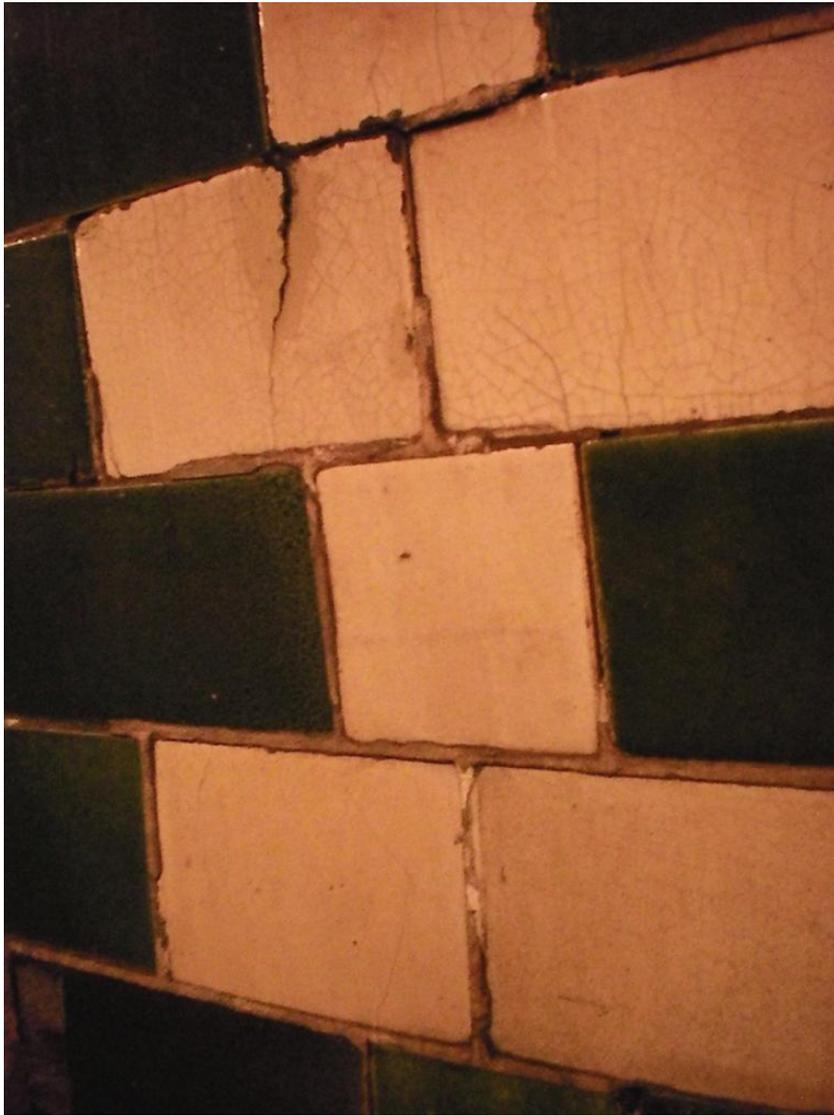
Figure 41: Water damaged tile from platform level vault rib.
Photo by author.

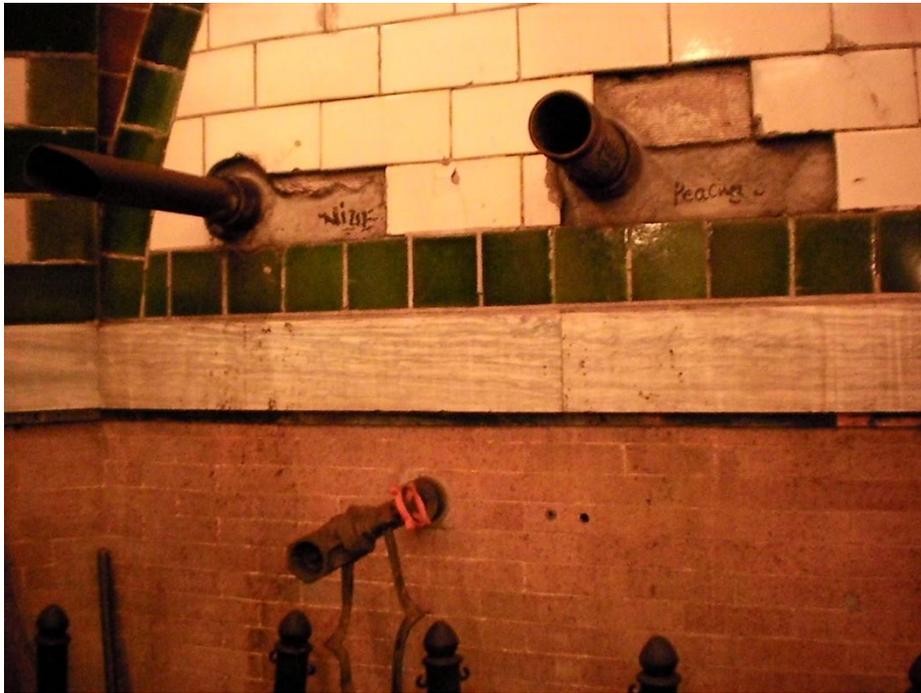
Figure 42: Open-ended pipes cut through the west wall on the mezzanine level, circa 2009. Photo by author.

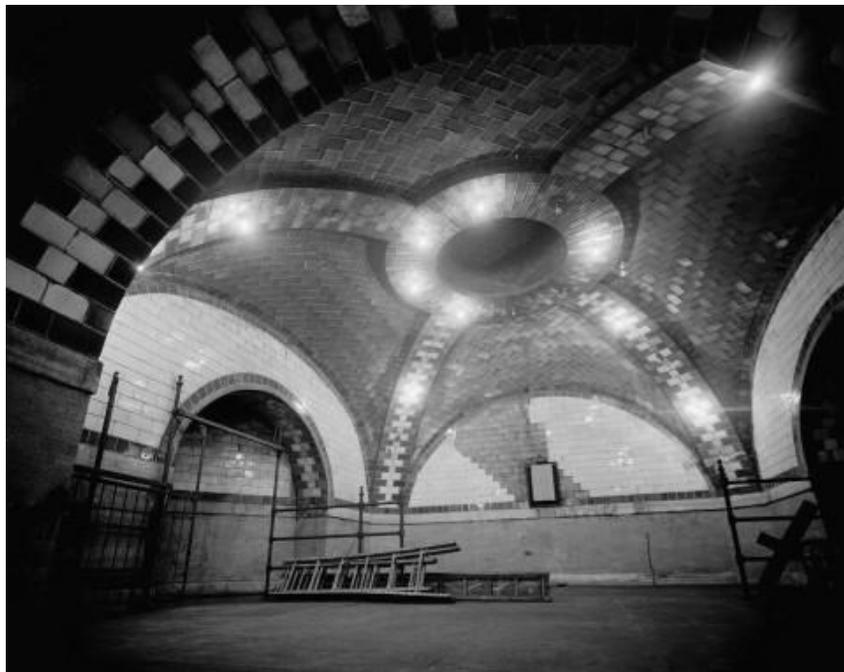
Figure 43: HAER photograph from 1978 depicting the same wall on the mezzanine level without pipes. From the Library of Congress.

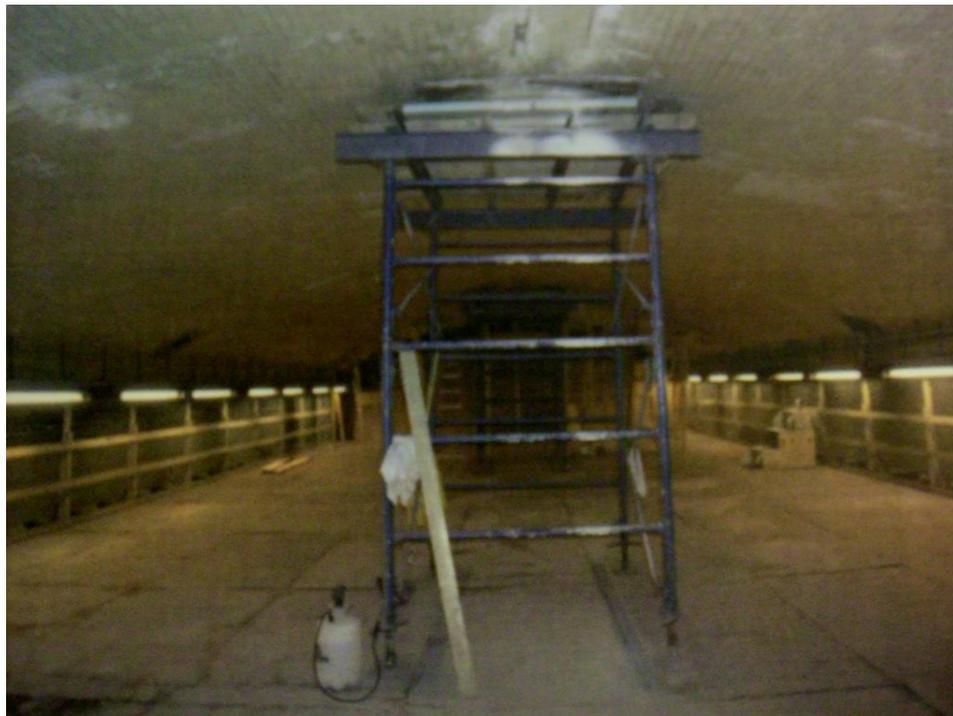
Figure 44: Cribbing supporting terracotta ornamentation while tests are performed on the 181st Street station. Photo from New York SHPO file.

In the meantime, MTA has shored up the terracotta decorative elements in the vicinity of the collapse using plywood (Figure 44). By working with the SHPO from the beginning of the collapse, MTA insures that whatever solution is ultimately put forward for both 181st Street and 168th Street will be sensitive to these stations' historic character.
