HISTORIC INTERIOR DOCUMENTATION
A CASE STUDY

A Thesis

Tamra L. Brosseau

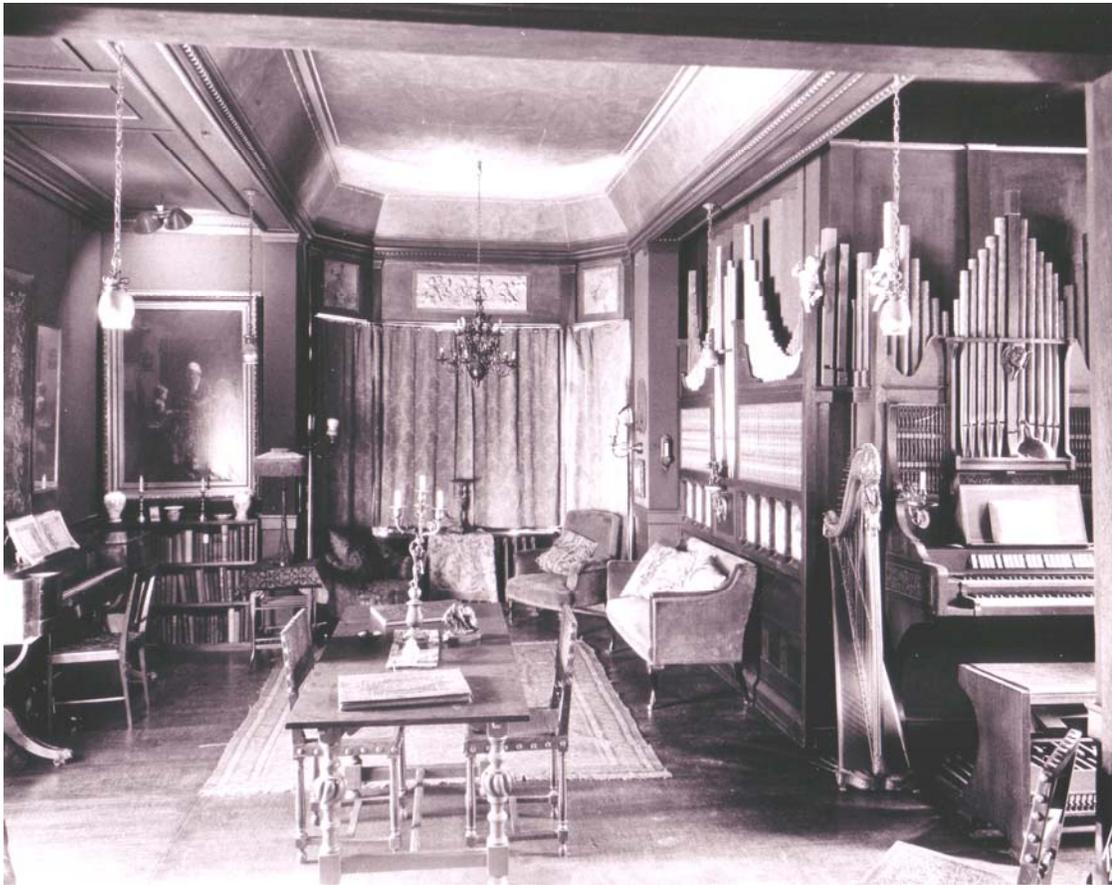
Figure: 0.1
Music Parlor-A

In the case of the Miller home, Wheeler created a fitting showplace for Miller's extensive furniture and art collection. She coordinated the decoration of the 1882-83 additions and remodel. Wheeler and her daughter Doris collaborated on several aspects of the decorative details including a painting on the music room's ceiling that featured clouds painted on a gold background. This painting was removed in the 1950s. This mural and the flower painting can be seen in the following photograph of the Music parlor taken in 1920.

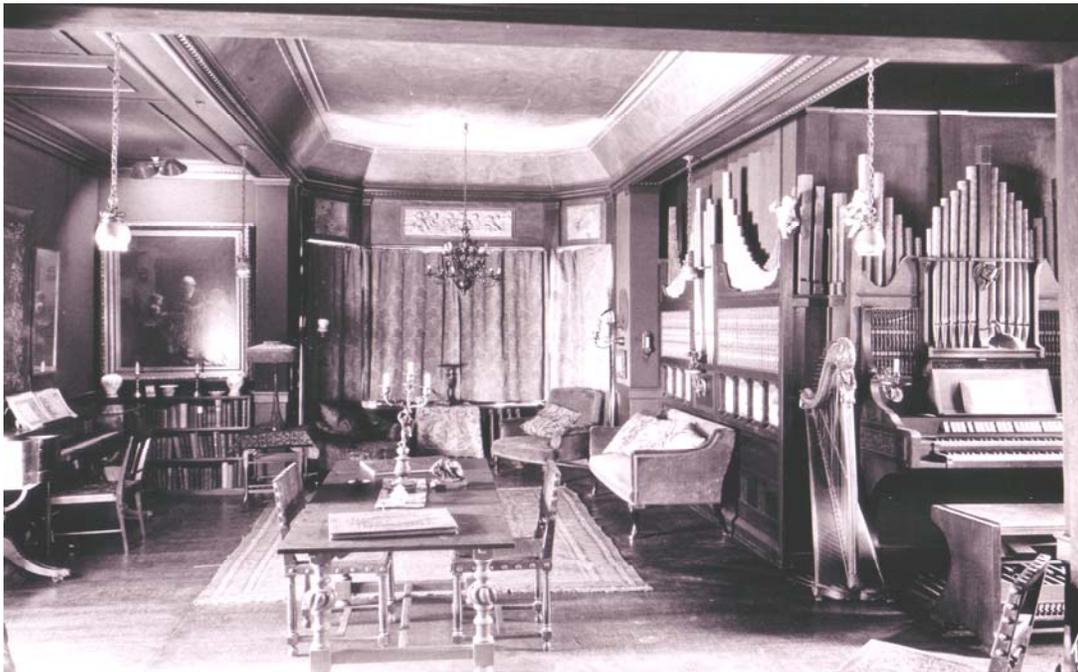
Figure 2.5
Pipe Organ parlor as photographed in 1920. Notice pendant lamps with original Tiffany shades. Copy from original which hangs in Miller Heller House.

In the photograph, (Figure# 2.5) the ceiling mural featured clouds and cherubs on a gold background. The cherubs that are still in situ on the organ have been authenticated by Amelia Peck at the Metropolitan Museum of Art, as to have been the work of Dora. Amelia Peck curated a show at the MET featuring Candace Wheeler that included a large collection of art by Dora. Dora also played a major role in the decoration of the Women's Building at the World's Columbian Exposition, held in Chicago in 1893.

The first electric lighting fixtures were a combination of gas and electric. There are no records that indicate if Miller's first electric fixtures were a combination. Currently, most of the lighting fixtures are not original to the house. The pendant lamps in the Music room (104A) are original to the 1920 photographs, except for the loss of the original Tiffany shades. In addition, the pendant lamps in the adjoining Music room (104B) are original to the 1920 photographs as well.

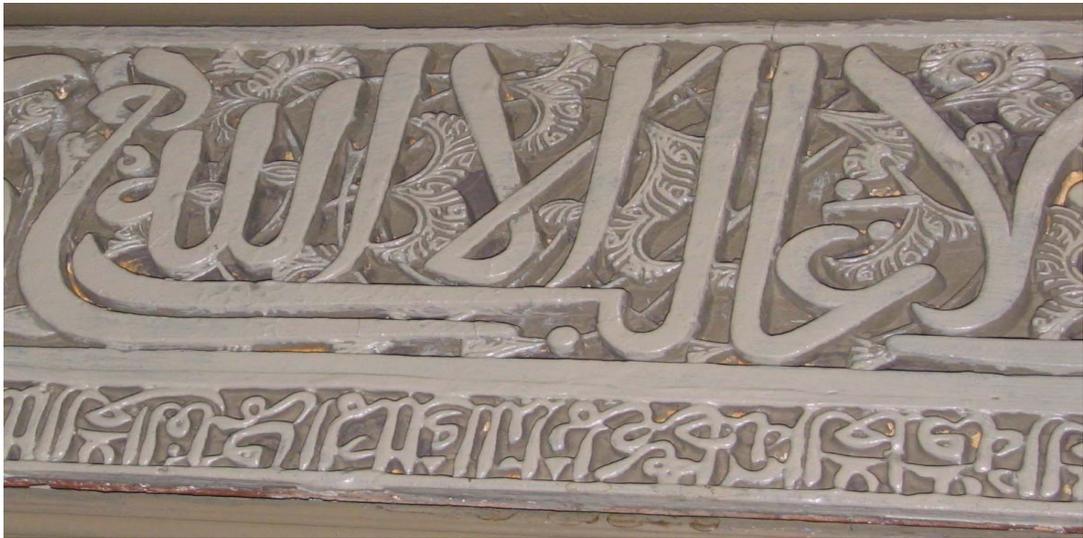
Figure 2.7
Plaster cast from Entry Hall Frieze at 122 Eddy Street

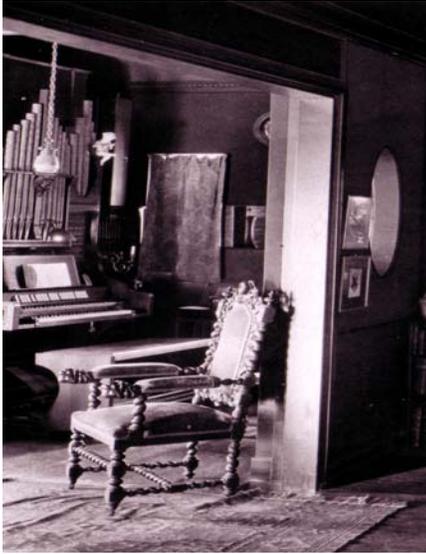
The first electric fixtures were converted gas fixtures and many homeowners used gas as a back up for the often unreliable electricity. The style and shape of older gas lamps had been dictated by the function of the lamp itself. There had to be a means for the gas to be carried to the mantle. A flame needed to face upward to allow for proper burning and a bowl was needed to surround the flame. This all changed with the electric lamp. If a lamp was converted from gas to electricity, the wiring was either exposed or was snaked through the existing gas pipes. When fixtures were designed expressly for the purpose of electricity, their style was unique and completely free from the previous design barriers (as seen in the pendant lamps in the following figures).

Figure 2.9
Pendant lamps with
Tiffany shades
Music Parlor

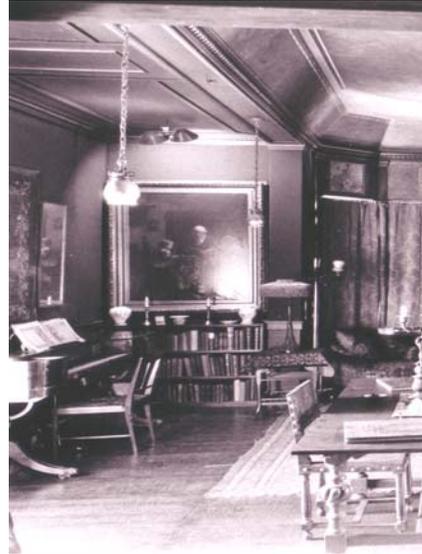
Figure 2.10
1920 photograph of pendant lights
in Music Room

Electric lights could be faced downward and could be used for task lighting. The lighting that Miller had installed, at least by 1920, was completely designed for electricity. Some of the lighting included pendant fixtures of Tiffany glass which held single bulbs hanging from exposed chains.

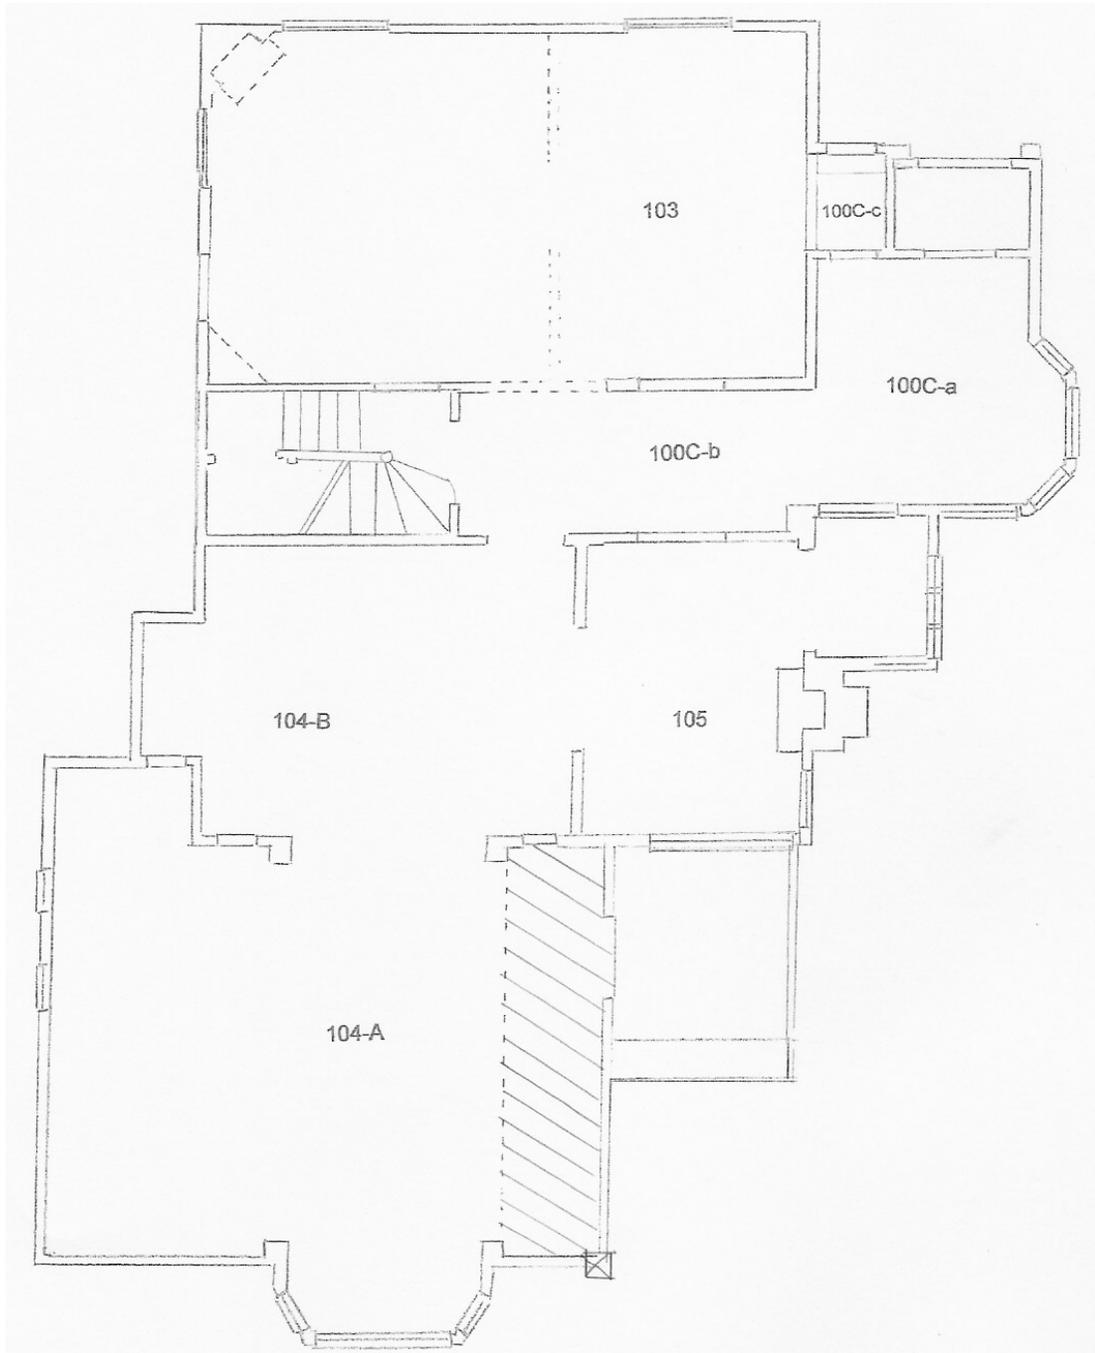
Figure: 3.1

The south bay possibly was designed as a porch and then enclosed at a later date. This could explain the south bay not being adequately supported by a proper foundation.

As a porch with no foundation support, the enclosed space lacked the structural integrity that was needed to prevent this portion of the room from sagging.

No foundation under area denoted with hash marks. Southwest corner is supported with a post.

The interior of the building is under stress due to its foundation problems. These issues must be addressed before any work is begun. The foundations should be monitored to detect the rate of any movement to determine if the movement is seasonal. Foundation supports should be added to stabilize the southwest corner of the room since this section has very little support. Lateral bracing maybe be installed under the floors and outside south wall to provide stability against wind loads.

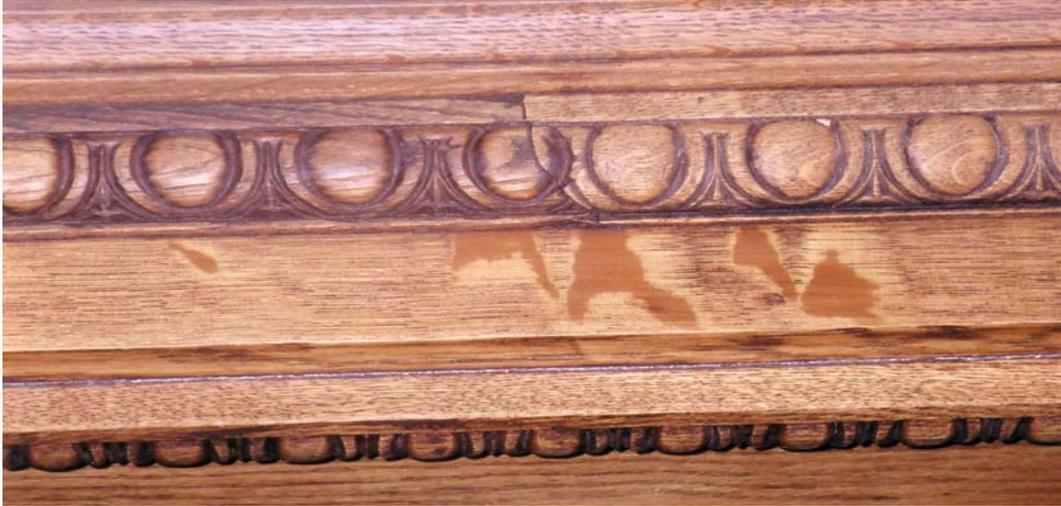
Figure 3.5
Scarf joint of egg and dart trim on same beam as figure 104-A.4

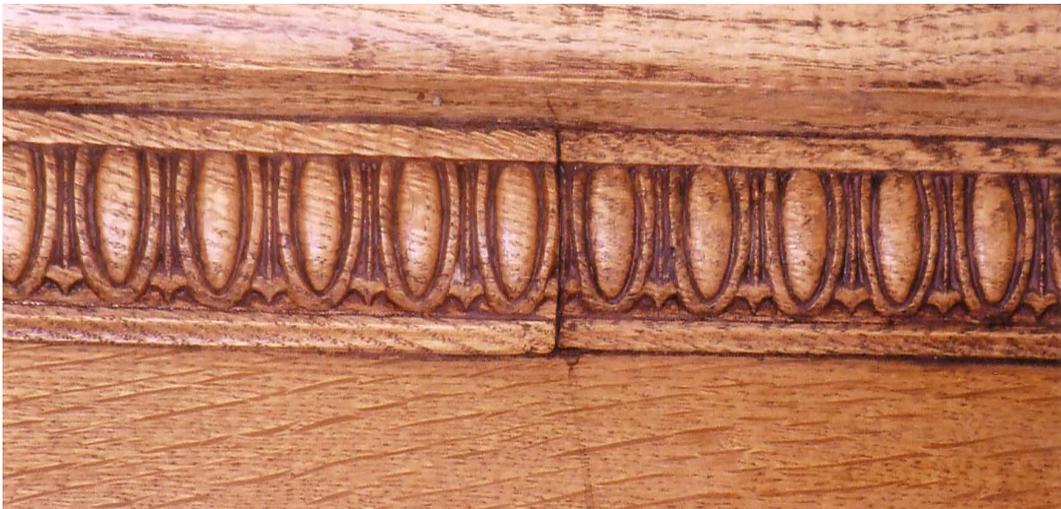
Figure 3.6
Butt joint on boxed beam dividing the central bay and the south bay

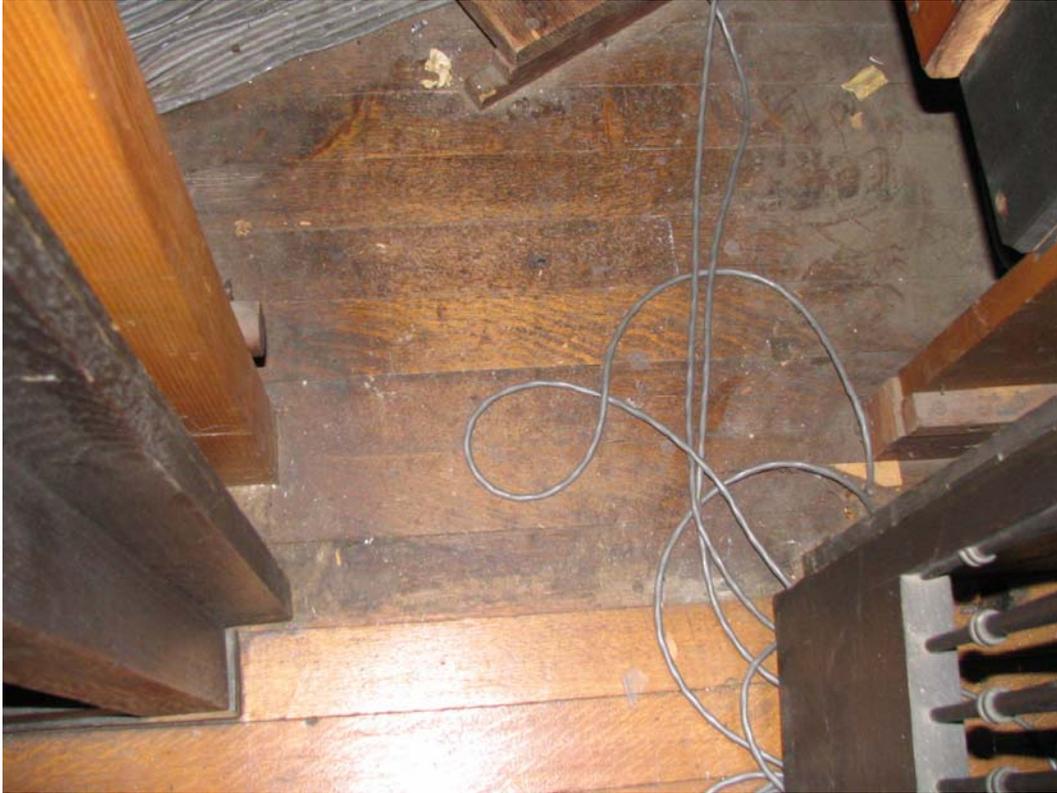
Figure 3.7

Condition: The oak flooring is in need of a complete sanding and refinishing, filling any gaps. The floor has received hard wear and has been poorly maintained.

Contrasting finishes on floor behind organ. Floor at threshold is refinished, other side of threshold is the original stain.

The original color of the stain of the floor can be seen within the organ case where it has not been stripped or refinished. The color of this stain should be replicated to produce the appearance of the original floor. (Figure 3.7)

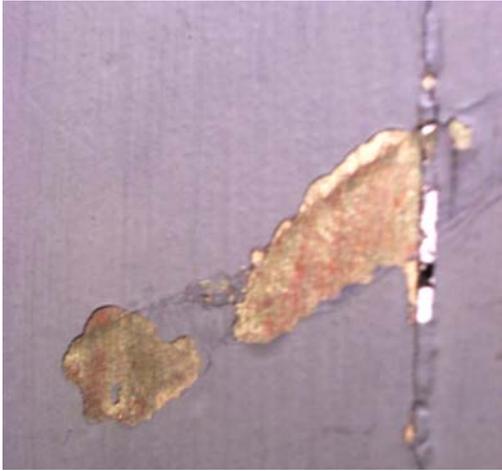
Figure: 4.2
Original paint uncovered on staircase

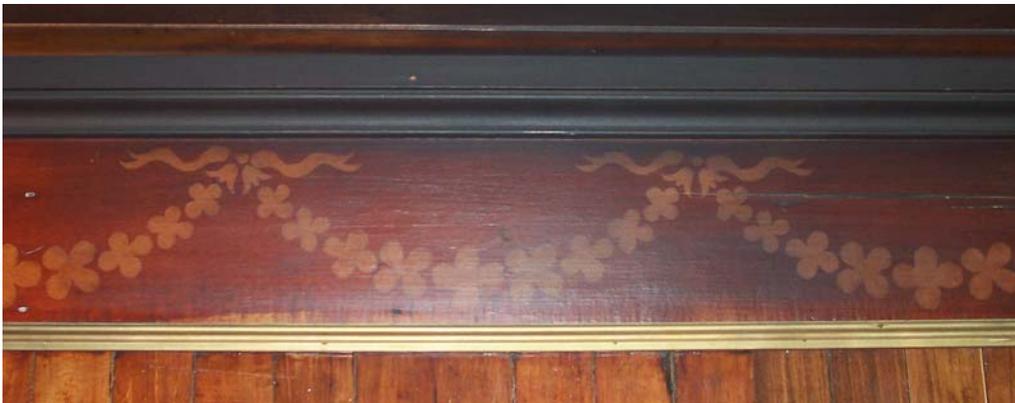
Figure: 4.3
Stenciled swag boarder in front entrance hall dating to the 1883 remodel

In the photograph above, Fig. 4.3, the original stencil still remains in the entrance hall of the Miller residence and is in relatively good condition. It could be argued that this original fabric should be left intact and not embellished, but possibly cleaned by a professional. However, what if there were only remnants left of this work?

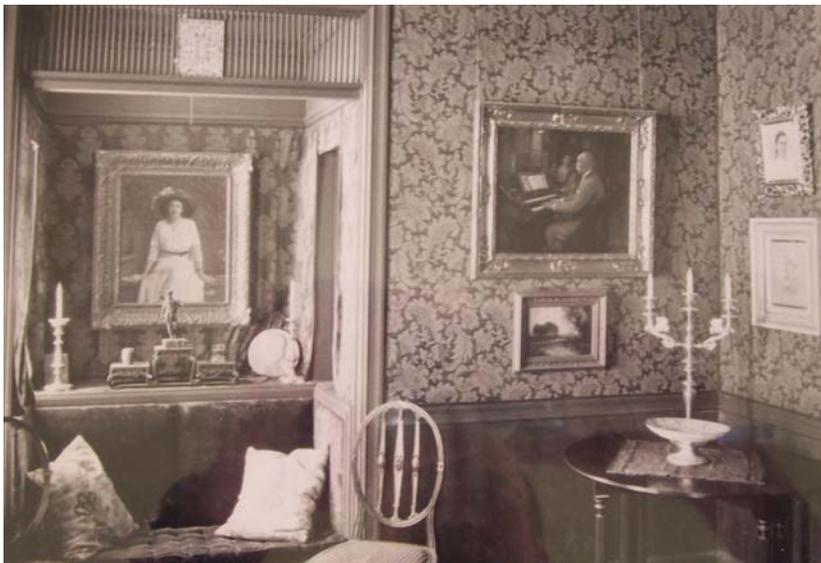
The following photograph, Fig. 4.4, from 1920 is of the nook, (now is a closet off of the entry hall) which is adjacent to the sitting room, (now part of the dining room). These rooms have been altered from what was photographed in that year. How can we as preservationists interpret the original look of these rooms? It all depends on the present use. It was no longer useful to the current owners to retain the spaces in their original state. That is not to say that with proper documentation, these spaces could not be returned to their previous arrangement.

Figure: 4.4
Original Parlor off of dining room seen below as marked 103 and 100C-c

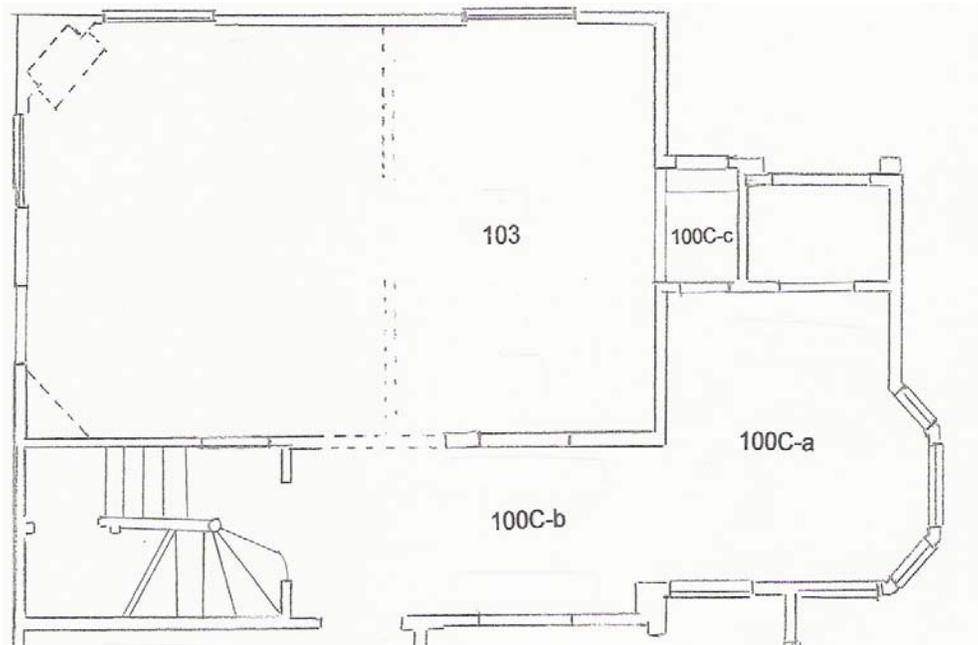
Figure 4.5
Floor plan illustrating original floor plan of dining room and sitting room
