SAND LADEN MANURE STORAGE AND TRANSFER

J. Skinner
JESS Engineering, PLLC, Alpine, NY

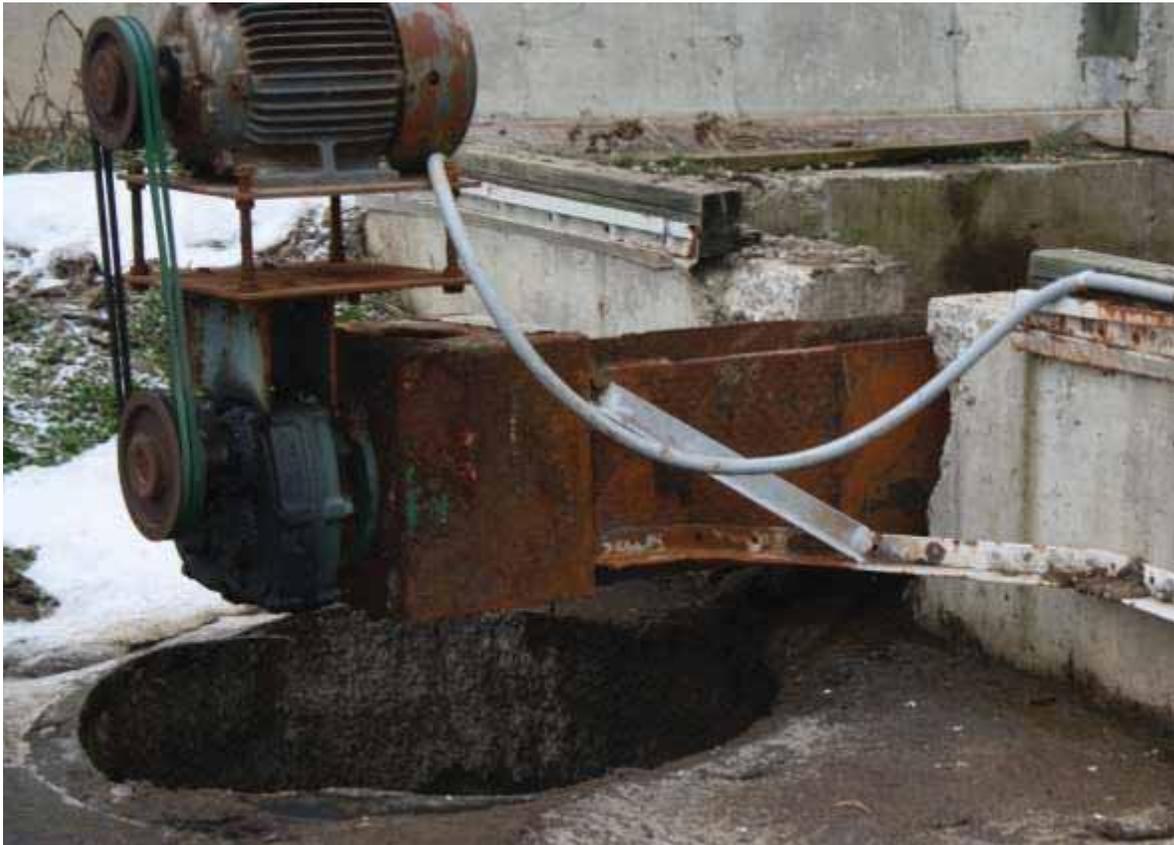
Photo 1. Auger depositing to a flush flume.

begun to adopt flush flumes. Flush flumes utilize an HDPE transfer pipe with flowing water to collect sand laden manure and convey it to the storage/treatment area. Flush flumes work well in a retrofit situation allowing the farm to continue using their current cleaning system. On one of the farms that we worked with to install a flush flume, the farm had an existing 800 cow barn with a center collection auger and did not want to disrupt cattle traffic to install a collection channel. We designed a manhole (see photo 1) at the end of the auger to carry manure down to the flush flume. With the slow rate of material exiting the auger and the 2500 gallon per minute flow rate maintained within the flume, the system has worked flawlessly for three years.

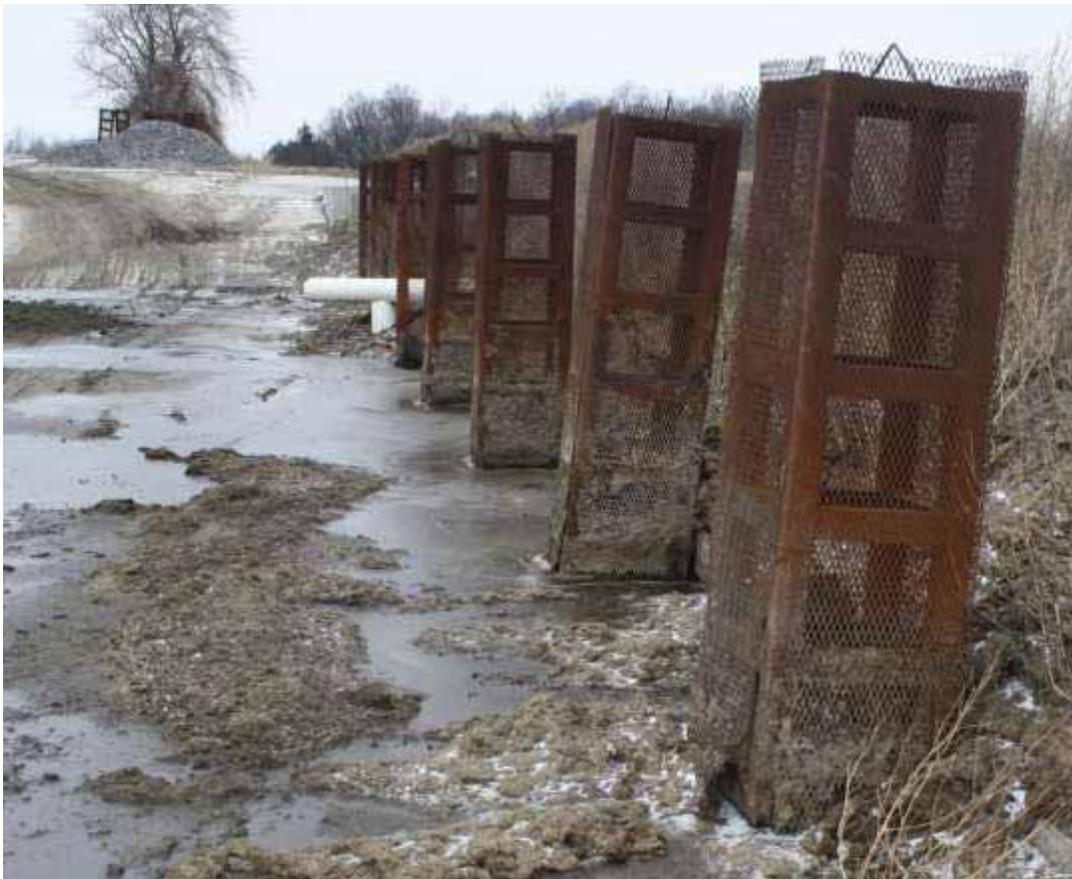
Photo 2. Screen Towers

Just as with conveyance issues, gravity separation in New York has evolved over the past ten to fifteen years. Many farms visited facilities across the nation and appreciated the simplicity of their gravity separation systems. The first gravity separation systems that I was involved with were a variation on the hog slat systems that are popular on flush dairies in the midwest and southwest. These systems accept manure into a three sided structure with a fourth wall constructed of hog slats. Solids build up against the hog slats and the system filters out sands and solids while allowing the liquid portion of the manure to continue to a long term storage. These facilities are generally constructed of concrete for ease of cleaning and have proven to be very effective. A variation of this system was developed by Southern Minnesota Agricultural Engineering Services. The structure was designed to have a manure depth of only 5 feet and utilized screen towers located near the center of an earthen structure with a concrete floor. Manure could be scraped directly into the structure and the towers would allow the liquids to drain to a long term storage.

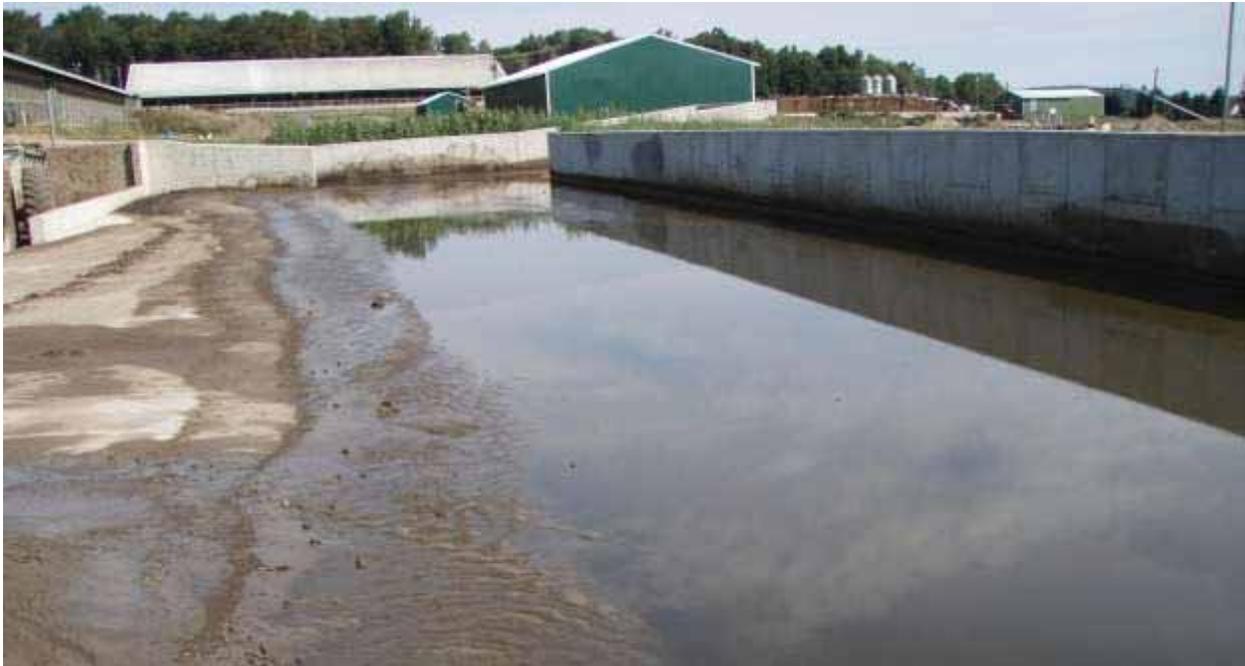
Photo 3. Completed Sand Lane

The sand lane was installed adjacent to the abandoned tower structure. The concrete floor of the tower structure could then be utilized to pile sand after removal from the sand lane, saving the farm approximately \$125,000 by avoiding the installation of a sand stacking area. This stacking area allowed the sand to continue to drain and discharged this runoff to the farm's long term storage through the piping already installed at the screen towers. The sand lane design was difficult in that we had to account for several different flow rates entering the lane, ranging from 7500 gallons per minute for the wider cow alley flushes to as little as 2500 gallons per minute for the flume outlet. The decision was made to design the sand lane for the largest flow rate and see how the lower flow rates reacted; this approach dictated a 20' wide sand lane. In addition, the farm installed a settling basin directly off the end of their sand lane, allowing for some sand to settle. The basin is also the source of flume water for this facility. The location of the farms long term storages are several hundred feet from the barns and down in elevation approximately 15 feet. Installation of the flume pump within this structure allowed for the use of a reasonably priced pump as well as reducing the amount of 12" supply line by fifty percent.

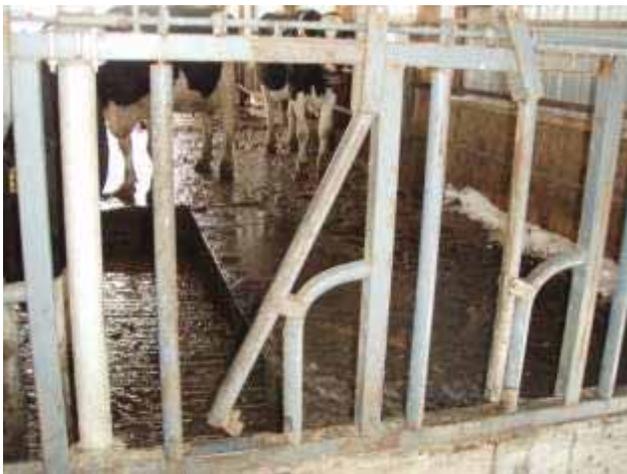
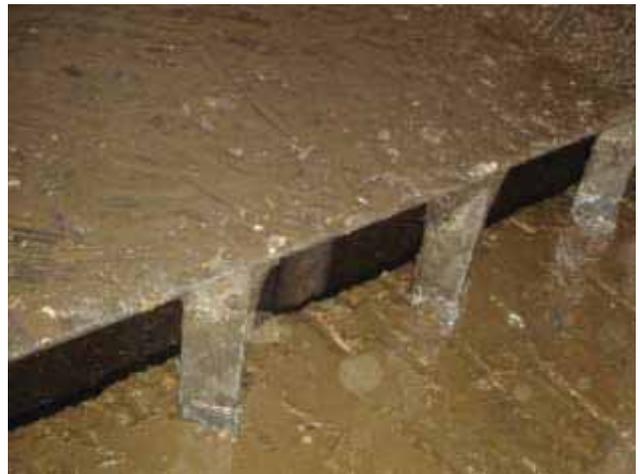
Photos 4. and 5. Two different views of the hood system installed

The farm has made a significant modification to the structure. As indicated the farm is located in Wyoming County, and particularly in the southwest corner of the county, which receives a large amount of lake effect snow. After working with the system through one winter the farm decided that to continue operation it was important for them to install a roof over the sand lane (see photo 6). The large volume of snow and ice buildup impeded the day to day cleaning and maintenance of the sand lane and took a large area to dispose of the “dirty” snow within the sand stacking area.

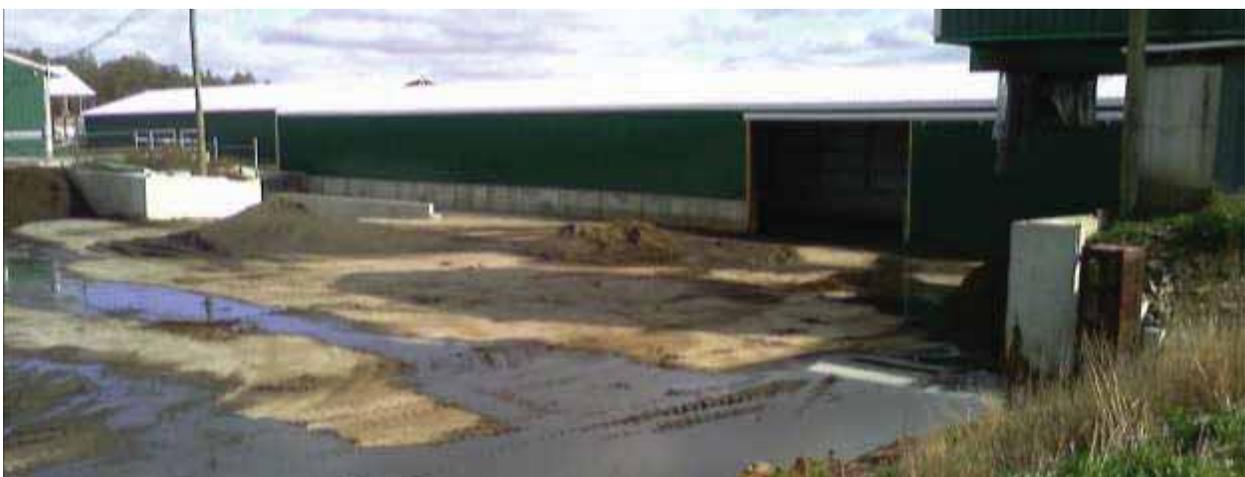
Photo 6. Roofed sand lane

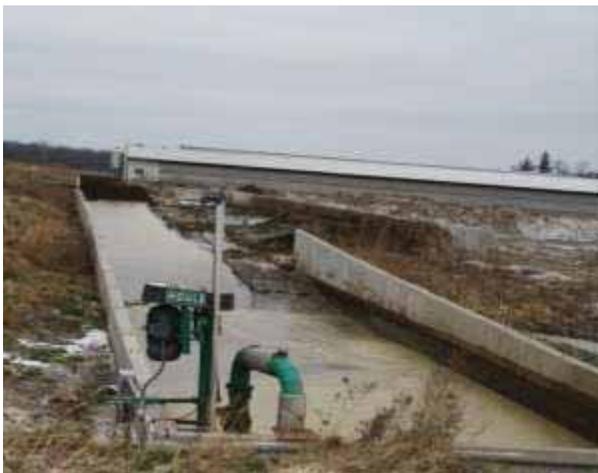
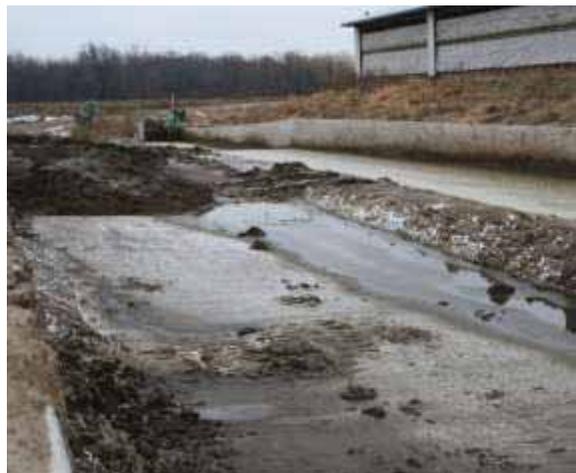
Photo 7. and 8. Sand lane and adjacent "beach"

A 24" flush flume was designed and installed at a minimum 1.25% slope from the existing milking facility through the new barn to the sand lane. The system was designed to allow for the farm to pump manure from their existing barn into the end of the flume. Similar to case 1, the lane was installed with a "beach" configuration to the side, allowing access throughout (Photo 8). Also similar to case 1, this system was designed with the flume supply pump placed in the sand lane reception pit (Photo 7). In this situation the sand lane was located downslope from all of the farm's manure storage structures. By placing the flume supply pump in the sand lane reception pit, it is virtually impossible to overflow the system.
