THIS OLD SILO: When Concrete Tower Silos Fail

By Brian Aldrich, CCE Cayuga County
August 2008

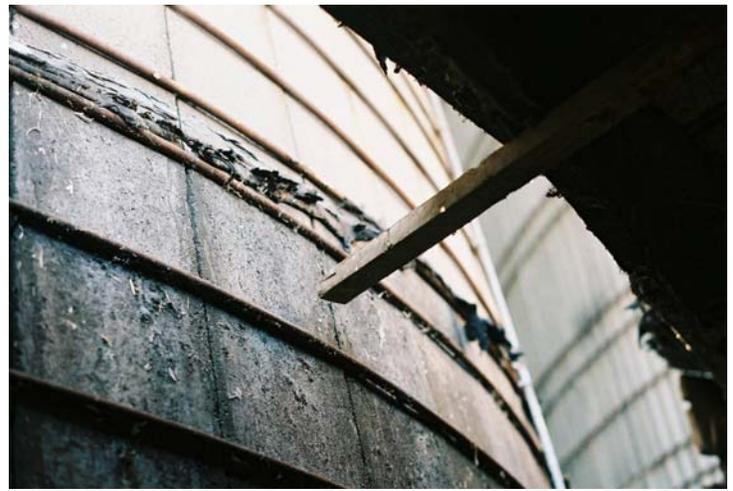
The photos below show how the silo looked last fall when it started to lean. The cause of the problem was that

Silo (left) pulling away from the barn. The board in the center was used to monitor the rate of shifting. Photo used with permission of owner.

the silo's foundation was below grade (below the surface), and the drains surrounding the foundation had become plugged, allowing moisture to penetrate the bottom course of staves. Freeze-thaw cycles slowly degraded the staves over the decades. (This silo was built prior to 1971.) The staves at the base gradually weakened until they were finally crushed by the weight of the staves above.

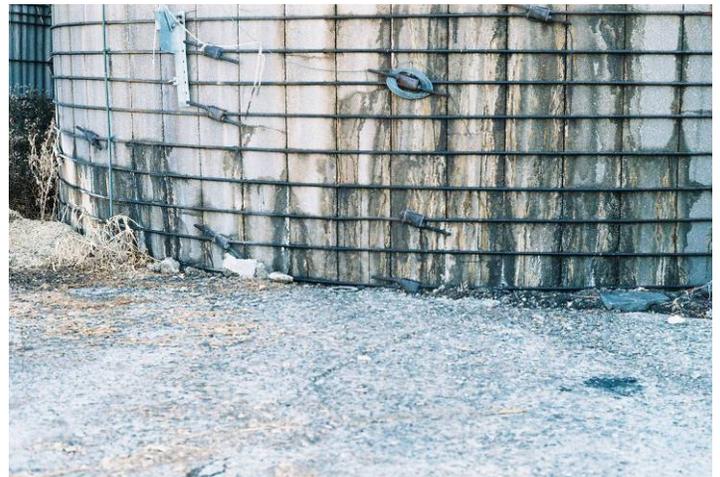
Base of silo showing deterioration of bottom row of staves. Photo used with permission of owner.

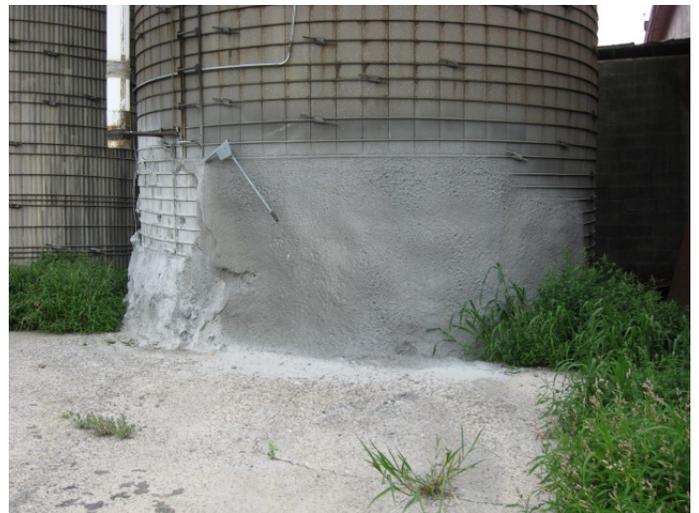
Base of silo temporarily reinforced with "shotcrete" concrete. Photo taken July 2008, used with permission of owner. The silo will be taken down this fall.

Fortunately, the farm had an established working relationship with a silo company that has many years of experience with old silos. The company was able to

stabilize it by reinforcing the bottom with “shotcrete” concrete that was sprayed on (see photo).
