Material Characterization and Testing of Cured-in-Place Pipe to
Resist Earthquake Related Ground Deformation

A Thesis

of Cornell University

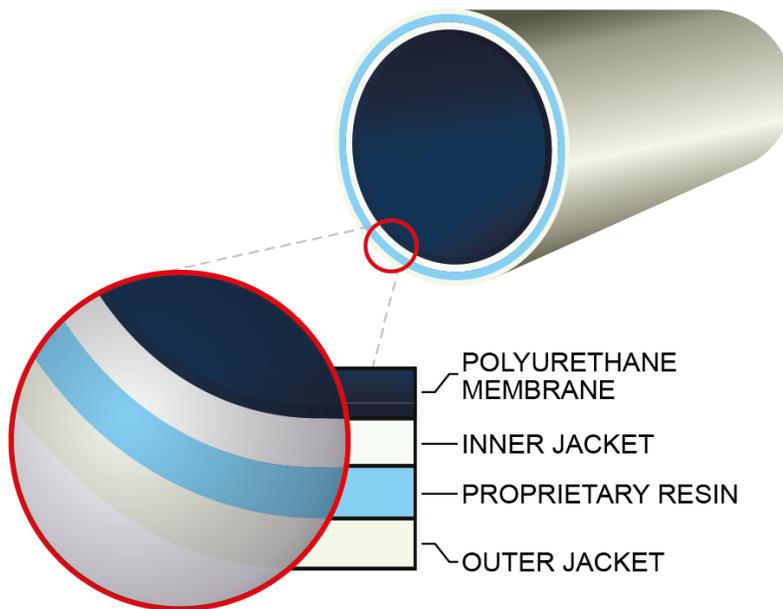
Figure 1.1. Aqua-pipe Geotextile Lining Components

As shown in Figure 1.1, Aqua-pipe is an epoxy resin-impregnated lining consisting of an inner and outer layer, or jacket, each composed of woven fabric. Each layer of woven fabric consists of polyethylene thermoplastic (PET) yarns in the longitudinal, or warp, direction and PET yarns in the circumferential, or weft, direction, as shown in the warp and weft schematic in Figure 1.2. There are 23 yarns/in. in the warp direction and 8.5 yarns/in. in the weft direction in the Aqua-pipe fabric. The yarns in the warp direction are a discontinuous filament, while the yarns in the weft direction are continuous and stronger than those in the warp direction. The ratio of stress at failure for the weft vs. warp direction is 1.39 according to data provided by the manufacturer. A layer of epoxy is located between the two jackets. The interior layer of the lining is composed of a polyurethane waterproof membrane. Figure 1.3 shows the two layers of woven fabric before being treated with epoxy and cured in place. Figure 1.4 shows Aqua-pipe after curing inside of an existing pipeline.

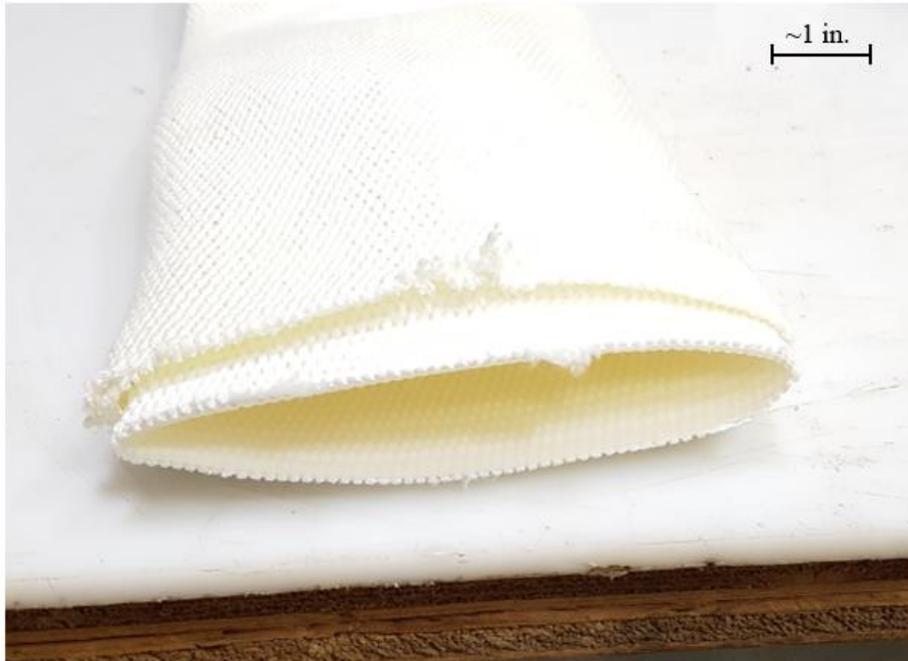
Figure 1.2. Schematic of Warp and Weft Yarn Pattern

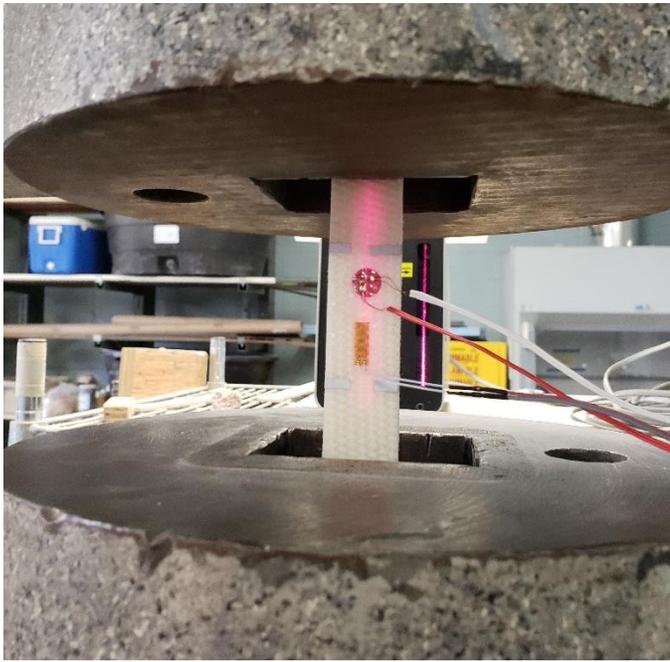
Figure 2.1. Tensile Coupon Test Setup with Aqua-pipe Material

0.20 in. (5.8 mm) in the weft direction. The gages were mounted in the center of the specimen. Such gages frequently debond at tensile strains of 2 to 4%. To provide supplemental measurements of strain beyond the 2-4% range, the laser extensometer was used to measure axial strain to failure. The extensometer is not as accurate as the strain gages at smaller strains, but it provides for reliable assessment of strain at larger values, specifically those beyond the initiation of plastic deformation.

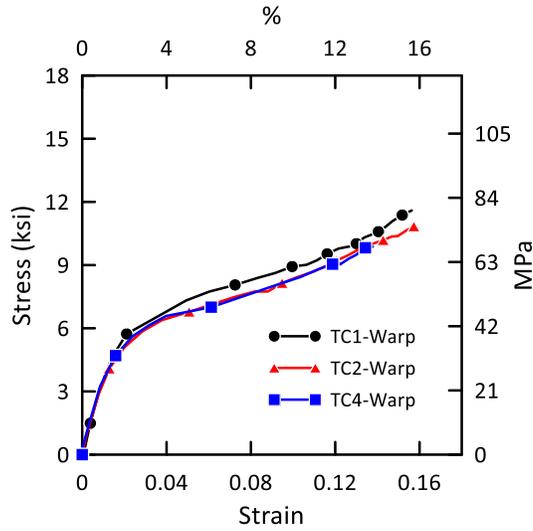
Figure 2.4. Stress vs. Strain Plots to Failure for Specimens in the Warp Direction

The results of the tensile coupon tests in each direction show good agreement. Each test was run until the woven fabric tore apart, indicating failure. Axial stress vs. strain data were used to determine the stress and strain at failure in each direction, as shown in Figure 2.4 and Figure 2.5 by the maximum measured stress. The average failure stress and strain for Specimens 1, 2, and 4 in the warp direction were 10.9 ksi and 15%, respectively, with standard deviations of 0.94 ksi and 1.2%. The average failure stress and strain for Specimens 3, 4, and 5 in the weft direction were 15.3 ksi and 11.1%, respectively, with standard deviations of 1.68 ksi and 1.6%. The ratio of the average stress at failure in the weft vs. warp direction is 1.40, which agrees closely with the ratio of stress at failure reported in Section 1.

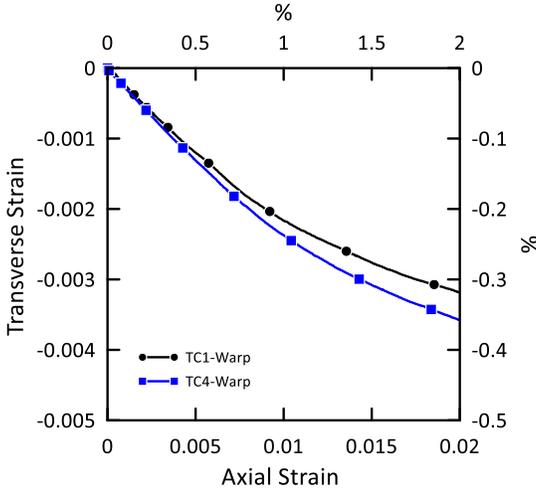
Figure 2.8. Transverse vs. Axial Strain for Tensile Stress for Specimens in the Warp Direction

Poisson's ratio, ν , is the negative ratio of transverse strain to axial strain for uniaxial loading. Poisson's ratio was derived from the transverse vs. axial strain plots. As shown in Figure 2.8 and Figure 2.9, the linear range in the warp direction of the transverse vs. axial strain terminates at approximately 0.05 axial strain, beyond which axial strain accumulates at a faster rate than the transverse strain. The average Poisson's ratio for Specimens 1 and 4 in the warp direction is 0.23 with a standard deviation of 0.016. The average Poisson's ratio for Specimens 3, 4, and 5 in the weft direction is 0.25 with a standard deviation of 0.010.

Table 2.2 provide summaries of the Young's modulus, tensile stress and strain at failure, and Poisson's ratio in the warp and weft directions, respectively. A close examination of the plots in Figure 2.6, Figure 2.7, Figure 2.8, and Figure 2.9 show a departure from linearity at a strain of between 0.5% and 1.0%. The Young's modulus and Poisson's ratio in both the warp and weft direction decreases at strains between 0.5% and 1.0%.

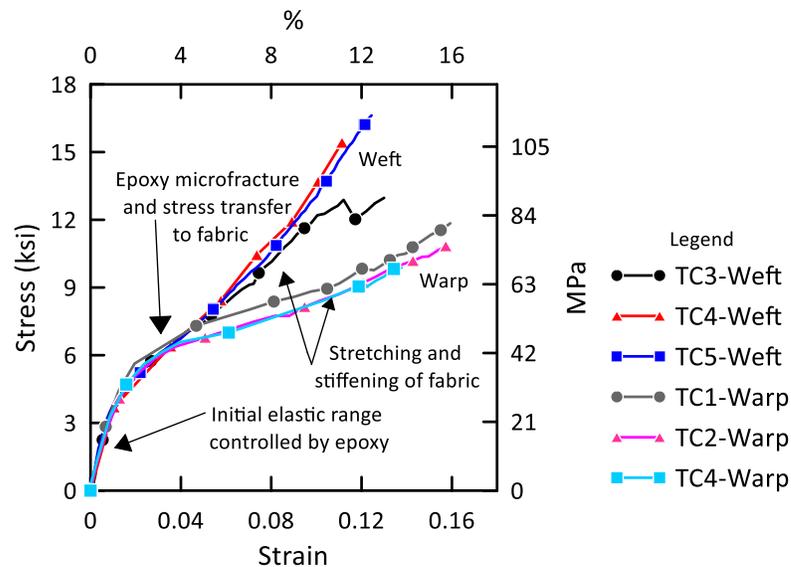
Figure 2.10. Stress vs. Strain Plots for Specimens in the Warp and Weft Directions

In Figure 2.10, the stress vs. strain data for the warp and weft directions are plotted at the same scale. From zero to between 0.5% and 1.0% strain, the lining responds as a linear elastic solid. The Poisson's ratio is approximately 0.24 in both directions, and the difference in the Young's modulus is less than 7% lower in the warp than in the weft direction. In this range of tensile strain, the Young's modulus and Poisson's ratio are controlled principally by the epoxy.

As the strain approaches and exceeds 1.0%, micro-fractures develop in the epoxy, and stress is transferred increasingly from the epoxy matrix to the fabric. This stress transfer results in a reduction of modulus. Moreover, the fabric stretches more in the warp direction than in the weft direction, where the strength of fibers is greater. As tensile strain exceeds approximately 5%, the fibers stretch and tighten, leading to increased modulus in both the warp and weft directions. The stiffness and strength in the weft direction exceed those in the warp direction due to the continuous nature of fibers in the weft direction.

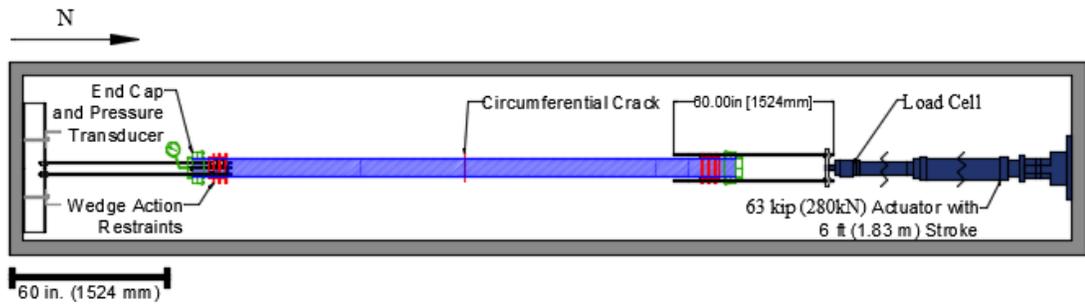
Figure 3.1. Plan View of a Direct Tension Test in the Large Load Frame

consisted of two pipe sections of equal length on each side of a gap, representing a round crack.

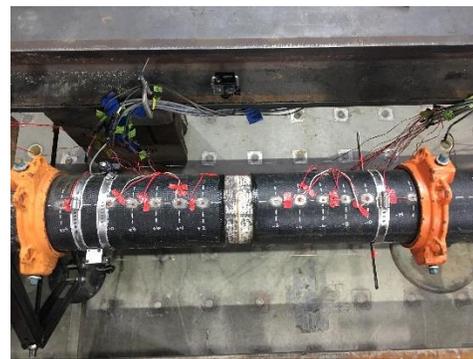
a) View of DT1 Specimen in Load Frame before Test Initiation

Figure 3.5 (a) – (d) show photographs of the DT1 test pipe. Figure 3.5 (a) shows the pipe at the beginning of the test. Strain gages on the crown of the pipe and a string pot along the eastern springline of the pipe can be seen in the photo. Figure 3.5 (b) – (c)

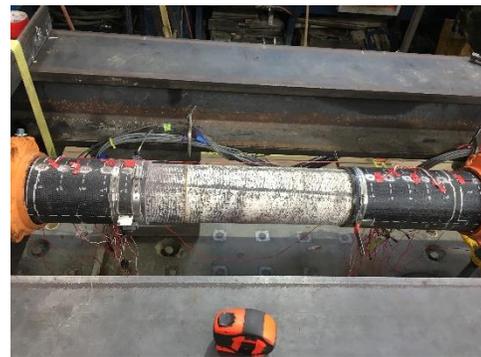
d) View of Lining Exposed after Completion of Actuator Displacement

Figure 3.5. Photos of the Center Gap at Various Levels of Displacement during DT1

show the pipe after the first and second 6 in. (152 mm) of actuator displacement. Figure 3.5 (d) shows the maximum 12 in. (305-mm) opening of the center crack near the end of the test. At 12 in. (305 mm) of crack opening, the geometric limits of the loading frame were met, and the specimen was unloaded.

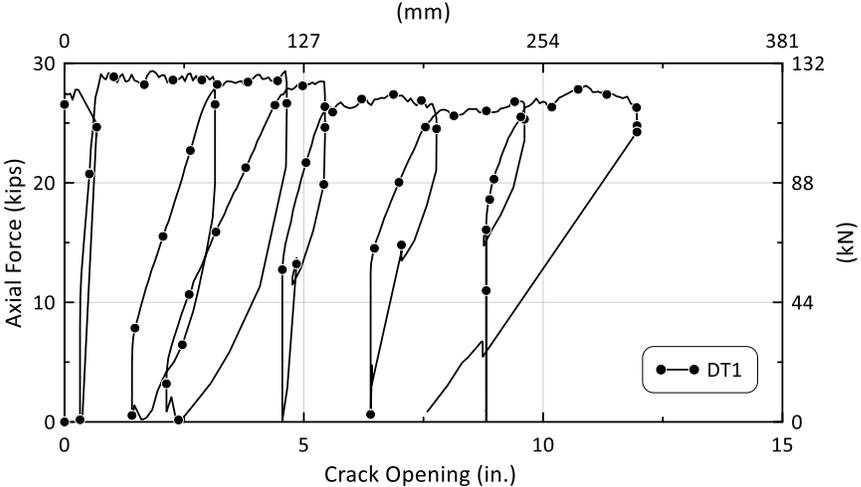
Figure 3.6. Axial Force vs. Crack Opening for DT1

Figure 3.6 shows the axial force vs gap, or crack, opening. As displacement was applied, the axial load increased rapidly so that the slope of the plot appears to be a vertical line. After approximately 1 in. (25 mm) of crack opening, the test was paused, causing the first cyclic loading in the figure.

The maximum axial force recorded varied between 26 kips (116 kN) and 29 kips (129 kN). This force represents the debonding capacity of the lining, which is the force required to propagate a Type II fracture between the lining and inside surface of the pipe (Argyrou et al, 2018). The maximum debonding force varied roughly $\pm 5\%$ along the pipe specimen, with an average of approximately 27.5 kips (122 kN).

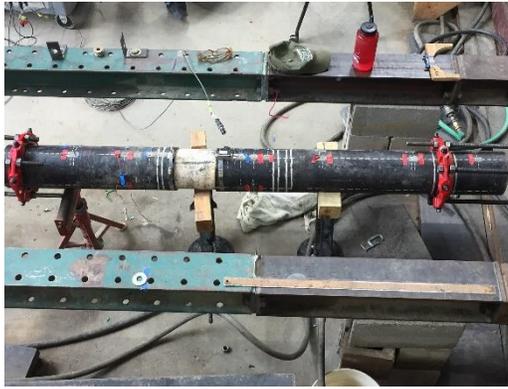
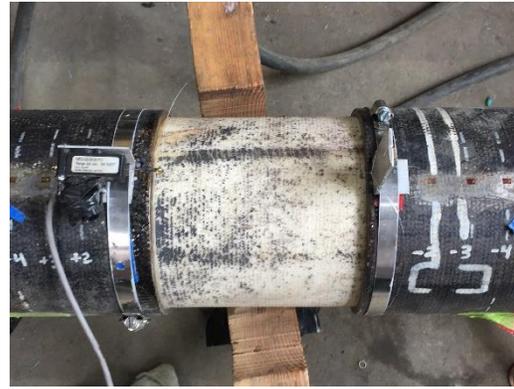
a) Full View of DT2 Specimen in Load Frame

Figure 3.8 (a) - (b) show photographs of the DT2 specimen after the lining fully debonded from the DI host pipe. Figure 3.8 (a) shows the specimen in the small load frame. A string pot on the crown of the crack opening and several strain gages are visible in Figure 3.8 (b).

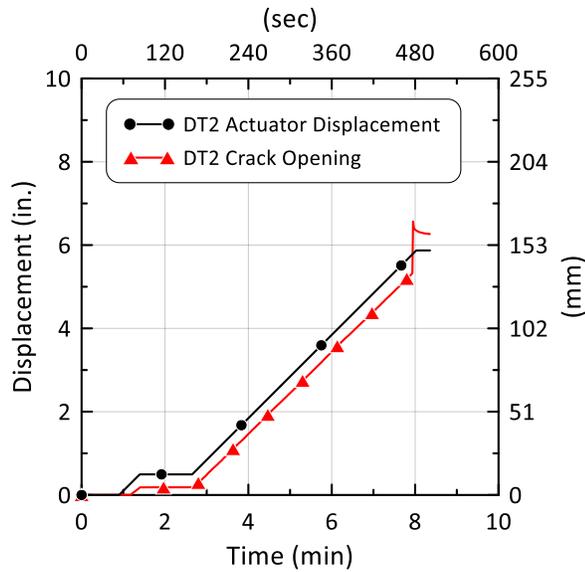
Figure 3.9. Actuator Displacement and Crack Opening vs. Time for DT2 Specimen

The actuator displacement and crack opening vs. time are shown in Figure 3.9. Actuator displacement is a direct measurement of the hydraulic piston movement. Crack opening represents the relative movement between the north and south pipe lengths. Only the south section of the pipe specimen debonded from the lining so the gap opening is equivalent to pipe movement along the south part of the lining.

Crack opening was determined by averaging the displacements of the horizontal string pots, N-Pipe and S-Pipe, across the centerline. At approximately 1 min, there was a slip of the retaining collars that resulted in an offset between the actuator displacement and gap opening. Further crack opening occurred in unison with the actuator displacement, indicating no further slip of the restraining collars and no significant axial deformation of the DI pipe.

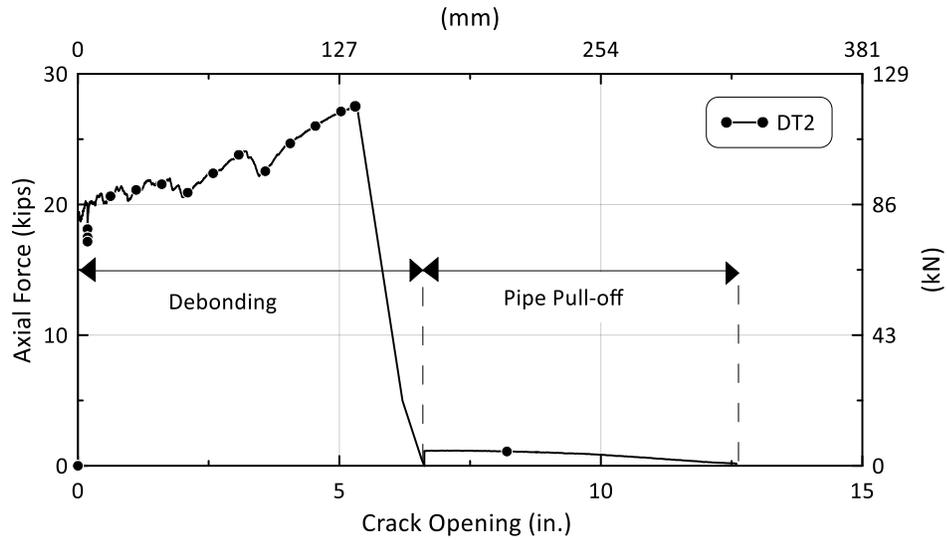
Figure 3.10. Axial Force vs. Crack Opening for the DT2 Specimen

Figure 3.10 shows the axial force vs. crack opening until 12.5 in. (318 mm) of crack opening. Both the debonding and pull-off phases of the test are identified. A maximum force of approximately 27 (120 kN) kips was reached at a corresponding crack opening of 5.5 in. (140 mm). At that point, the debonding front reached the south end of the pipe with a corresponding rapid decrease in axial load. The test was paused before the second phase of loading.

As shown in Figure 3.11, the debonding front propagated rapidly through the south section of pipe to 40 in. (1016 mm) at a gap opening of 0.5 in. (13 mm). Further debonding was affected by additional axial resistance as the southern section of the pipe was pulled along the lining. The increase in debonding length after 40 in. (1016 mm) is presented as a dashed line to indicate that there is uncertainty about the relationship between debonded length and crack opening from 40 to 51 in. (1016 to 1295 mm). The displacements after the initial gap opening of 0.5 in. (13 mm) and a corresponding 40 in. (1016 mm) of debonding correlate with a steady rise in axial force from approximately 20 kips (89 kN) to 27 kips (120 kN) as shown in Figure 3.10.

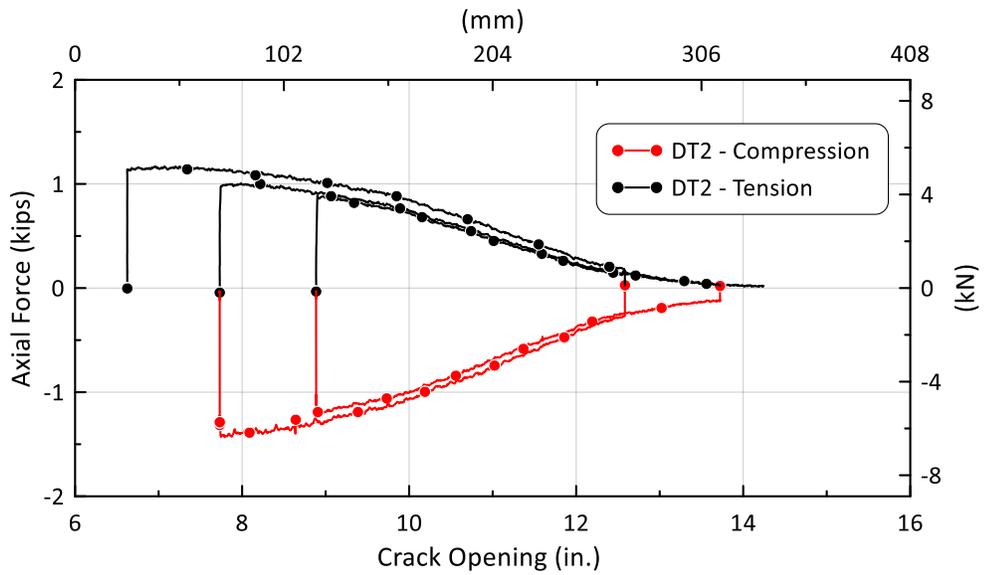
Figure 3.12. Axial Force vs. Crack Opening During Pipe Pull-off

Figure 3.12 shows the axial force vs. crack opening for the initial pipe pull-off as well as two additional cycles of pushing and pulling the DI pipe along the lining. When the pipe was being pulled from the lining, it was in tension (positive force). The lining was in compression (negative force) while the pipe was pushed onto it. The axial force initially increased at the beginning of pipe pull off and decreased to zero. When the pipe was pushed back onto the lining, the force increased slowly from zero to the initial force necessary to pull the pipe off.

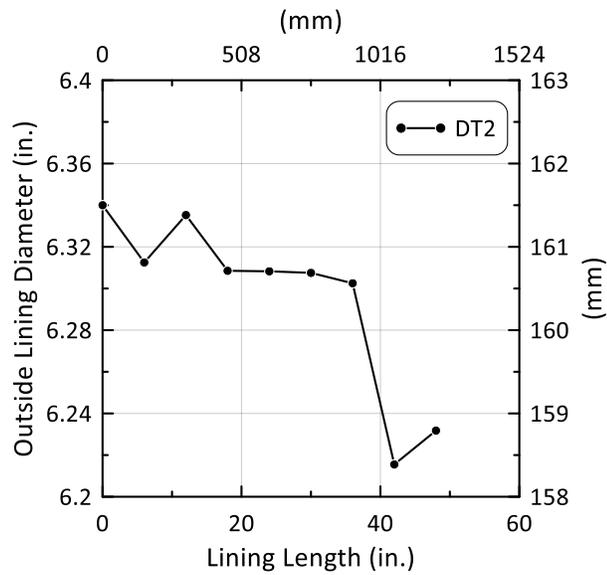
Figure 3.13. Average Outer Diameter of Lining Along the South Section of the DT2 Specimen

Figure 3.13 shows the average outside lining diameter plotted with respect to distance along the south side of the lining that was exposed after the south section of the pipe was pulled from the lining. The diameter is measured from the center of the specimen at zero to near the south end of the lining at 48 in. (1219 mm).

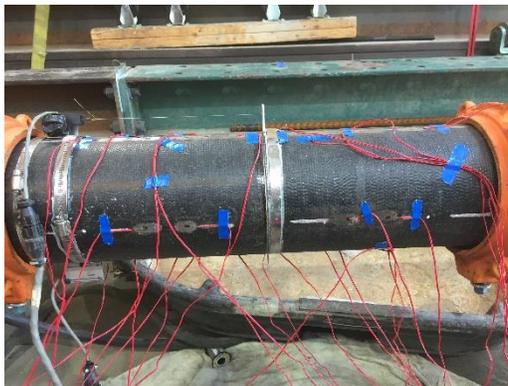
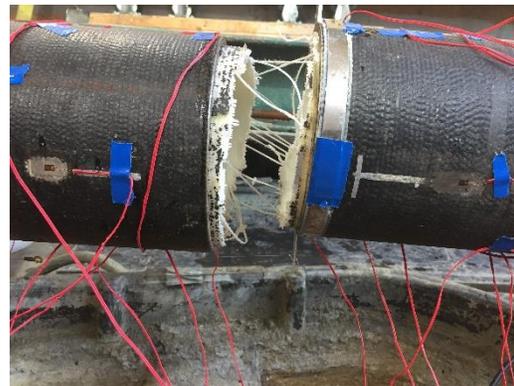
a) Full View of Specimen in Load Frame

Figure 3.14 (a) - (b) show photographs of the DT3 specimen before the start of the test and after the Aqua-pipe lining failed. At approximately 2.5 in. (64 mm) of crack opening, the liner broke in tension rather than debonding along the length of the pipe. As the DI pipe was a new, clean specimen there was a relatively large amount of frictional resistance against debonding compared to the frictional resistance mobilized in field specimens.

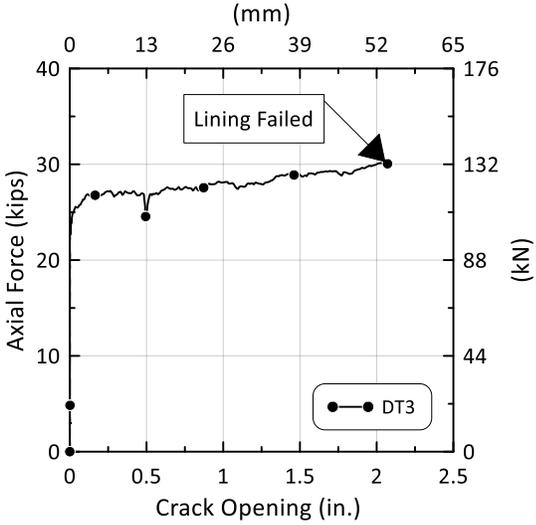
Figure 3.15. Axial Force vs. Crack Opening for DT3

Figure 3.15 shows the axial force vs. crack opening. The force increased until a maximum force of approximately 30 kips (133 kN) was reached and the Aqua-pipe lining failed at approximately 2 in. (51 mm) of crack opening. The stress at failure in

DT3 was 10.7 ksi (74 MPa). This agrees with the findings of the tensile coupon test, which show an average failure stress in the warp direction of 10.9 ksi (75 MPa).

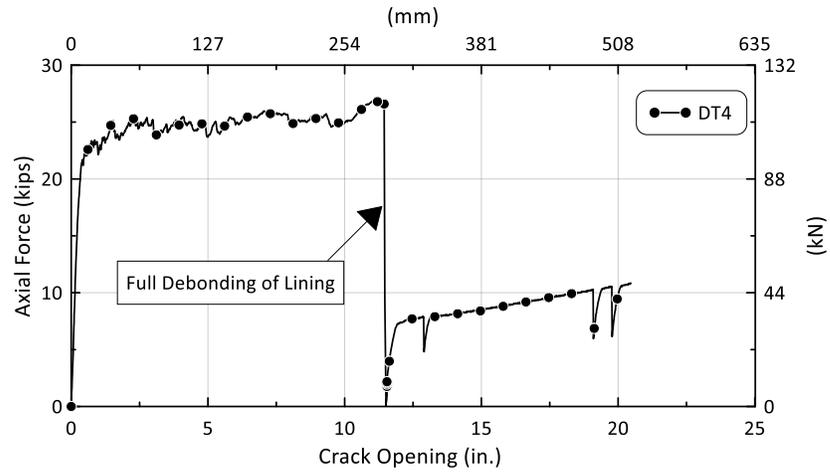
Figure 3.16. Axial Force vs. Displacement for DT4 During Debonding

Figure 3.16 shows the axial force vs. crack opening until 20 in. (508 mm) of movement. The gap opening was caused by displacement of the north pipe section relative to the lining. Thus, the gap opening is equivalent to the axial displacement of the north pipe. The force increased rapidly at first followed by a relatively constant load of 25 kips (111 kN) until a peak load of 26.9 kips (120 kN). At about 12 in. (305 mm) of gap opening, the load dropped rapidly to 0 kips. With further crack opening the axial force began to increase.

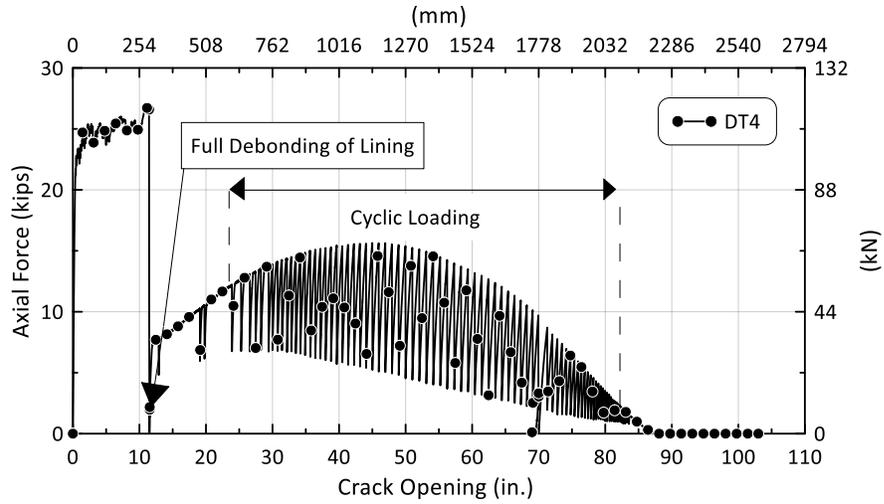
Figure 3.17. Axial Force vs. Displacement for DT4 During the Full Test

Figure 3.17 shows the axial force vs. crack opening until 103 in. (2616 mm) when the north pipe section was pulled completely from the lining. After the sudden drop in axial force at 12 in. (305 mm) of crack opening, the force increased steadily to a maximum force of 15.5 kips (69 kN) at about 48 in. (1219 mm) of crack opening. This increase in axial force was accompanied by a cyclic loading generated as the north section of the pipe was pulled along the lining. These cycles of axial force are shown in the force vs. crack opening plot. The greatest difference between maximum and minimum load in a load cycle occurred when the maximum force of 15.5 kips (69 kN) was measured at 48 in. (1219 mm) of gap opening.

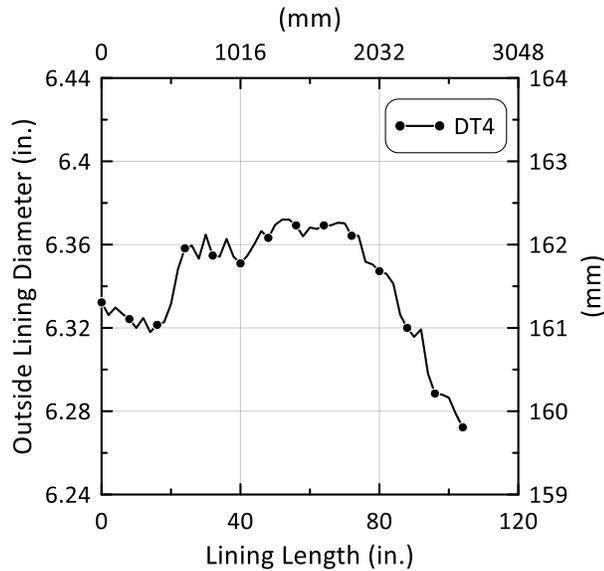
Figure 3.18. Average Outer Lining Diameter Along the North Section of the DT4 Specimen

Because the lining was cast and cured inside the pipe, the outside diameter of the lining is the inside diameter of the pipe. As the pipe was pulled along the lining, the smaller end of the pipe was pulled across a lining diameter that increased until a maximum at about 48 in. (1219 mm). Pulling a smaller diameter pipe along an increasingly larger diameter lining generated an axial load in the pipe that peaked at the location of the maximum lining diameter. After a pipe displacement along the pipe length of roughly 70 in. (1778 mm), corresponding to a crack opening of 70 in. (1778 mm), the lining diameter decreased rapidly, corresponding to rapidly decreasing axial force. When the end of the pipe was pulled along the lining past a lining diameter lower than that of the pipe, the axial force was rapidly approaching zero.

As the smaller diameter pipe was pulled across an increasingly larger diameter lining, the axial load increased. Increased axial load in the lining was accompanied by a load-induced reduction in lining diameter that caused the lining to lurch forward with decreasing axial load until the lining diameter increased again and came into contact

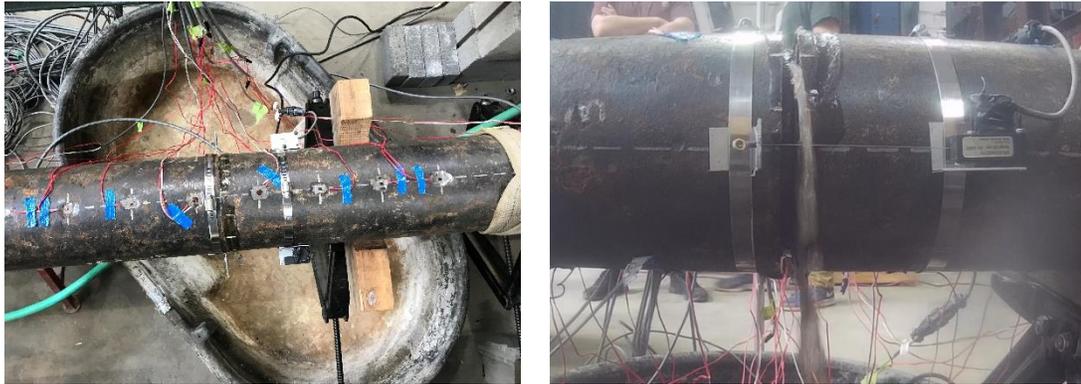
a) View of Specimen in Load Frame before Test Initiation

Figure 3.19 (a) – (b) show photographs of the DT5 test specimen. Figure 3.19 (a) shows the pipe at the beginning of the test. Strain gages on the crown of the pipe and string pots along the eastern and western springlines of the pipe can be seen in the photo. Figure 3.19 (b) shows the leaking that occurred after approximately 0.3 in. (7.6 mm) of crack opening. The leaking was initiated when the debonding front propagated to the

south end of the pipe, breaking the end seal and causing water to flow longitudinally between the pipe and lining into the gap at the center of the specimen.

(b) View of Specimen Leaking after 0.3 in. (8 mm) of Crack Opening

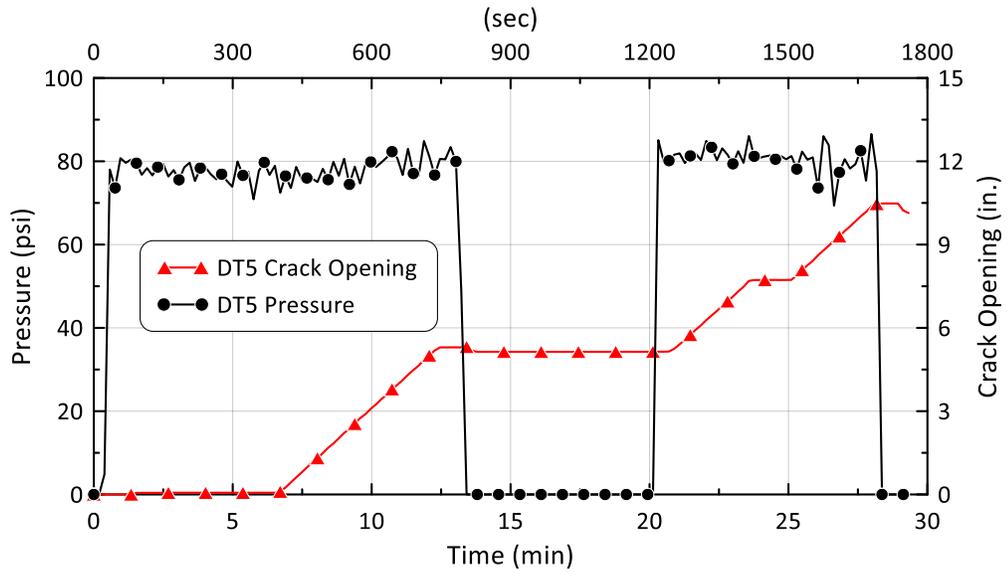
Figure 3.20. Pressure vs. Time During the First Stage of DT5

Figure 3.20 shows both the internal pipe pressure and crack opening measured during the test plotted with respect to time. The test was paused from approximately 14 min to 20 min, during which time the pressure decreased to zero and the crack opening remained constant. At all other times the pipe pressure was maintained at approximately 80 psi (551 kPa). The gap opening was caused by displacement of the south pipe section relative to the lining. Thus, the gap opening is equivalent to the axial displacement of the south pipe. Figure 3.21 shows the axial force vs crack opening during debonding of the CI pipe from the Aqua-pipe lining. At 0.35 in. (9 mm) of crack opening and an axial force of 15.1 kips (67 kN), the pipe debonded to the south, causing a significant drop in axial force to 6 kips (26.6 kN).

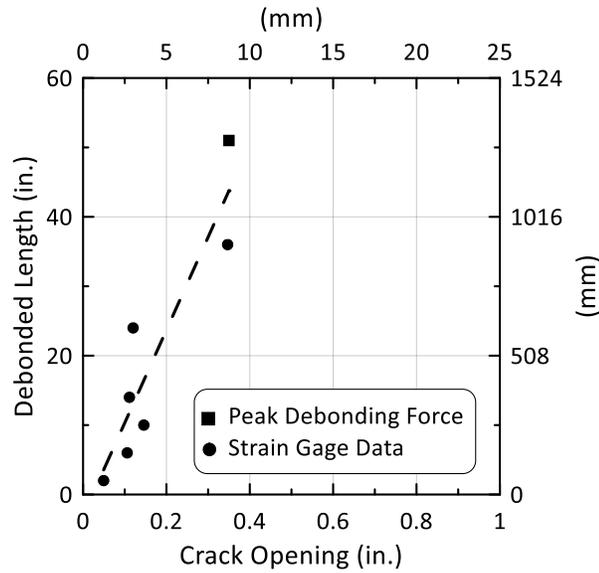
Figure 3.22. Debonding Front vs. Crack Opening for DT5 specimen

The debonded length vs. crack opening was evaluated using strain gage data as explained for DT2. The relatively low sampling rate (2 Hz) for this test makes it more difficult to interpret the data so there is greater variability relative to the 50 Hz sampling rate used in DT2 (see Figure 3.11) when plotting debonded length vs. crack opening.

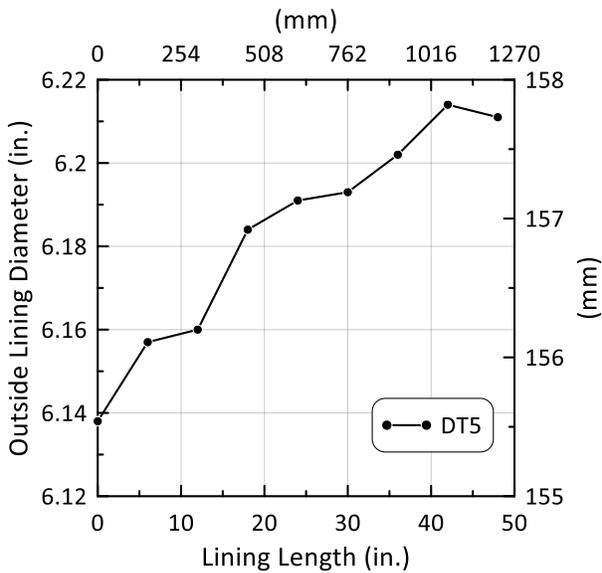
Figure 3.24. Average Outer Lining Diameter along the South Section of the DT5 Specimen

Figure 3.24 shows the average outside lining diameter plotted with respect to distance along the lining. The diameter was measured from the center of the specimen at zero to near the end of the lining at 48 in. (1219 mm). As the pipe was pulled along the lining, the smaller end of the pipe was pulled across a lining diameter that increased until a maximum distance of 42 in. (1067 mm). Pulling a smaller diameter pipe along an increasingly larger diameter lining generated an axial load that peaked at the location of the maximum lining diameter. After a crack opening of 42 in. (1067 mm), the lining diameter decreased, corresponding to rapidly decreasing axial force.

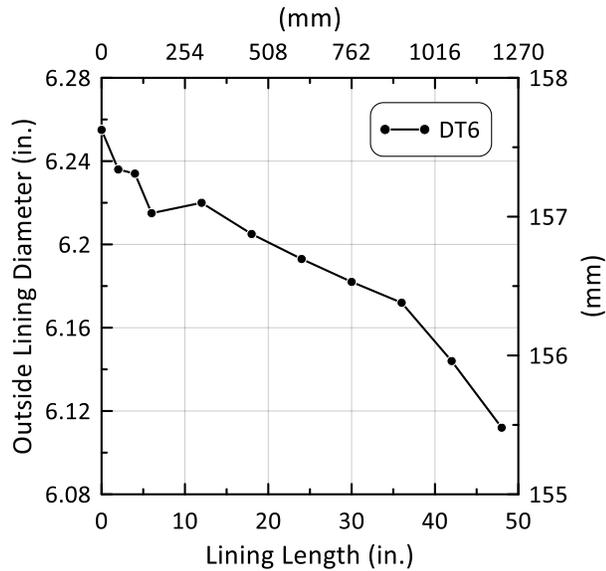
Figure 3.27. Average Outer Lining Diameter along the South Section of DT6

3.27, the lining diameter decreases in the direction that the north pipe section was displaced across the test specimen. Thus, a larger pipe section diameter was pulled across a progressively smaller lining diameter, resulting in decreasing axial load similar to the response of DT2.

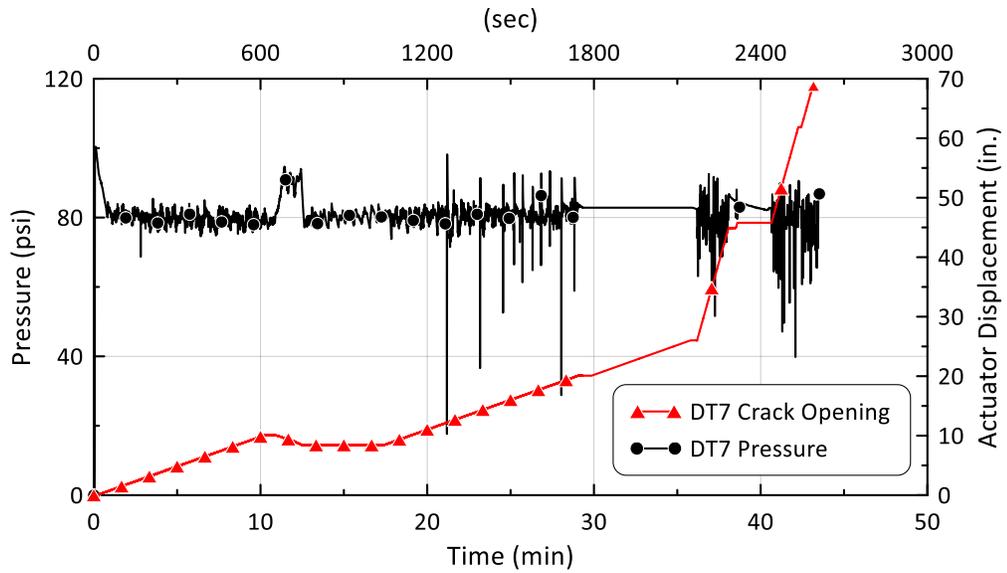
Figure 3.29. Pressure and Actuator Displacement vs. Time for DT7

Figure 3.29 shows a plot of internal pipe pressure vs. actuator displacement. Throughout the test, the pipe pressure was maintained with some fluctuation at 80 psi (551 kPa). This test differed from DT5 and DT6 where the pipe was pulled from the lining under diminished or near zero pressure. In DT7, axial movement of the pipe relative to the lining occurred under 80 psi (551 kPa) for the entire test.

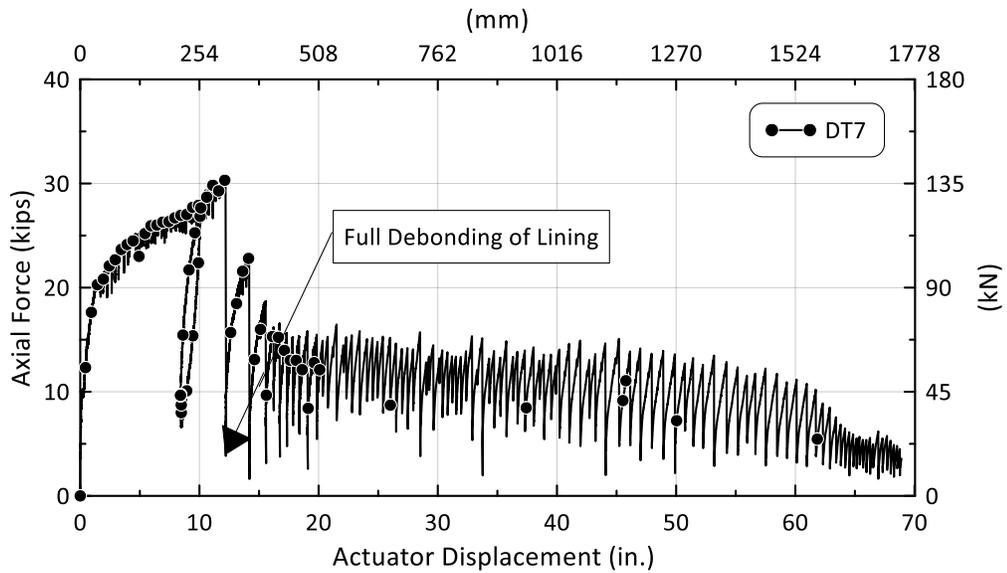
Figure 3.31. Axial Force vs. Actuator Displacement for DT7

Figure 3.31 shows the axial force vs. actuator displacement. The north pipe section debonded from the lining. At approximately 12 in. (305 mm) of actuator displacement, the force rapidly decreased to 6.5 kips (30 kN) during debonding, as it shows in the figure. At full debonding of the north pipe section, the pipe had been pulled 9.3 in. (236 mm) from the lining.

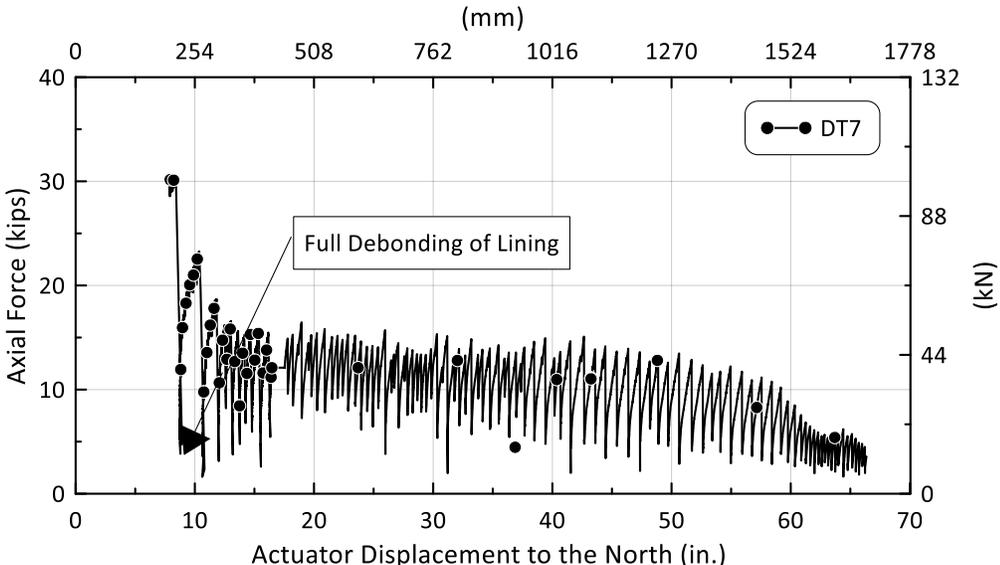
Figure 3.33. Axial Force vs. North Pipe Displacement after Debonding for DT7

smaller diameters. This agrees with the decrease in axial force after 41 in. (1041 mm) of north pipe displacement seen in Figure 3.33.

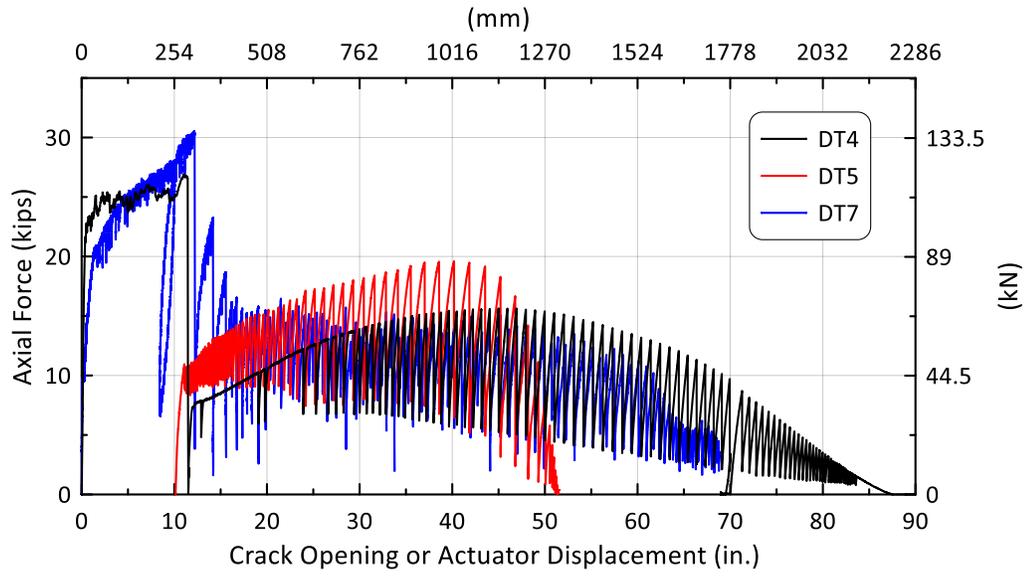
Figure 3.35. Axial Force vs. Crack Opening or Actuator Displacement for DT4, DT5, and DT7

The test results show a complex interaction involving the pipe and lining geometry, friction between the lining and pipe, and internal pressure. After debonding, DT4 and DT5 were performed at zero internal pressure. The highest maximum force after debonding was recorded in DT5. A larger change in pipe and lining diameter over distance was measured in DT5 than in DT4. DT7 was performed with the smallest change in pipe and lining diameter over distance. Although DT7 was performed under a pressure of 80 psi (551 kPa), it nonetheless shows the lowest axial load after debonding, which is apparently related to a smaller change of diameter compared with DT4 and DT5 specimens.

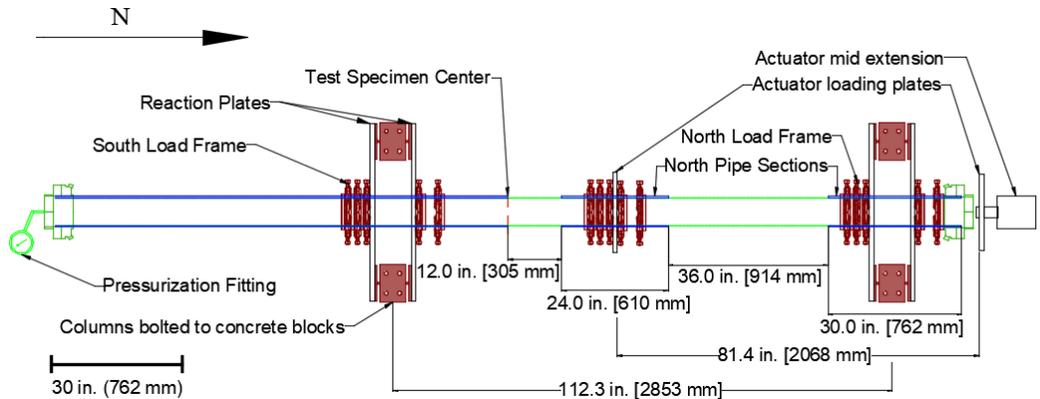
Figure 4.1. Plan View of Friction Test Setup

Each friction test was performed from an initial position where the leading side of the 24-in. (610 mm)-long section of pipe was located 36 in. (914 mm) north of the DT4 specimen center. The pipe was then pulled along the lining 36 in. (914 mm) until contact with the north section of pipe. The moveable pipe section was then reset by pushing it under zero lining pressure back to its initial position. Figure 4.4 shows the movement of the 24-in. (610 mm)-long pipe section on the plot of the DT4 lining diameter vs. distance along the lining. As the pipe was pulled in the northward direction, it moved onto a lining that increased in diameter from 6.318 in. (160.5 mm) to 6.372 in. (161.9 mm) as shown in the figure.

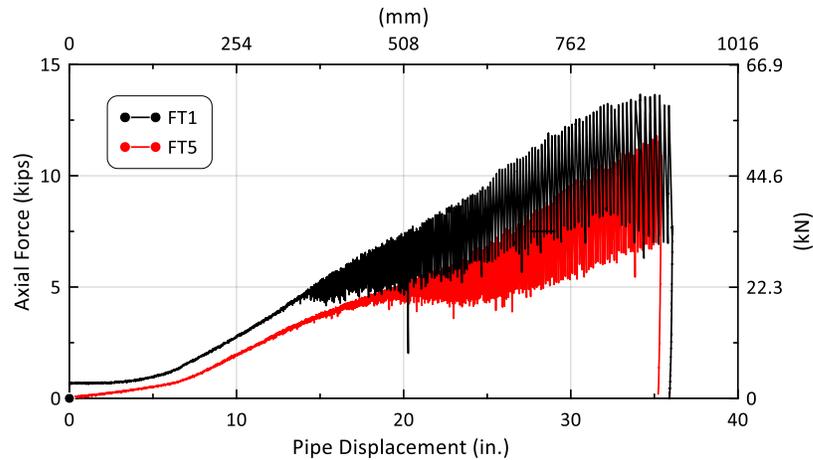
Figure 4.5. Axial Force vs. Pipe Displacement for the Initial Friction Test (FT1) and a Subsequent Friction Test (FT5)

Figure 4.5 presents the results of two friction tests performed under zero internal lining pressure. The axial force vs. pipe displacement are shown side by side for the first friction test (FT1) and a subsequent test (FT5) performed after intervening tests.

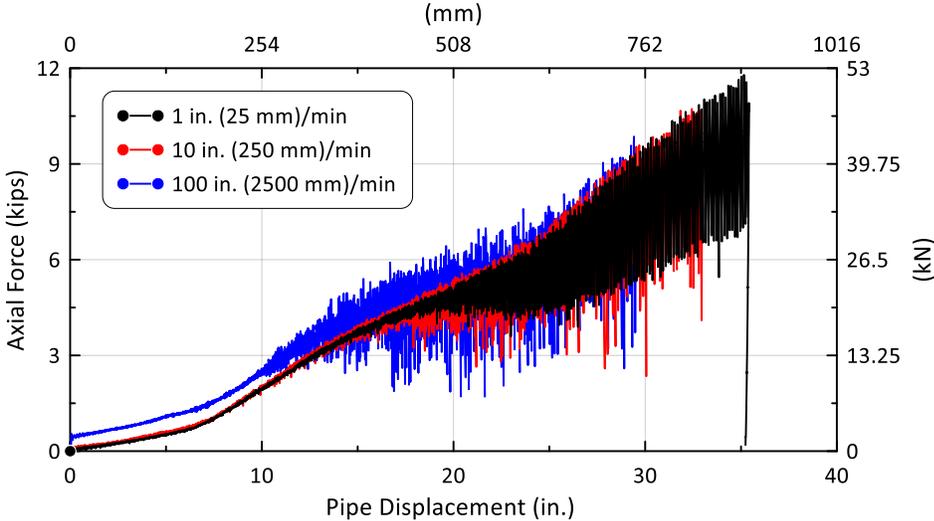
Figure 4.6. Comparison of Axial Force vs. Pipe Displacement Response at Zero Pressure for Different Loading Rates

These results show that axial load vs. displacement performances is not influenced by the loading rate. The load response remains unchanged over two orders of magnitude in displacement rate. Showing the independence of load response to the rate of loading displacement eliminates an important variable, and simplifies both the experimental conditions for relevant testing as well as the characterization of ground deformation effects on cured in place pipe behavior.

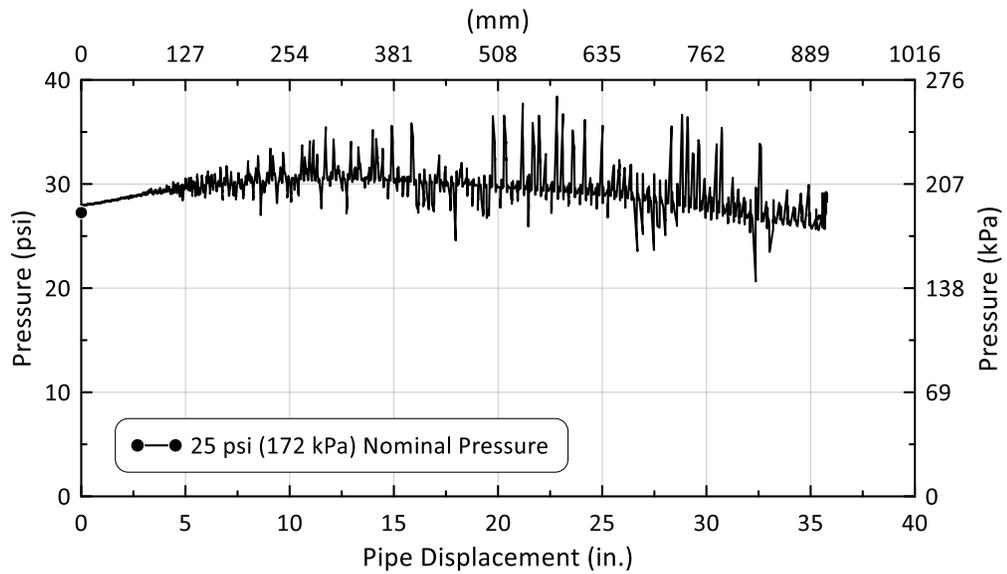
Figure 4.8. Lining Pressure vs. Pipe Displacement for Nominal 25 psi (172 kPa) Pressure

To explore further the relationship between axial load and lining pressure, the pressures measured in each test are plotted with respect to pipe displacement in Figure 4.8 through Figure 4.10. Because of the cyclic loading and associated rapid changes in axial movement, it was difficult to maintain constant pressure. The trend in average pressures is plotted for each test, from which the pressure at any displacement can be identified and used to evaluate the relationship between peak axial load and internal lining pressure.

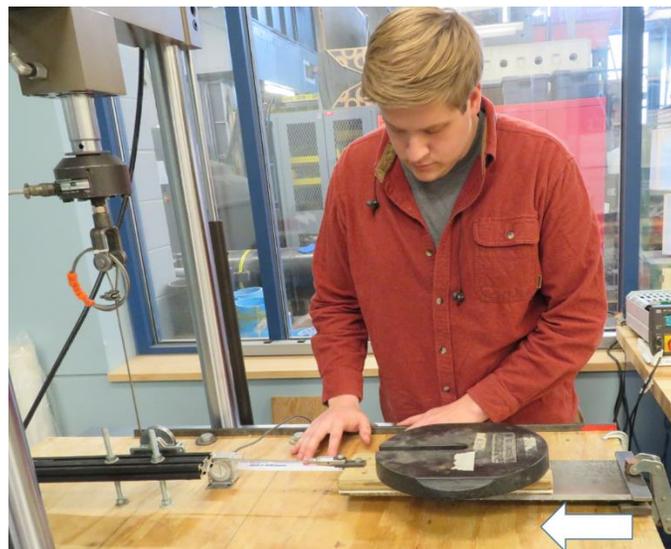
Figure 5.2. Photo of Aqua-pipe Direct Shear Test Setup

shown in Figure 5.3. a. The section was cut so that the lining was in contact with the interior pipe surface at the location where it was cured in place during installation. The lining was then separated from the host pipe as shown in Figure 5.3. b. The lining specimen was fixed to a wooden insert that was used to convey weights of various magnitude across the lining/pipe interface, as illustrated in Figure 5.2.

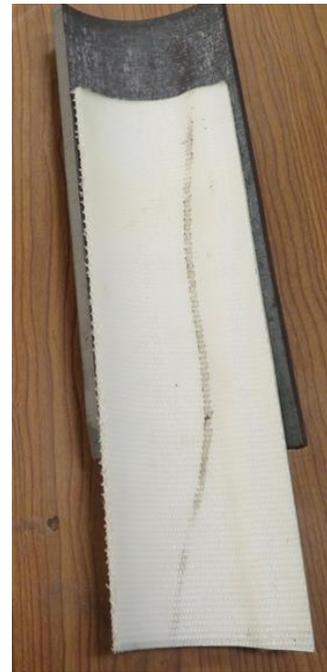
(b) View of Aqua-pipe Lining and Pipe Specimen after being Cut and Prepared

Figure 5.3. Photos of Aqua-pipe Direct Shear Test Specimen
