Albany Housing Authority Building Inspection

Report prepared by Thomas Gallagher, Cornell Cooperative Extension Sr. Resource Educator

Creighton Storey Homes, 158 Third Ave, Albany, NY

Ezra Prentice Homes, 625 South Pearl Street, Albany, NY

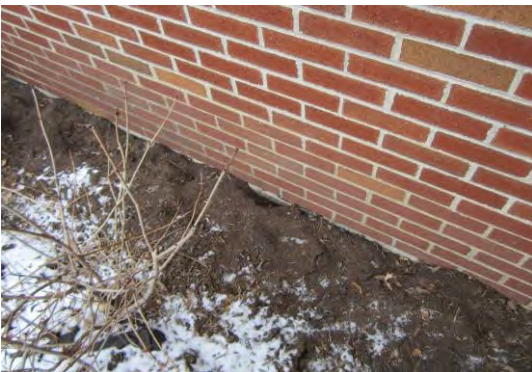
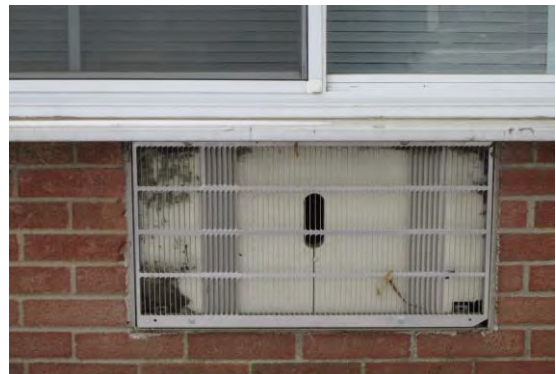
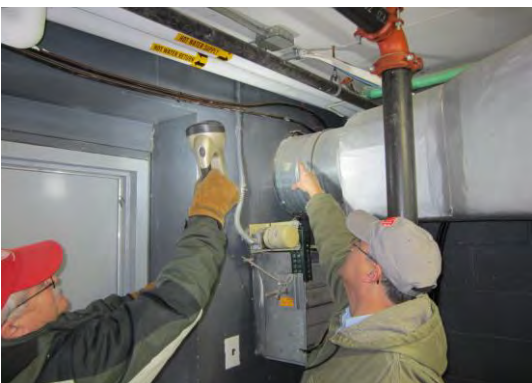
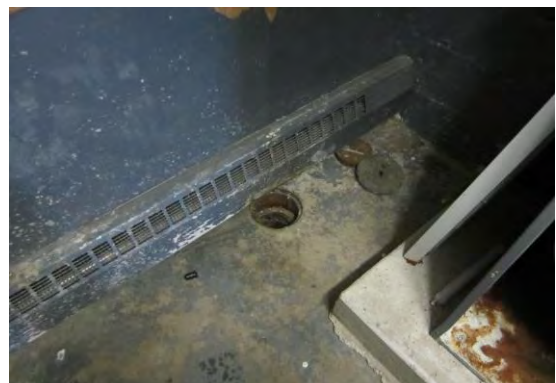
This complex has 128 living units. There was evidence of moles tunneling under mulch around the main office building (158). Removal of some of the mulch in the spring was recommended. All garbage collection areas at the site were clean, well-kept and under a roof. Building 166 had openings around air conditioning units and the drain covers in the boiler rooms were missing which could be an area for insects and mice to enter. Building 164 and 168 had dryer and furnace vents that had no screening covers. Building 168 in the boiler room had several problems including wrapping around pipes had signs of mice boring, the heater vent had grates missing and vents to the outside had pieces missing. There was evidence of a sewage leak which was cleaned up while we were on site. Building 156 main drainpipe has a large hole around the pipe. Building 158 boiler room door needs a new sweep.

Based on Pest Management reports left on site by Northeast Pest Control, building 152 has had the most problems with mice and roaches. The mice have been baited with sealed bait stations and glue traps have been used. Roaches have been treated with a baseboard treatment and empty apartments have been fogged. Our outdoor inspection revealed holes around vent pipes, air conditioner grates with holes and molding missing on the outside of the building. There was no access to any apartments but by the number of roach complaints from tenants, there probably is a sanitation issue in some apartments.

As an inspection team we would recommend that all of the minor structural repairs be made as soon as possible and that a fact sheet on sanitation be distributed to renters in building 152. Overall this building complex was well maintained with limited pest problems.

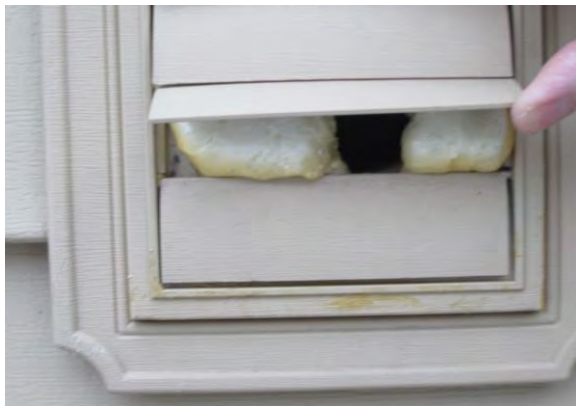
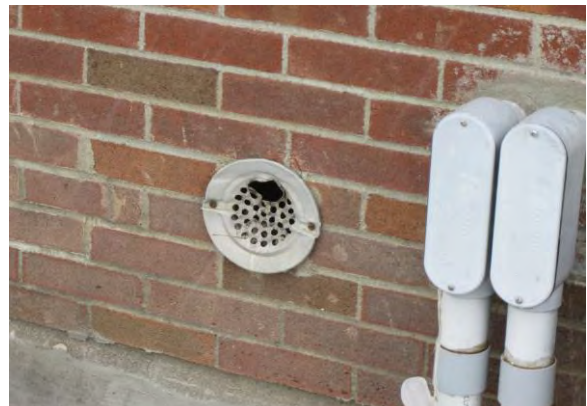
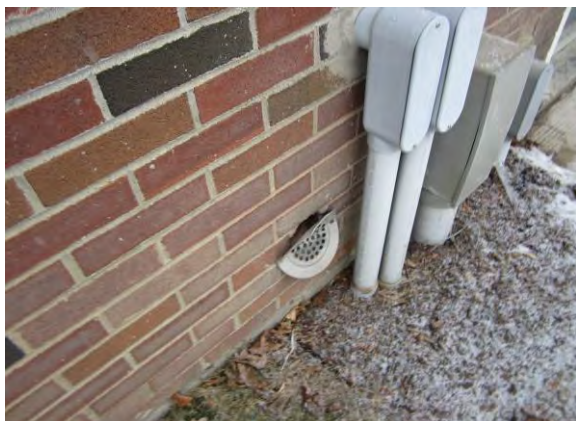
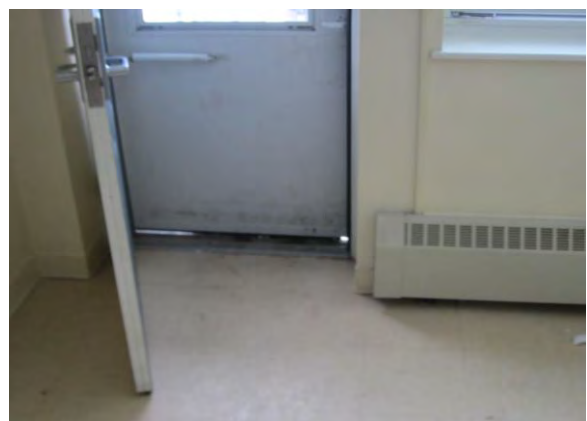
This complex is made up of 16 buildings and 179 living units. Rehabilitation at this site has been ongoing with the latest being completed in 2006. Building 627 had foam to fill old vent holes which allows mice and insects to enter easily. Wire mesh or steel wool was recommended to replace the foam. Building 629 had a sewage smell in the boiler room and many first floor vents to the outside do not have covers to adequately keep out pests. We were able to enter apartment 631C which was vacant at the time. The apartment did not show any signs of a pest problem with the kitchen and bathroom clean and dry. The inside door had good sweeps to keep out pests. There was an outside vent cover which had been bent in half allowing access to mice in the apartment next door. Building 638 had a hole in a roof vent caused by squirrels. Here we recommended the hole be covered or the vent replaced to keep the squirrels out of the attic. Building 633 and 637 had mouse problems, probably because of vents not properly covered. Northeast pest Control is using traps and bait stations to bring the problem under control. All holes around pipes should be filled and vent covers installed where missing or not adequately covered. Individual recycle bins were seen outside of many apartments, which could attract rodents. None of these bins appeared to have covers. We would recommend that the bins be dumped daily or covers be provided.

Currently all apartments are sprayed for ants, mites and roaches when vacant. We recommend that sticky traps be used to determine the level of infestation before random spraying of every apartment.

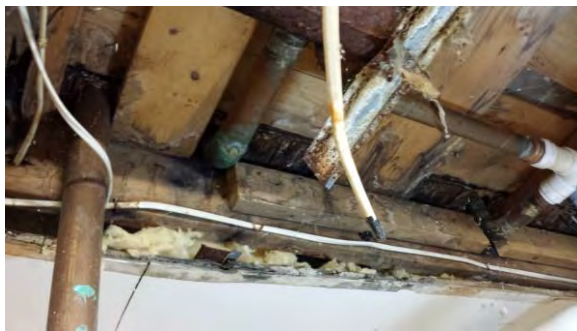
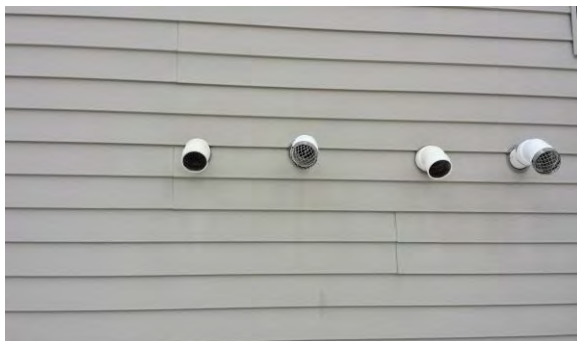
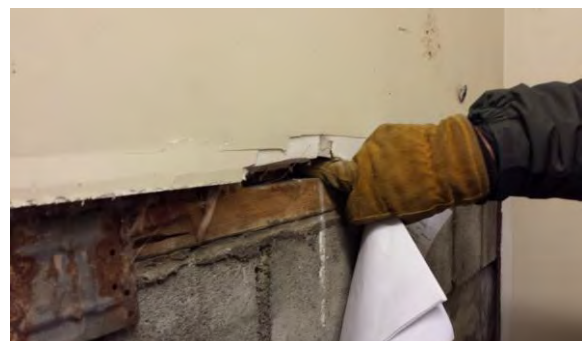
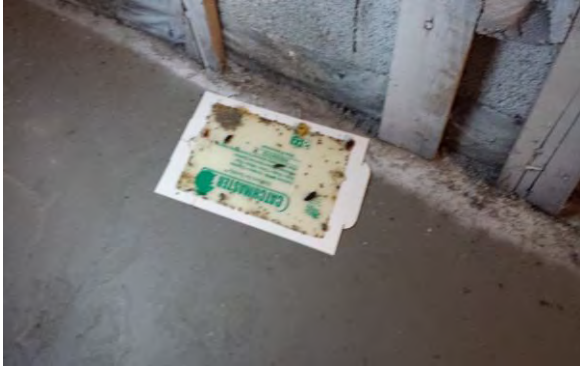
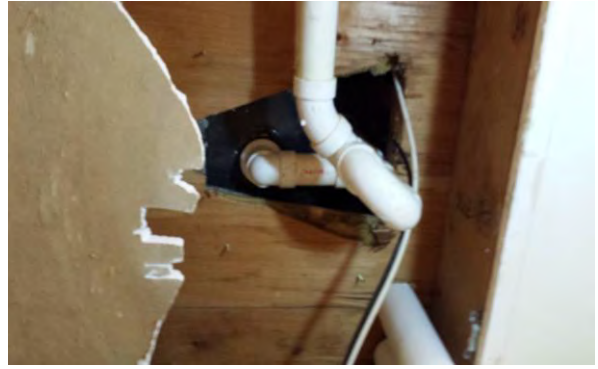
As we began our inspection of the site, we noted the outside of the building was in excellent shape with vinyl siding sealed at the bottom, window air conditioners removed or properly installed and vent pipes properly installed and covered.

We were allowed to enter former basement apartments in buildings 80, 20, 50, 150 and 100. It appeared that all of the former basement apartments had had water damage and the bottom 1/3 of each wall had all sheet rock removed. There were large holes in the basement floor with soil at the bottom of each hole. Ceilings and floors of first floor apartment had been removed to access plumbing in the first floor apartments. Some outside block walls had insulation on them and appeared to be wet. Walls between the former apartments had large holes as did ceilings as you first walked in the door allowing rodents and insects to move freely from apartment to apartment. In almost every case glue traps and snap traps were found in these basement apartments with dead mice in most traps. Sticky traps revealed evidence of a minor roach problem in the building.

Our inspection team would recommend the following: First, each basement should be cleaned, removing any dead pests, old traps and pieces of ceiling or sheetrock. Holes in the floor and ceiling to first floor apartments below the bathtub area should be covered to eliminate the movement of mice from the basement. New sticky traps should be placed in each basement and monitored by Northeast Pest Control. Poor sweeps to any of the basement apartments should be checked and replaced where needed. It appears that all vent pipes going to the basement are properly sealed.
