ANNUAL REPORT ON THE ECOLOGICAL MONITORING OF DAM REMOVAL PROJECTS IN THE HUDSON RIVER ESTUARY

**New York State Water Resource Institute
Department of Biological & Environmental Engineering
Cornell University**

**Jeremy Dietrich
Department of Natural Resources
Cornell University
November 06, 2020**

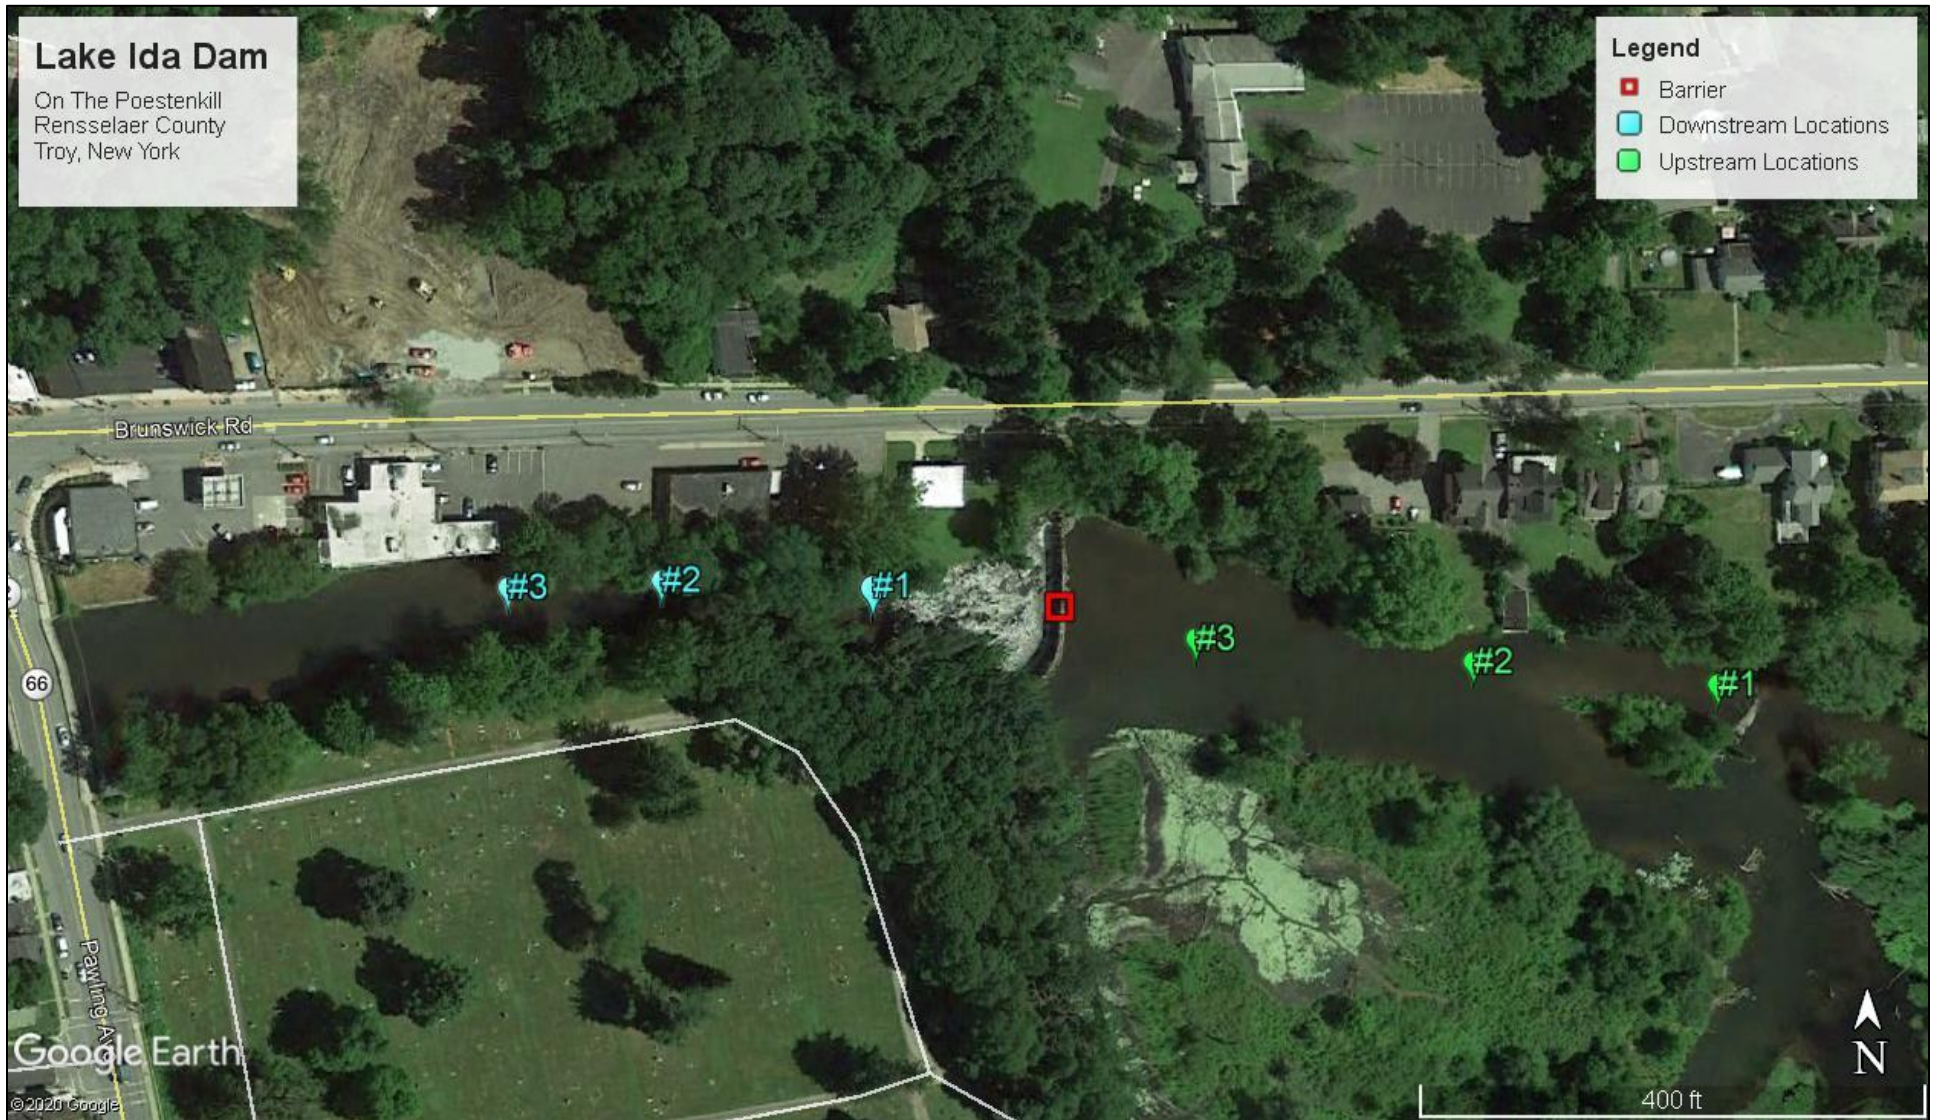
Figure 2: Upstream and downstream transect monitoring locations at Lake Ida dam on the Poestenkill during 2019 and 2020.

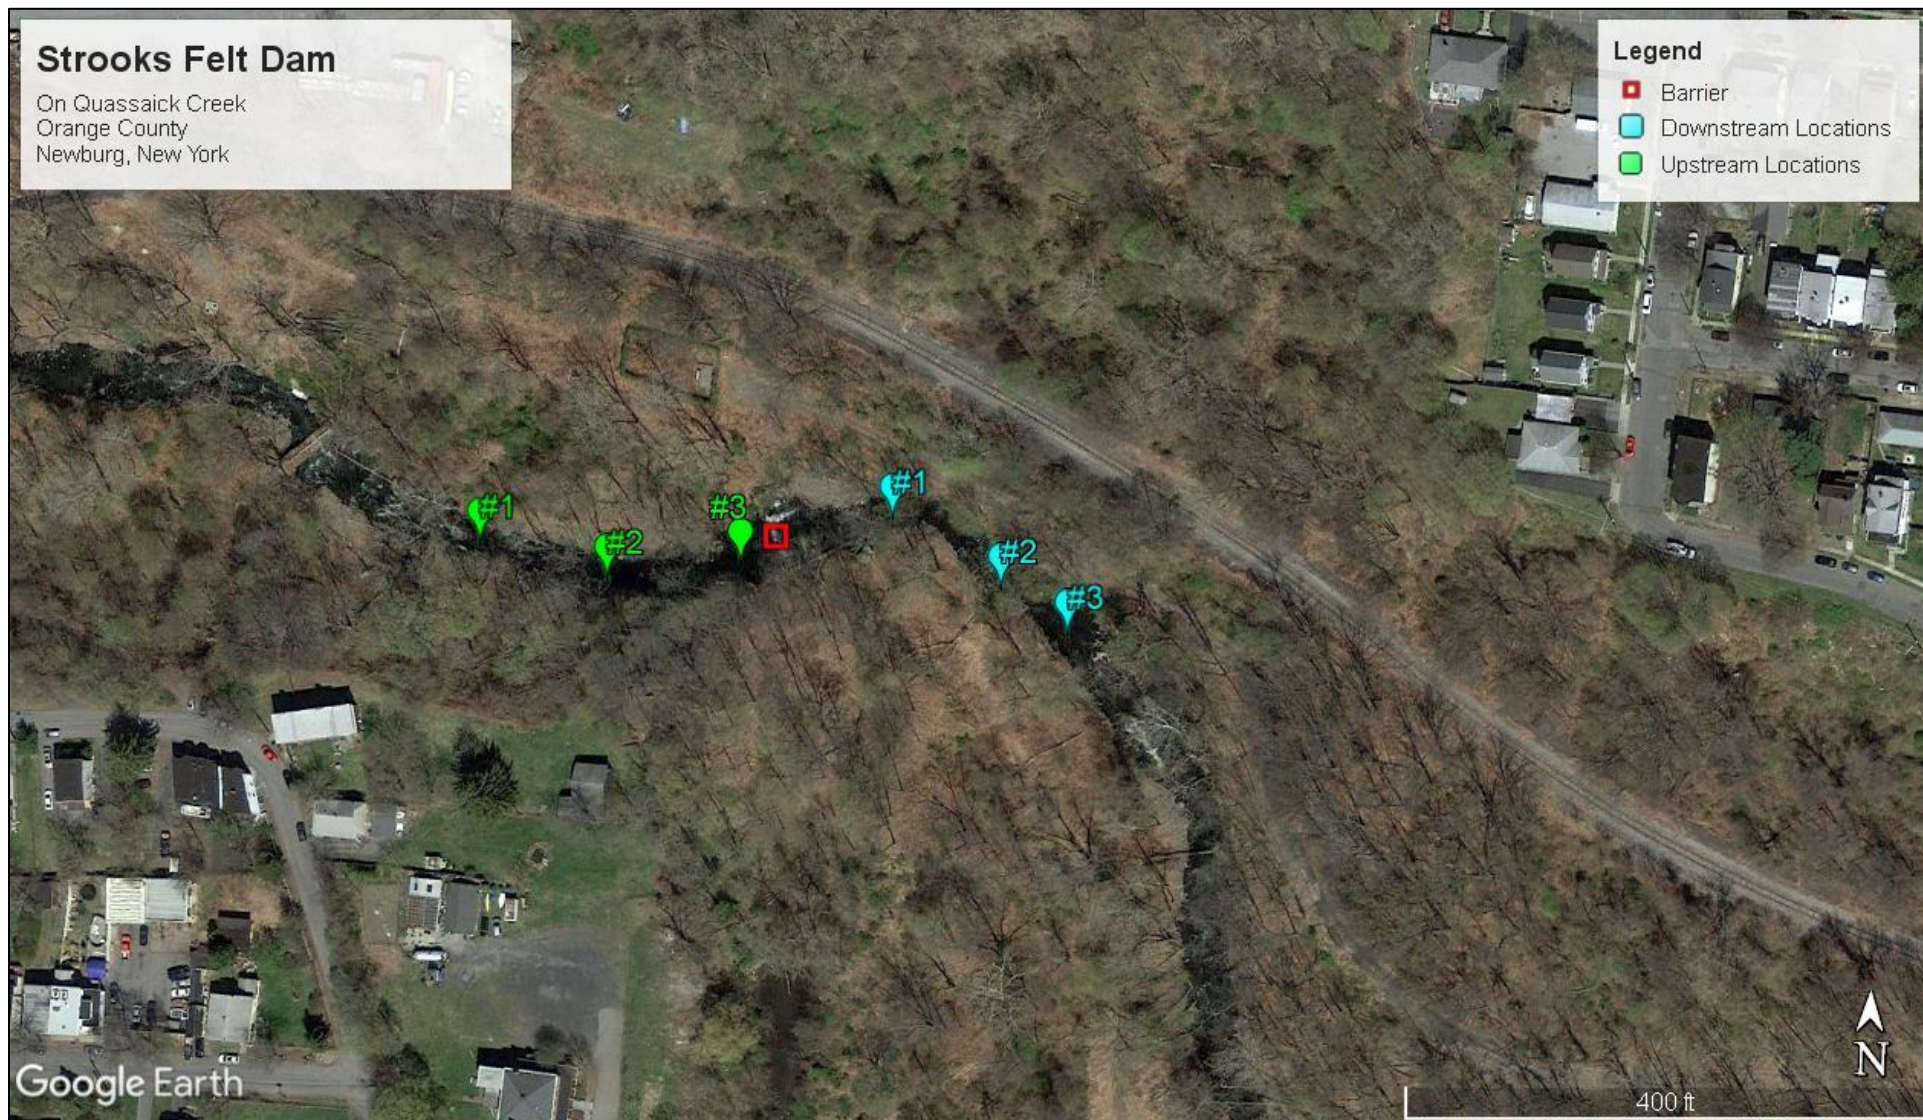
Figure 3: Upstream and downstream transect monitoring locations at Strooks Felt dam on Quassaick Creek during 2019 and 2020.

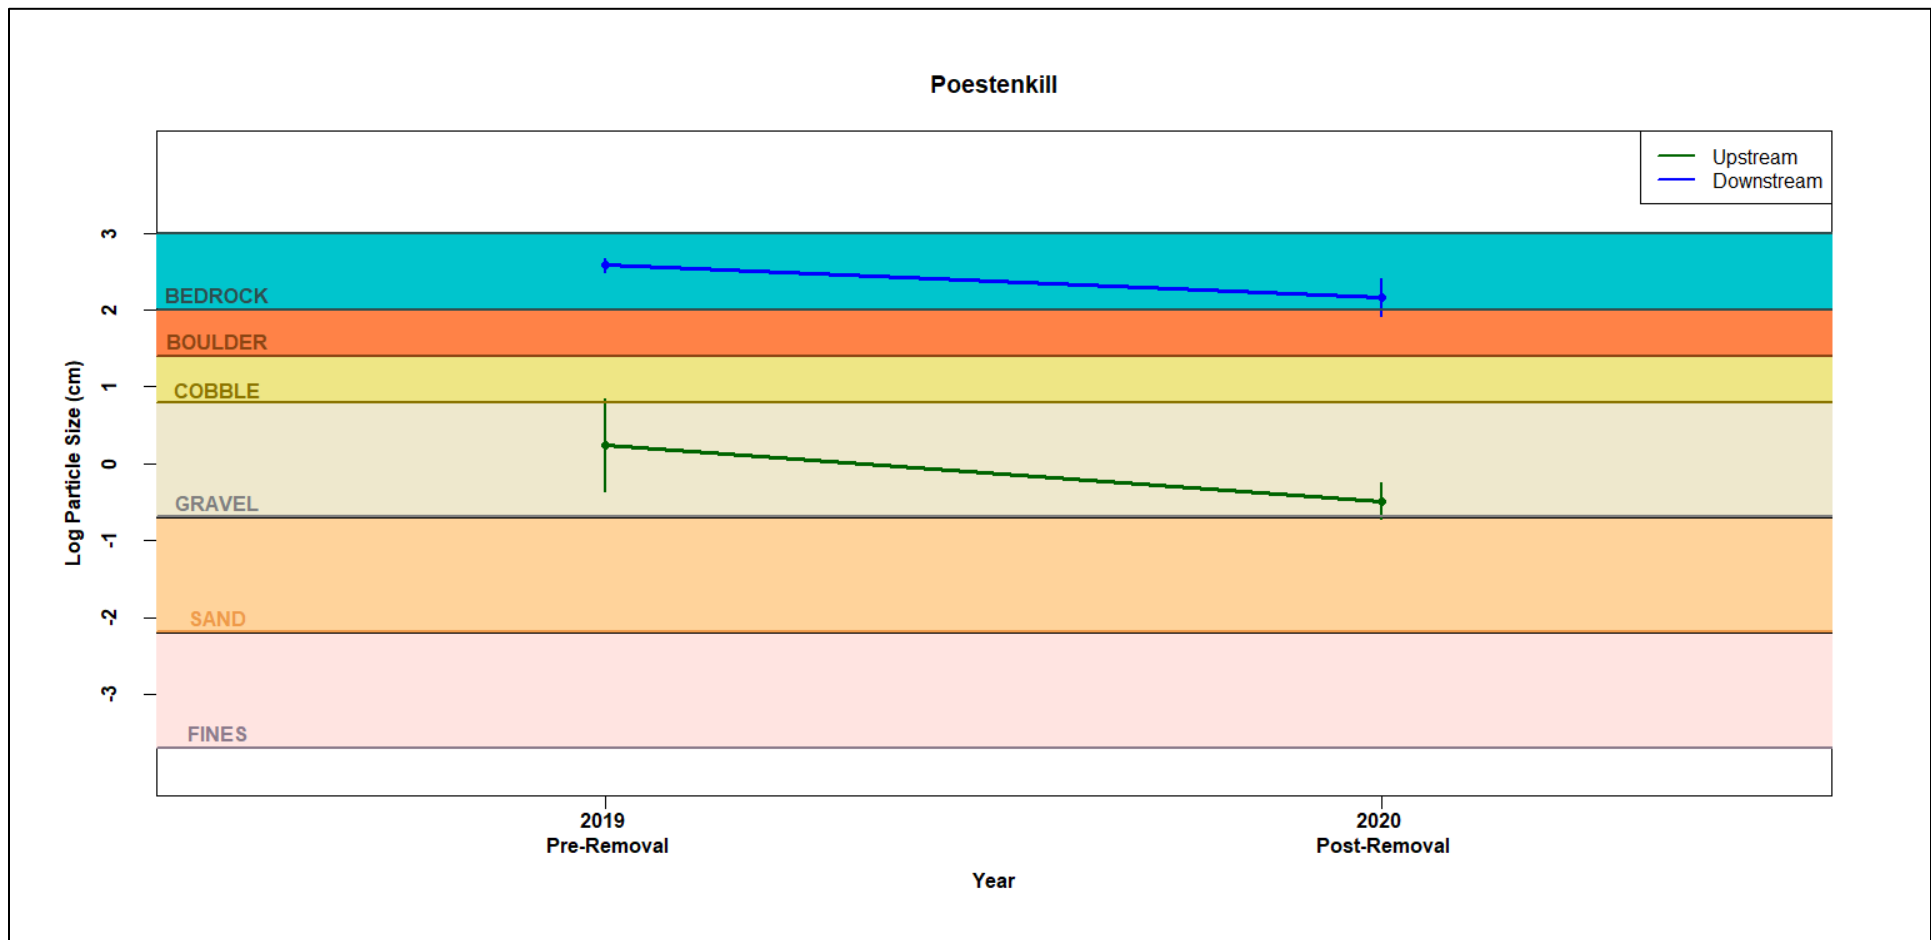
Figure 6: Change in substrate particle size at monitoring locations upstream and downstream of Lake Ida dam on the Poestenkill under 2019 pre-removal and 2020 post-removal conditions.

This change caused the wetted-width mean particle size to decline significantly from 384cm to 155cm [Figure 6]. This sand deposition also raised the elevation of the channel bed, on average, 0.214ft across the immediate downstream reach. The amount of this deposition increased for each individual transect as distance from the dam increased. Mean bed elevation at Downstream #1 was raised 0.018ft and Downstream #2 was raised 0.264ft. The channel bed at Downstream #3 raised highest at 0.324ft [Figure 12], and sand uniformly blanketed the former bedrock sheet, and filled in many of the crevices [Figure 13].

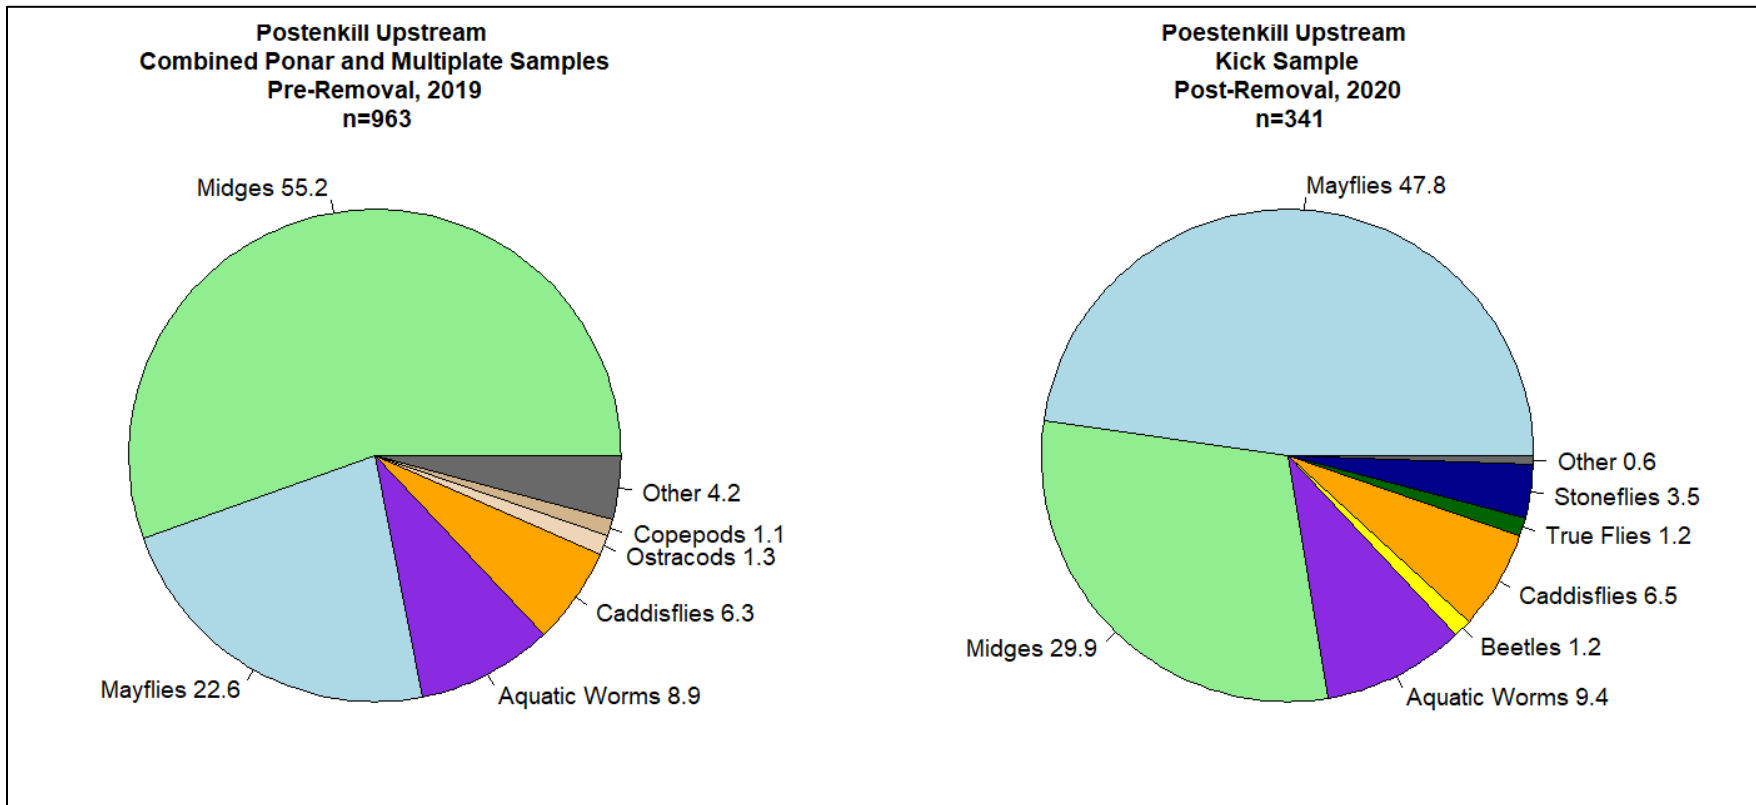
Figure 7: Aquatic Macroinvertebrate community assemblages on the Poestenkill within the lentic pre-removal upstream impoundment during 2019 and the restored lotic stream segment post-removal in 2020.

The initial upstream pre-removal invertebrate assemblage in 2019 was dominated by Chironomid midges which composed 55% of the community composition [Figure 7, left panel]. Mayflies were the next abundant taxa at 22.6% abundance; however, their presence was disproportionately represented in drift. Mayflies composed 29.6% of the drift organisms, as captured by the multiplate samples, versus only 3.5% of the benthic habitat sampled by the

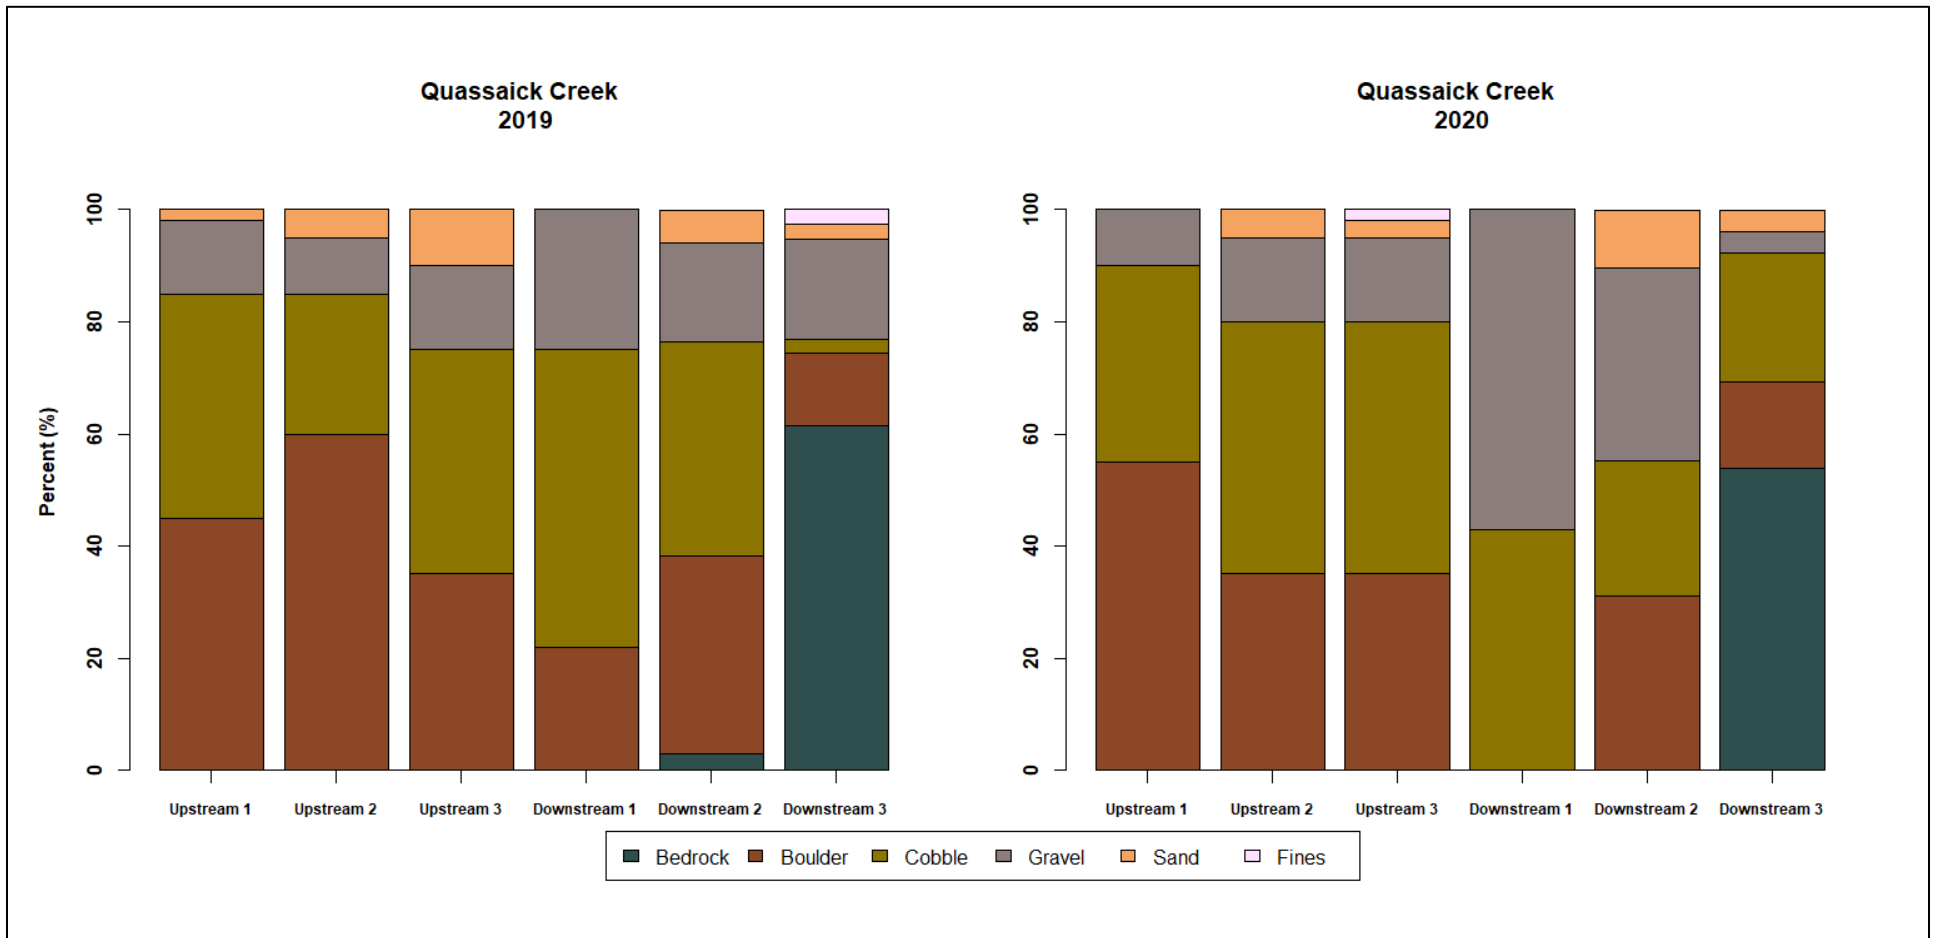
Figure 14: Pre-removal wetted-width substrate composition along each upstream and downstream monitoring transect surrounding Strooks Felt dam on Quassaick Creek during 2019 and 2020.

Continuing pre-removal monitoring efforts on Quassaick Creek found consistent habitat conditions above and below Strooks Felt dam [Table 5, Figure 14]. Two years of pre-removal observation data found substrate conditions above the dam were dominated by boulder (44.3%) and cobble (38.3%). Gravel, sand, and silts/clays represent only 13.0%, 4.2%, and 0.3%, respectively. The mean particle size above the dam during 2019 was 40.2cm and during 2020 it was 36.8, maintaining an overall boulder description [Figure 15]. Downstream of Strooks Felt dam, pre-removal observations showed a highly coarse overall substrate composition averaged 19.7% bedrock, 19.4% boulder, 30.7% cobble, and 25.9% gravel. Sand and fines represented only 3.8% and 0.4%, respectively. The mean particle size downstream of the barrier during 2019 and 2020 was 129.2cm and 102.4cm, respectively, also indicating overall boulder composition [Figure 15]. No significantly different substrate conditions were found during the first two years of pre-removal data on Quassaick Creek.

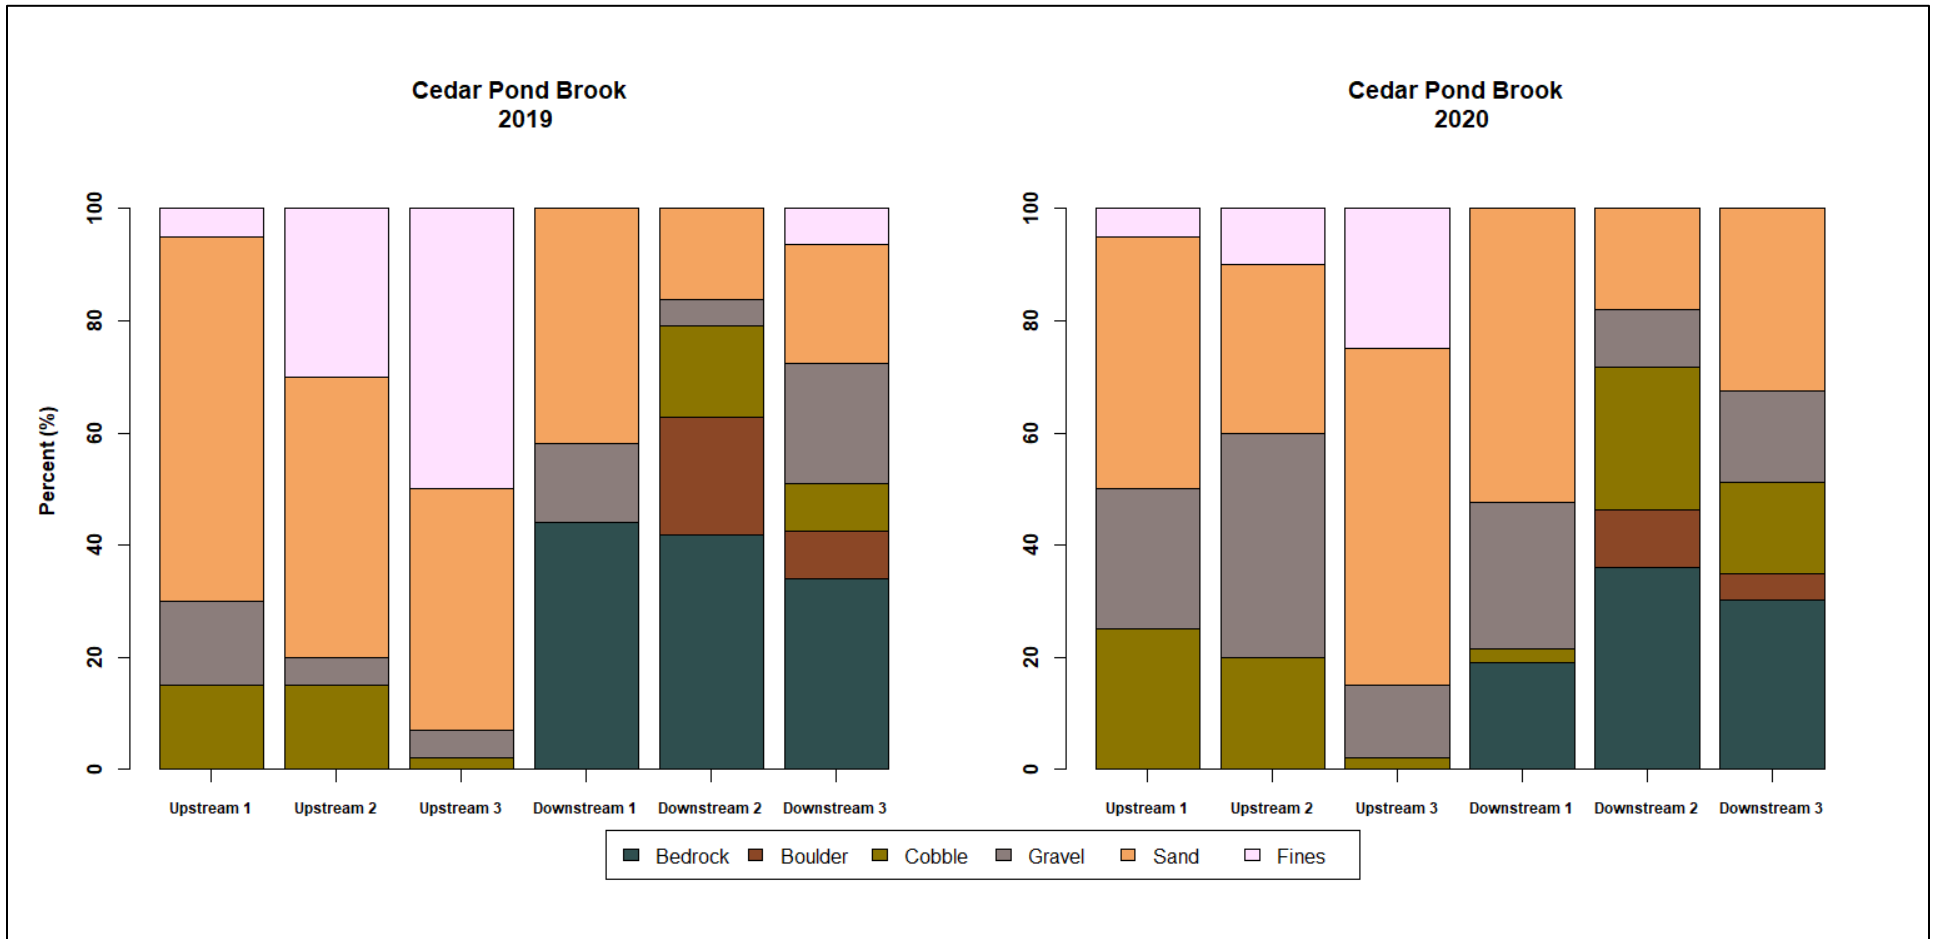
Figure 21: Pre-removal wetted-width substrate composition along each upstream and downstream monitoring transect surrounding Stony Point dam on Cedar Pond Brook during 2019 and 2020.

During two seasons of pre-removal monitoring on Cedar Brook contrasting habitat types were observed above and below Stony Point dam [Table 8, Figure 21]. Overall, sand and fine-sediments (silt/clay) were most prevalent upstream of the dam, with 48.9% and 20.8%, respectively, and combined, attributed nearly 70% of the substrate composition at each replicate location. The remaining substrate composed of gravel (17.2%) and cobble (13.2%). The mean particle size upstream of Stony Point dam was 1.845cm, representing medium gravel [Figure 22]. Downstream of Stony Point dam, the substrate composition was more varied, with 34.2% bedrock, 7.4% boulder, 11.6% cobble, 15.5% gravel, 25.4% sand, and 1.1% fines. The mean particle size downstream of the barrier was 177.1cm, representing large boulder [Figure 23]. The high particle size downstream is attributable to the prevalence of bedrock, which contributed to a third of the wetted-width substrate composition at the two lower downstream transect locations. Overall, substrate composition at Cedar Pond Brook did not change significantly during the past two years of observation, upstream or downstream of the dam.

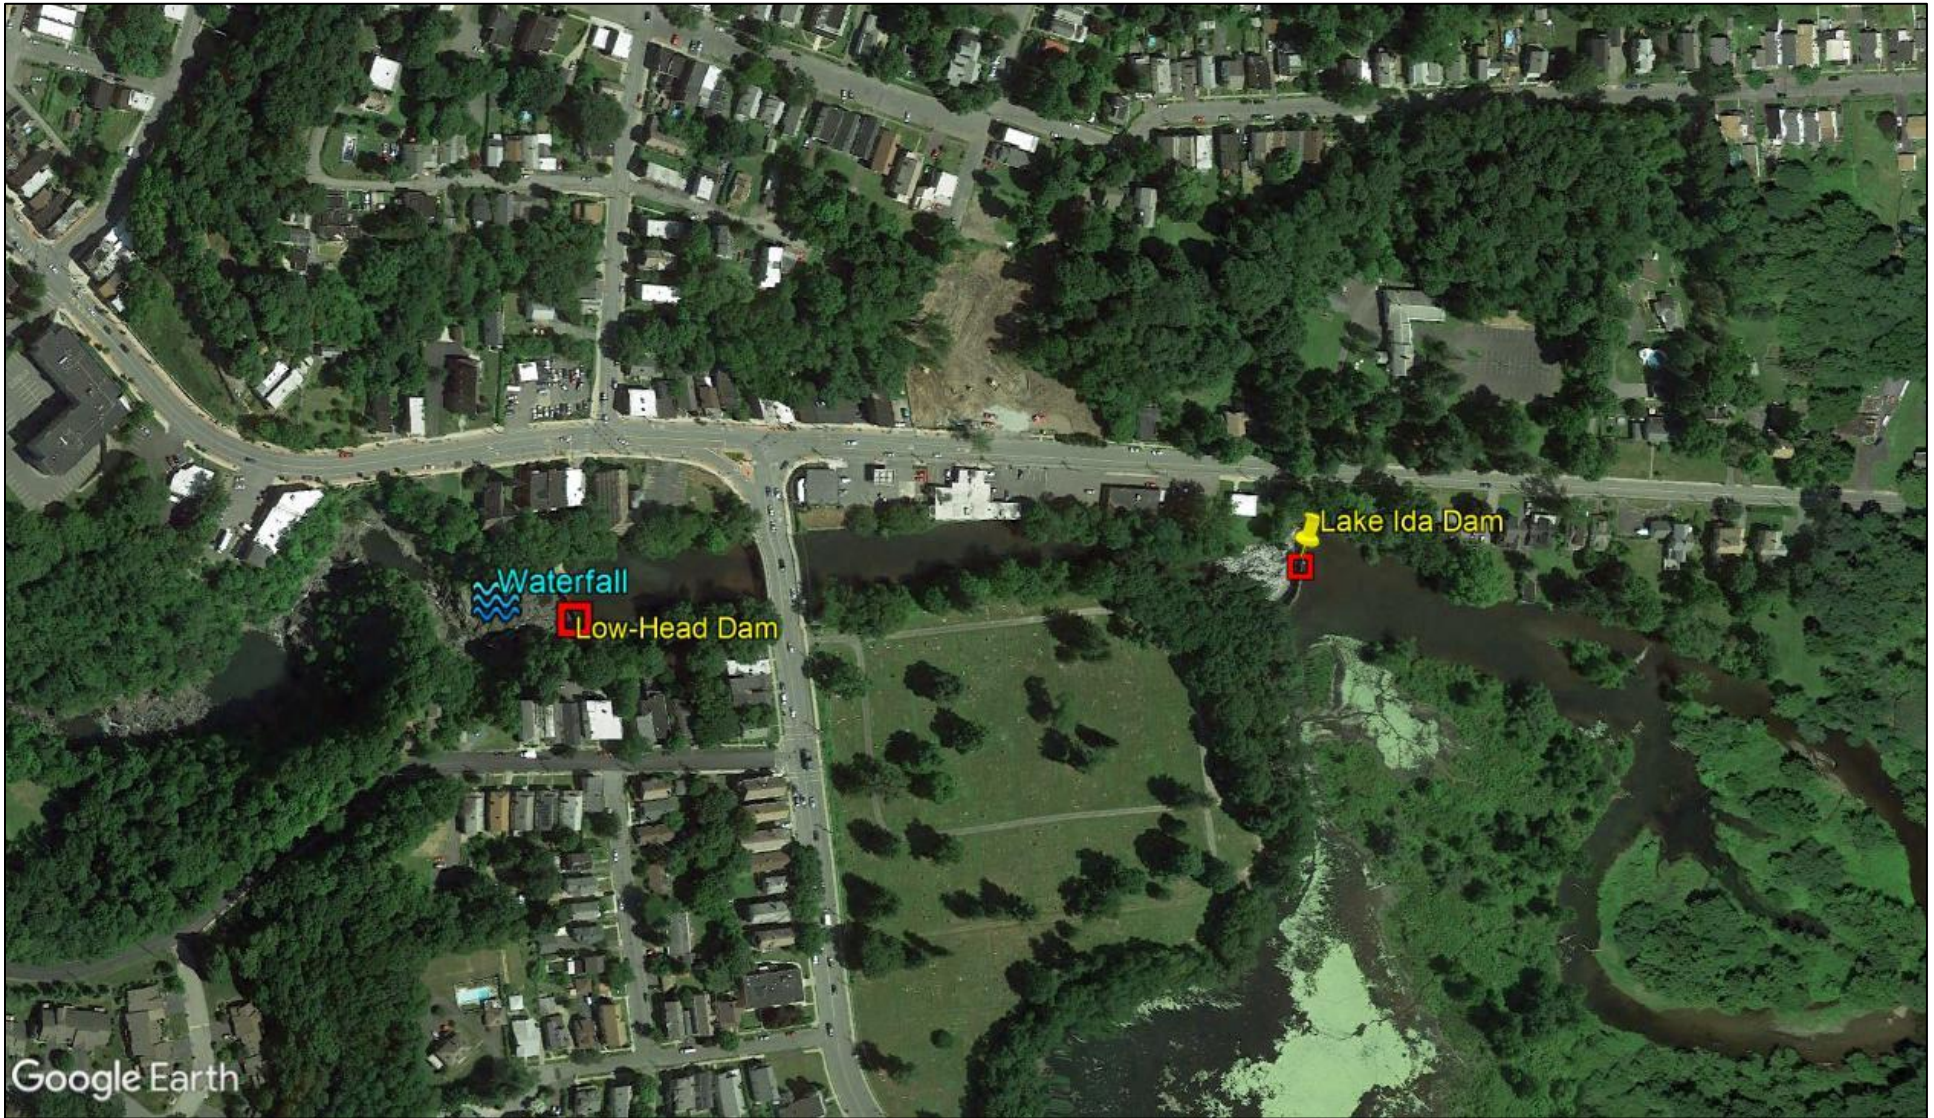
Figure 30: A map depicting the proximity of the next low-head dam downstream of the former Lake Ida dam on the Poestenkill, followed by a natural waterfall. The distance run-of-river distance between the former Lake Ida dam and the next downstream barrier is ~384 yards.

The emigration of upstream sediment, particularly sand and silt/clay, imposed negative consequences within the immediate downstream reach below the barrier. A decline in biometrics, habitat quality, and key macroinvertebrate taxa was observed. An idiosyncratic characteristic of the downstream Poestenkill reach, which is influencing the sediment emigration behavior, is the presence of a low-head dam approximately 1,150ft downstream of Lake Ida dam, positioned immediately upstream of a waterfall and gorge [Figure 30]. This dam would block the complete emigration of sediment originating from the Lake Ida impoundment, and cause it to back-up and be retained within the downstream reach monitoring locations.
