# PARROTT HALL

New York State Agricultural Experiment Station

## ARCHITECTURAL CONSERVATION ASSESSMENT

Prepared for the New York State Agricultural Experiment Station  
by Curtis Eaton  
Graduate Program in Historic Preservation  
University of Vermont  
Spring, 2000

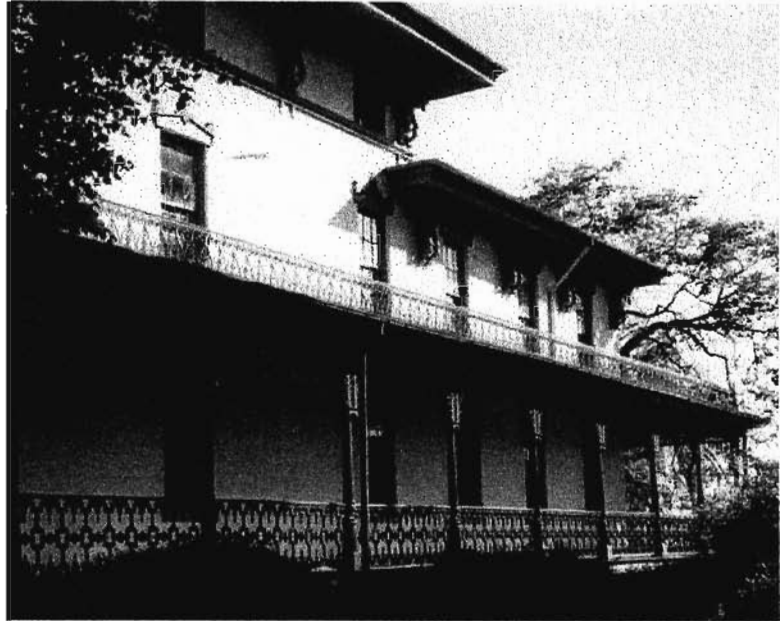
**Figure 2:** West elevation showing the wing to the rear of the main block. View from the northwest.

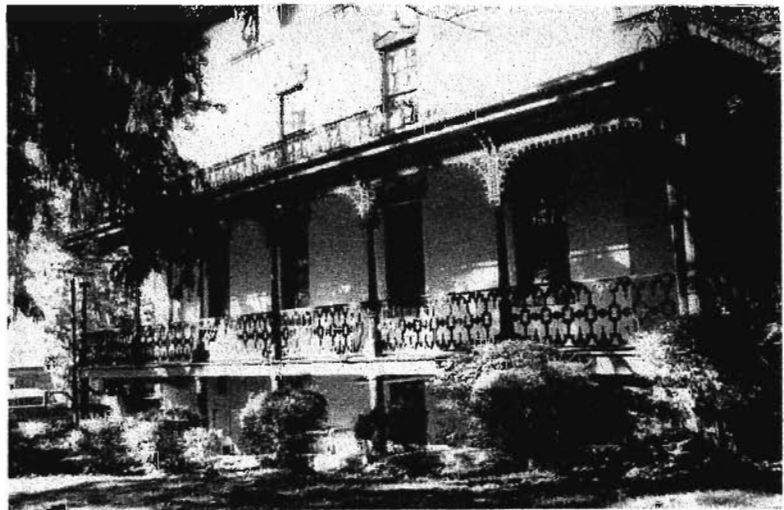
**Figure 3:** East elevation of main block showing slope of the site from north to south (front to rear), revealing basement. View from the northeast.

time, which allows water to drain onto the verandah roof directly below the main block. Since then, the rolled roofing has failed and is the major source of water infiltration in the upper stories of the building. Moisture is also being introduced into the basement through condensation, seepage, and rising damp, which together comprise a serious threat to the brick walls at this level of the structure.
